Region of Peel

# Study Area Profile

## Dixie Road Complete Corridor Study

March 2024 – Memorandum

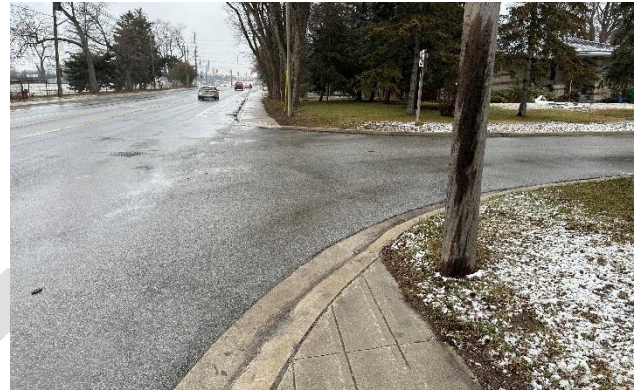
Photo Location: Dixie and Larchview, looking north

**TWSIs and crosswalk markings are absent at many unsignalized intersections.**

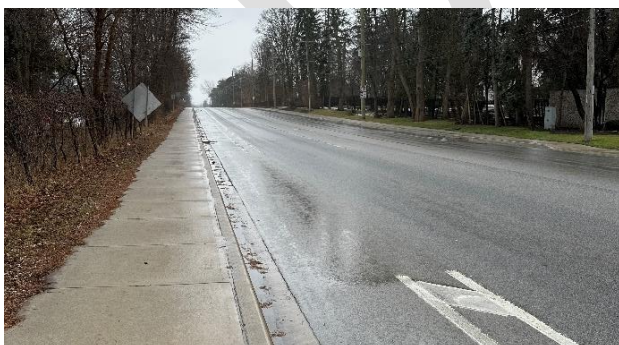
Photo Location: Dixie and Fairways Condo Access east sidewalk, looking south

**Bicycle lane markings are frequently discontinued**, especially at T-intersection locations on the side with no vehicle leg.

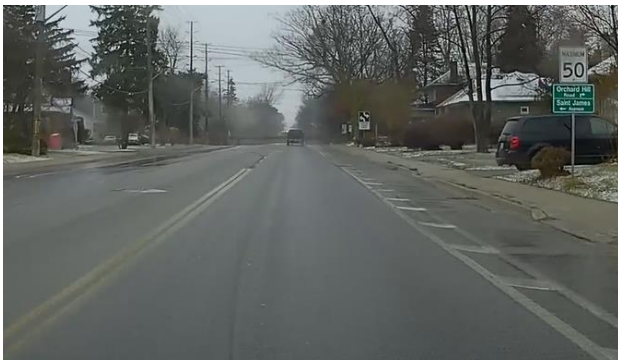
Photo Location: Dixie ~50 m north of Lakeshore, looking north

**Poor retroreflection and visibility of bicycle lane markings.**

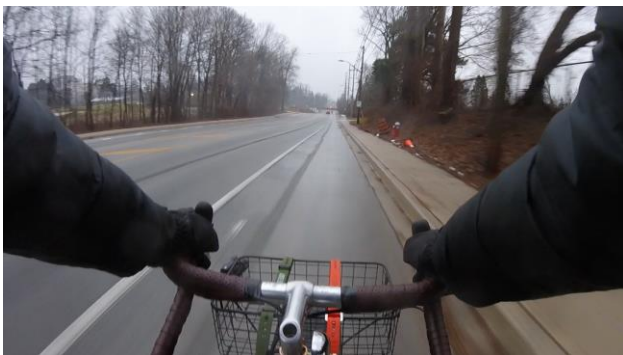
Photo Location: Dixie ~50 m north of CN Rail Underpass, looking south

**It is generally easy to cycle southbound** due to the moderate downhill grade, especially towards the CN Rail Underpass.

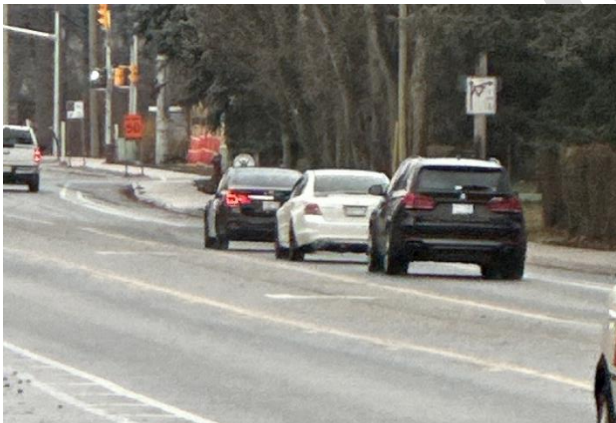
Photo Location: Dixie ~100 m south of Dixie Mall South Access, looking north

**Tailgating is frequent,** primarily against drivers that comply with the 50 km/h speed limit.

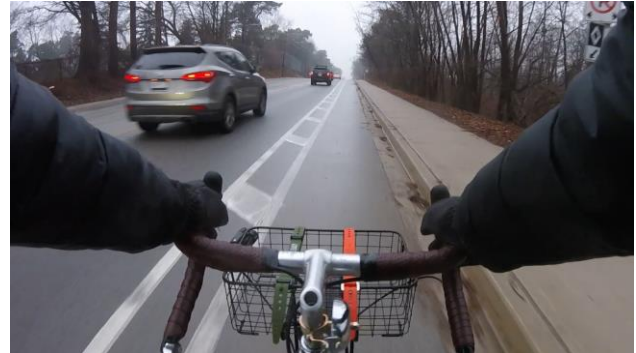
Photo Location: Dixie on east side of Lakeview Golf Course access, looking north

**Drivers tend to drive closer to the inner line and distance themselves from the buffer in the presence of cyclists.**

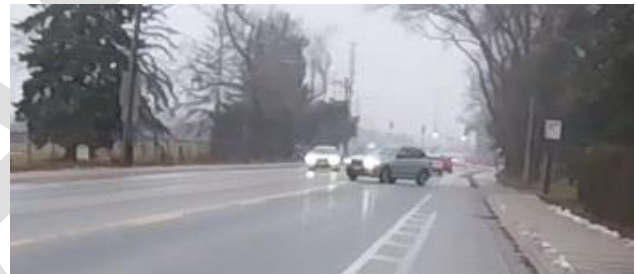
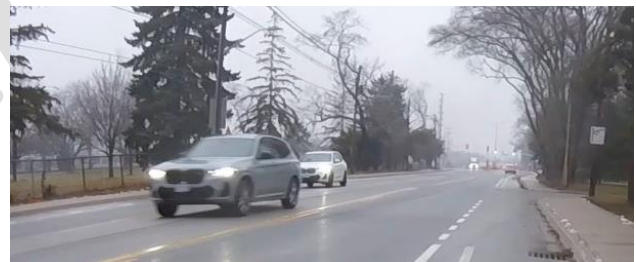
Photo Location: Dixie ~50 m south of Larchview Trail, looking north

**Frequent permissive turning opportunities corridor-wide.** At all intersections, vehicles travelling in/out of side streets had multiple entering/exiting opportunities during peak hours. However, vehicles exiting side streets would occasionally use the TWLTL to cross Dixie in two stages.

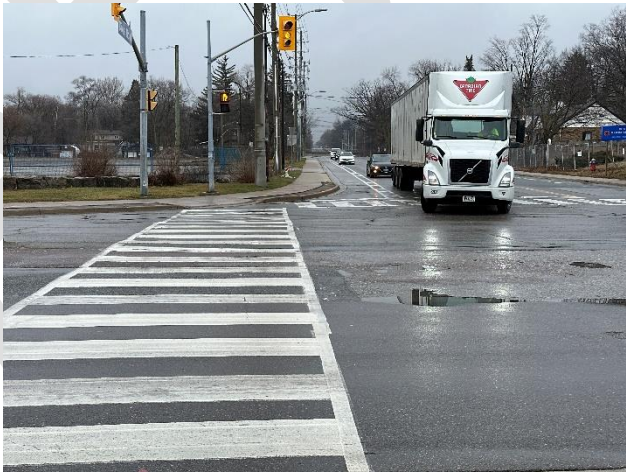
**Geometrics:** Large vehicles are frequently observed on the southbound right approach and can clear the turn with ample space.  
Photo Location: SW corner, looking north

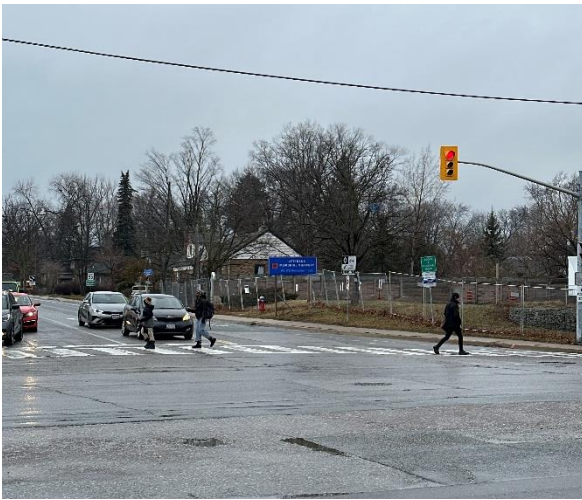
Photo Location: SW corner, looking north

**Pedestrian Activity:** School-aged pedestrians frequently cross the intersection from adjacent MiWay bus stops.

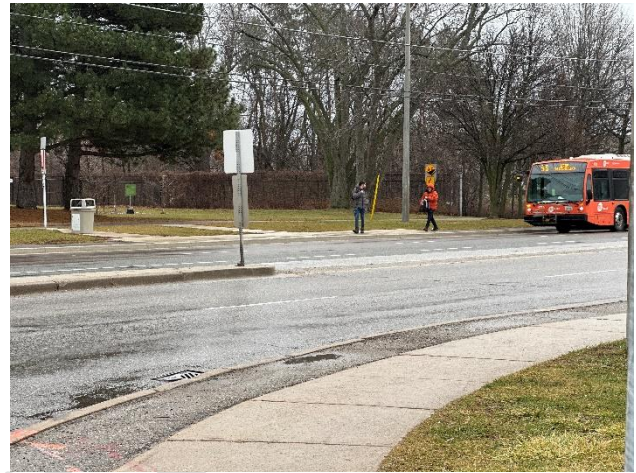
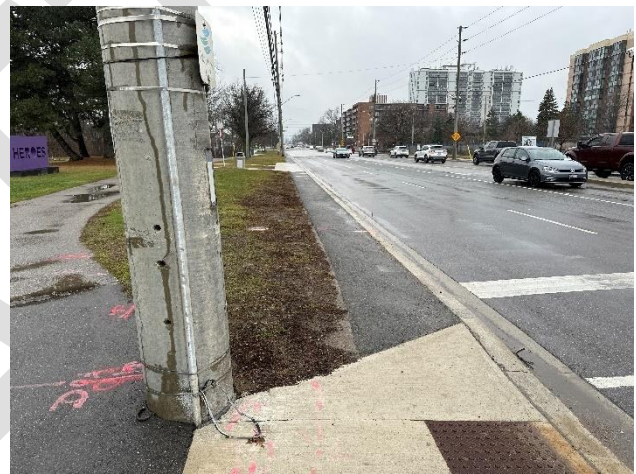
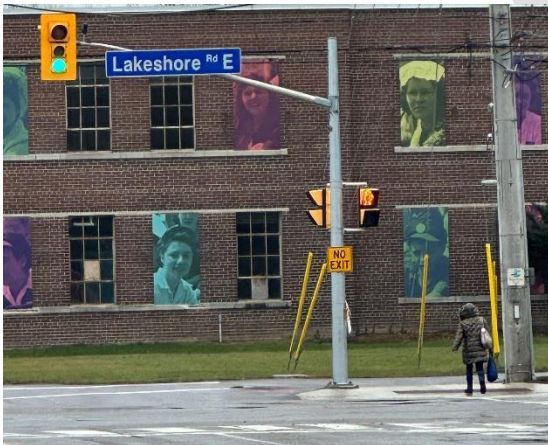
**Pedestrian Activity:** Occasionally, pedestrians will cross the solid “don’t-walk” indication if they miss an opportunity to actuate the pedestrian pushbutton.

**Pedestrian Activity:** Pedestrians boarding/alighting from the eastbound bus stop tend to use the narrower walkway instead of the multi-use path to reach the Lakeshore intersection. Grass condition may suggest that pedestrians walk on the inner side, or fully off the asphalt walkway.

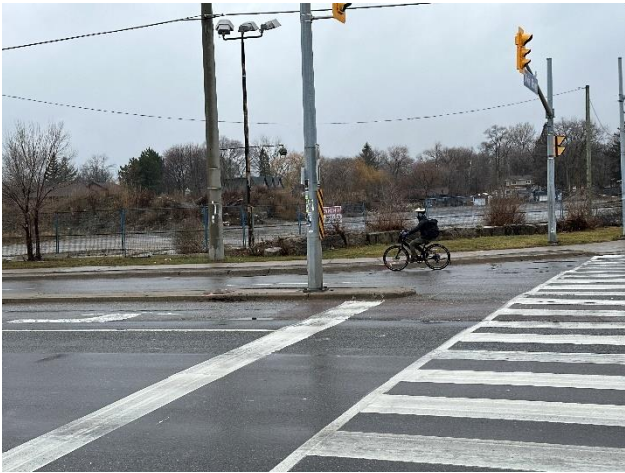
Photo Location: Southwest corner, looking north

**Cycling Activity:** During the PM peak period, two cyclists were observed travelling westbound on Lakeshore. Cyclists continued to use the vehicle right-of-way on Lakeshore Road headed west of the intersection, instead of the Waterfront Trail.

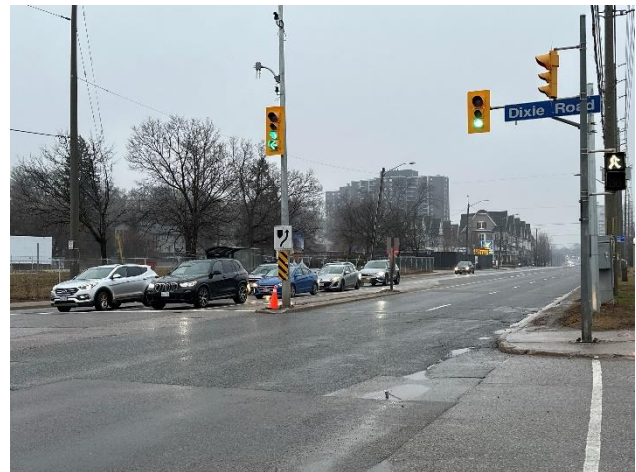
Photo Location: SW corner, looking east

**Traffic Observations – AM Peak:** Moderate westbound through traffic with 7-11 car queues that occasionally extend up to Cherriebell Road. Light westbound left turning traffic. All queues clear quickly and in one cycle.

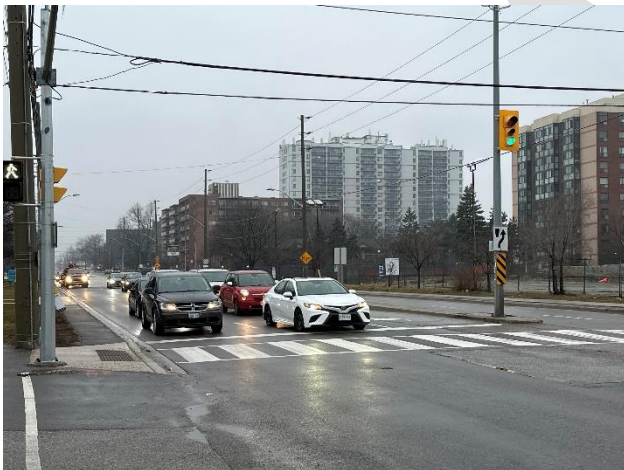
Photo Location: SE corner, looking west

**Traffic Observations – AM Peak:** Light to moderate eastbound traffic. Queues clear in one cycle and eastbound left-turning vehicle queues generally clear before the protected period (green arrow) ends.

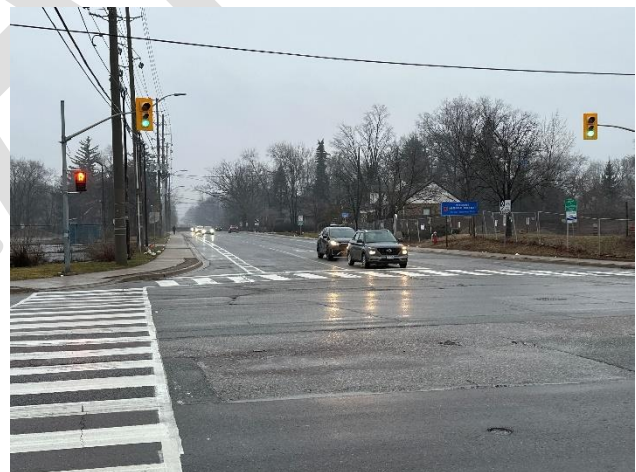
Photo Location: SW corner, looking north

**Traffic Observations – AM Peak:** Light southbound traffic. Most vehicles (95%+) in the shared southbound through-right lane turn right. Queues clear in one cycle and all turns are traversed slowly by drivers.

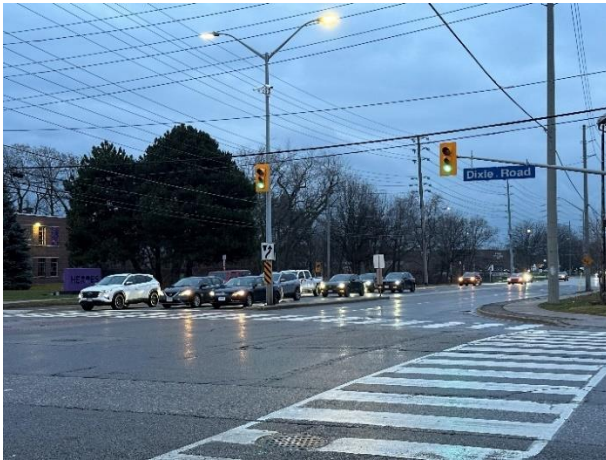
Photo Location: NE corner, looking west

**Traffic Observations – PM Peak:** Moderate to heavy eastbound traffic, with the eastbound left turning storage occasionally exceeded. However, queues clear in one cycle and there are multiple permissive periods where vehicles could turn on green. Vehicles at the back of the queue tend to speed up to complete the turn before the protected period (green arrow) ends.

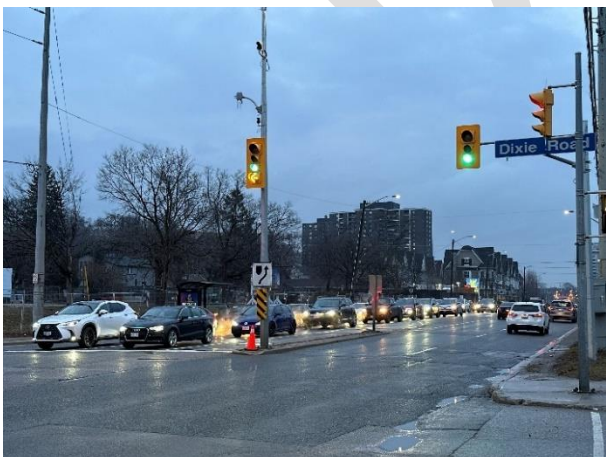
Photo Location: SW corner, looking east

**Traffic Observations – PM Peak:** Heavy westbound through traffic with queues that extend to the west end of the gas station, but light westbound left turning traffic. However, queues clear quickly and in one cycle.

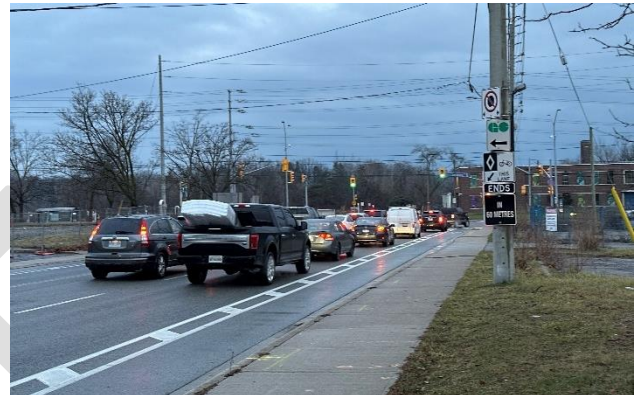
Photo Location: ~50 m north of intersection, looking south

**Traffic Observations – PM Peak:** Moderate to heavy southbound traffic. Most vehicles (95%+) in the shared southbound through-right lane turn right. Queues clear in one cycle and all turns are traversed slowly by drivers.

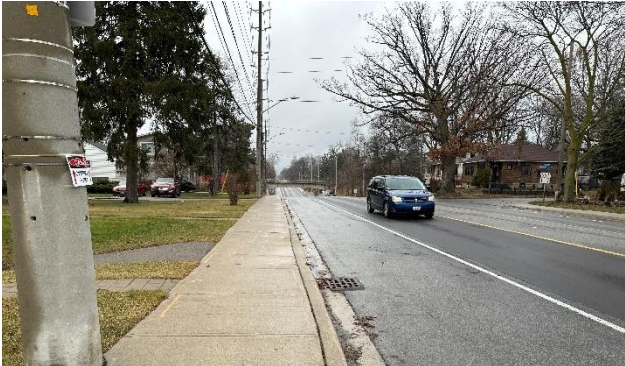
Photo Location: On northwest corner, looking north

**Cycling Facilities:** No buffer headed southbound into intersection.

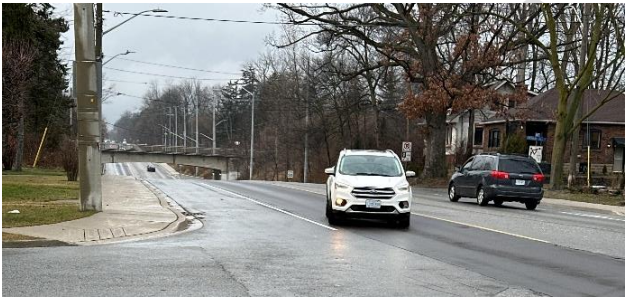
Photo Location: On southwest corner, looking north

**Driver Behaviour:** Southbound right turning drivers obey the bicycle lane markings when turning, and perform their turn slowly.

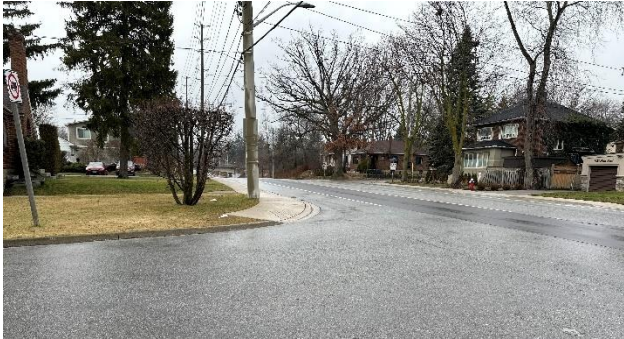
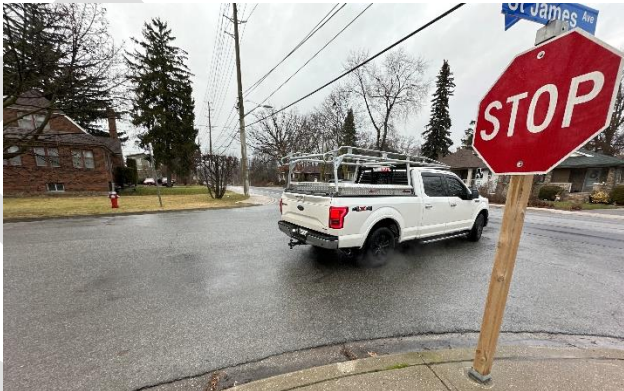
Photo Location: On eastbound approach, looking north

**Motor Vehicle Facilities:** Sightlines facing north are partially obstructed by utility poles, vegetation, and the grade change at the underpass. This requires drivers to encroach the pedestrian right-of-way for a clear sightline.

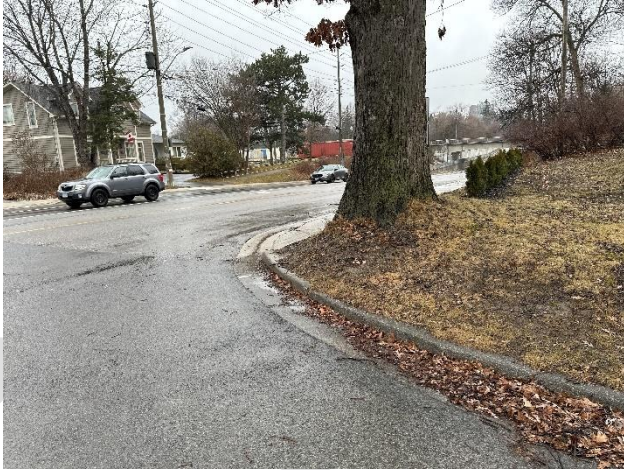
**Motor Vehicle Facilities:** Sightlines facing north are partially obstructed by large tree and grade change at the underpass, requiring drivers to encroach the pedestrian right-of-way for a clear sightline.  
Photo Location: On westbound approach, looking north

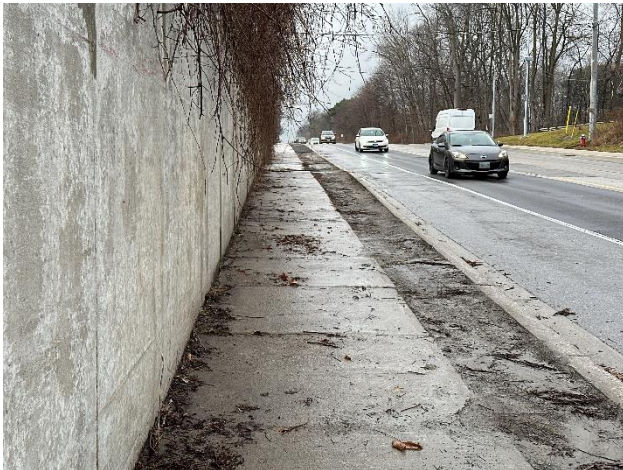
**Pedestrian Facilities:** Low-hanging branches from trees above retaining wall encroach on right-of-way .

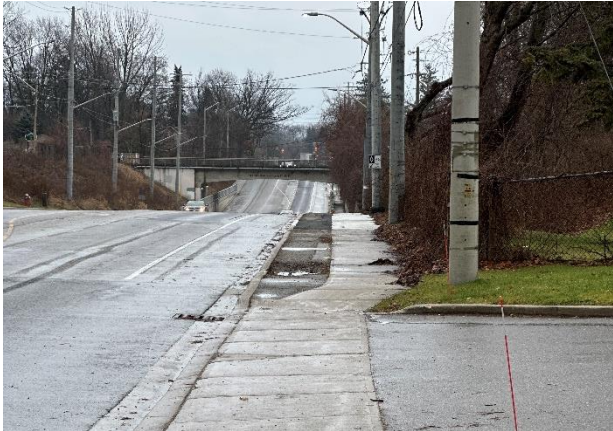
**Pedestrian Facilities:** West sidewalk narrows south of the intersection.

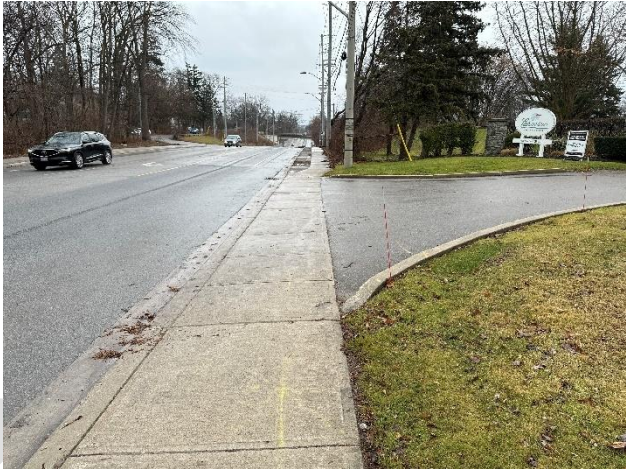
**Motor Vehicle Facilities:** Southbound right turning radius is large.

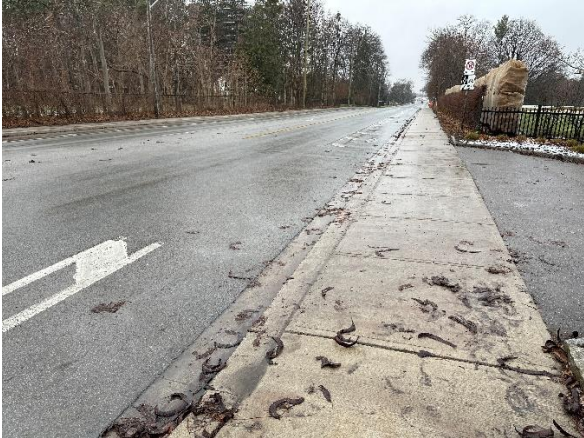
**Cycling Facilities:** Bicycle lane markings are discontinued through intersection.

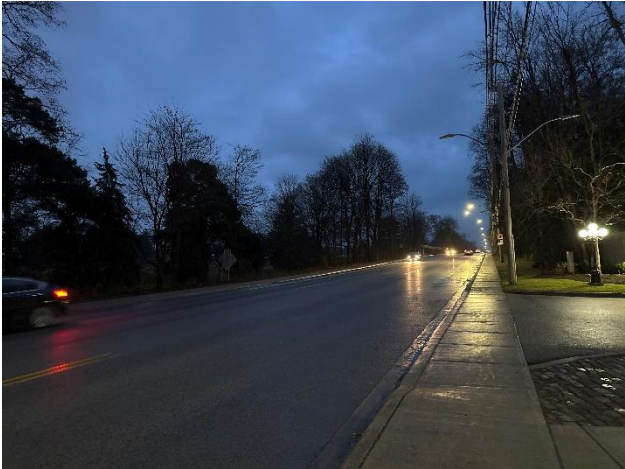
**Pedestrian Facilities:** No streetlighting is provided on the east side of the intersection.

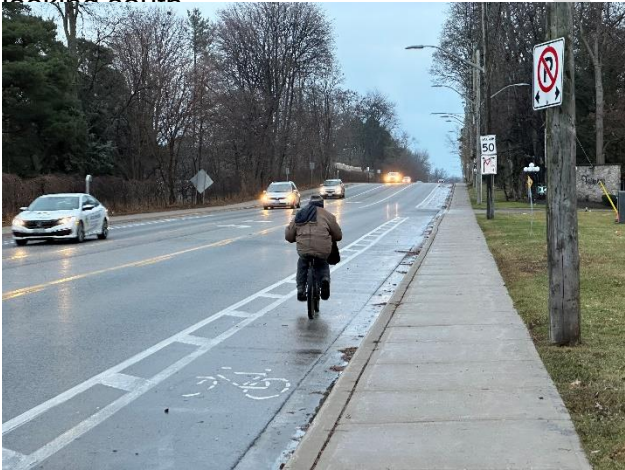
**Cycling Activity:** Seniors were commonly spotted around the Fairways Condo area, with some observed to be cycling around the area.

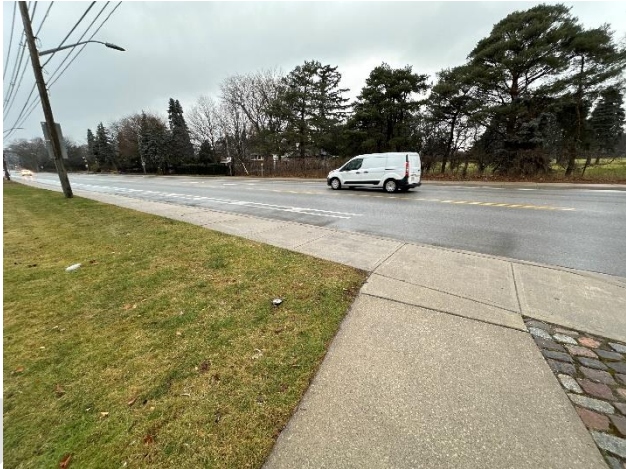
**Driver Behaviour:** Eastbound left turning drivers at this intersection have multiple permissive opportunities in all periods. Occasionally, drivers use the TWLTL to cross Dixie Road in two stages.

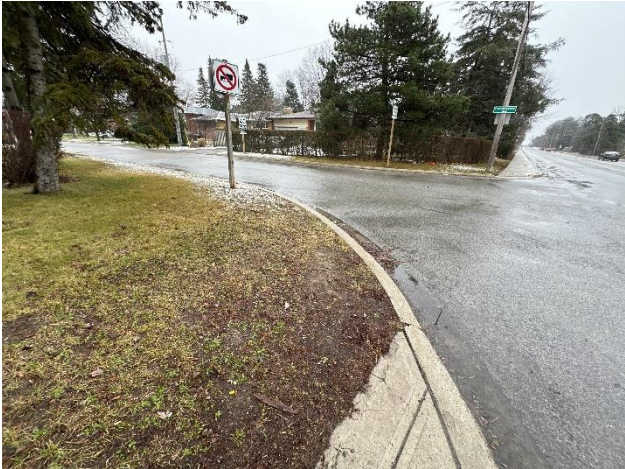
**Pedestrian Facilities:** Potential desire line on north side of intersection leads into roadway, as there is no crosswalk on Larchview Trail.

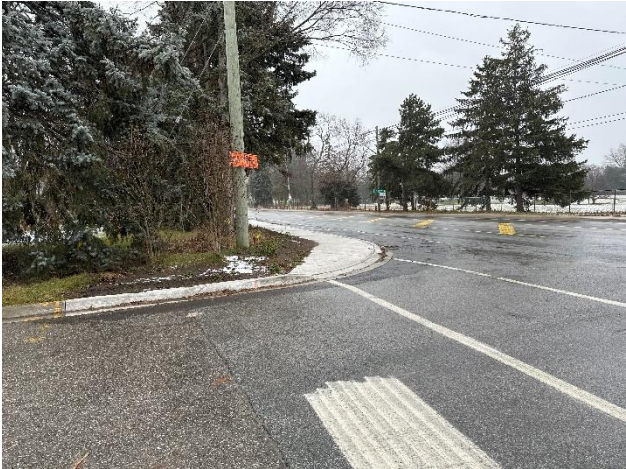
**Motor Vehicle Facilities:** Sightlines looking south are partially obstructed by vegetation and requires drivers to encroach the pedestrian right-of-way for a clear sightline.

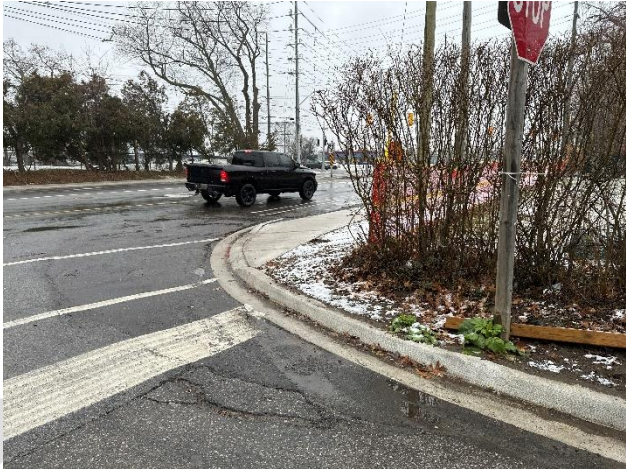
Sightlines looking north are partially obstructed by vegetation and requires drivers to encroach the pedestrian right-of-way for a clear sightline.

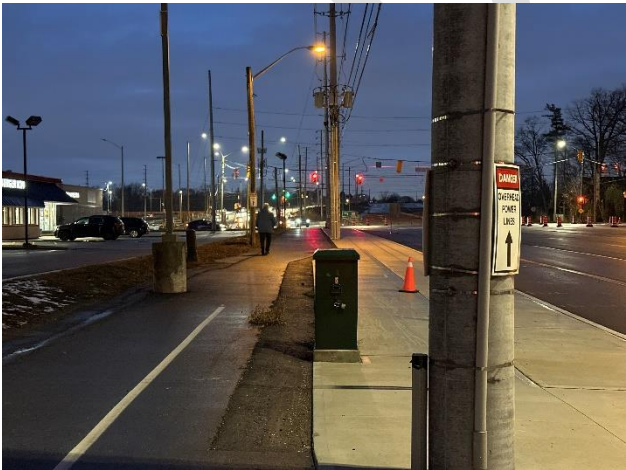
**Pedestrian Activity:** Pedestrians travelling on the northwest side tend to use the multi-use path instead of the concrete sidewalk.

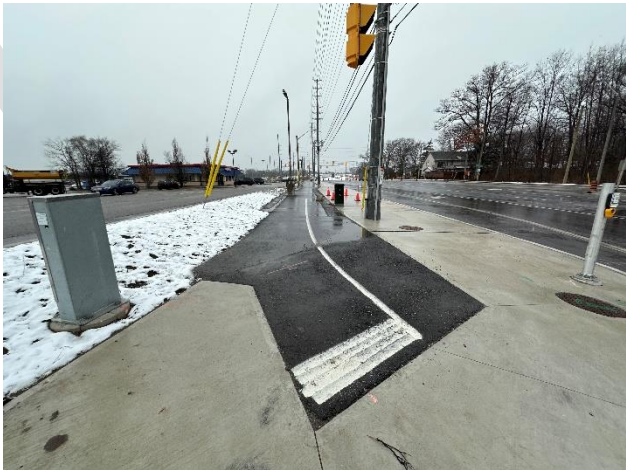
**Pedestrian Facilities:** A multi-use path has been installed parallel to the sidewalk on the northwest side of the intersection.

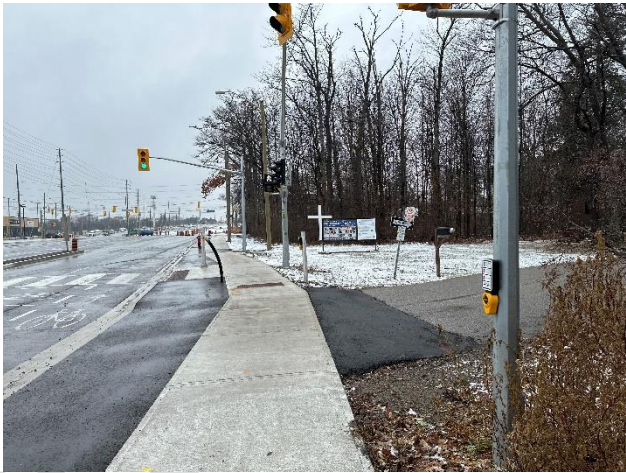
**Pedestrian Facilities:** Lack of eastbound through traffic and short crossing distance enables pedestrians to cross the east side crosswalk on red hand indication.

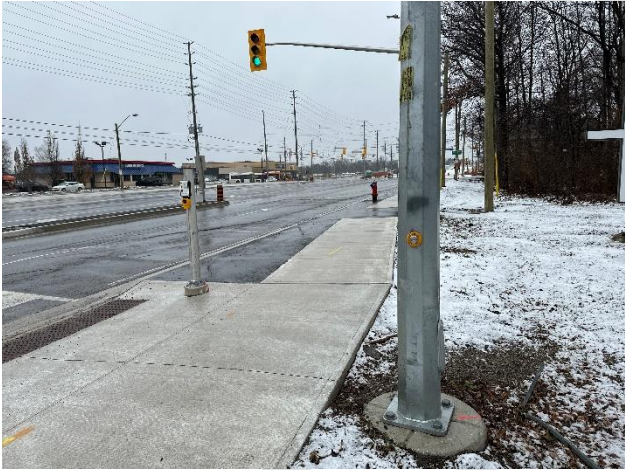
**Pedestrian Facilities:** At the northeast corner crossing the north crosswalk, the standard pushbutton remains on the traffic mast.

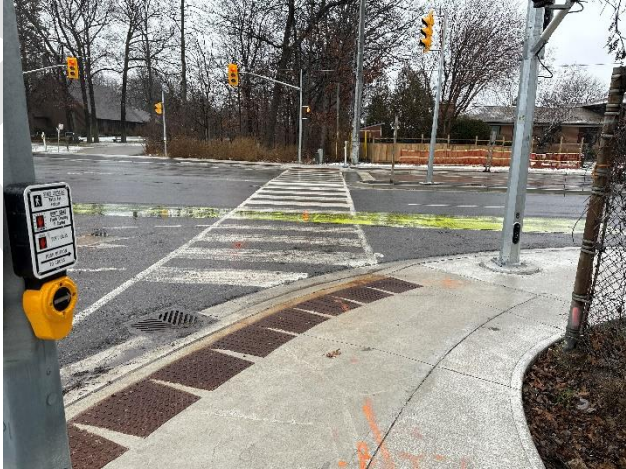
**Pedestrian Facilities:** The APS on the southwest corner is located far from the south side crosswalk, and on the same pole as the west side crosswalk APS.

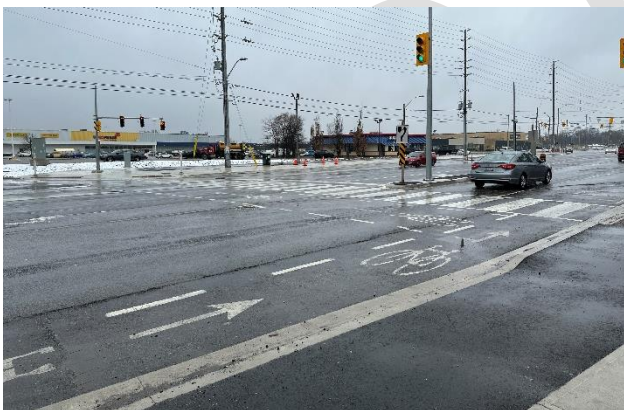
**Cycling Facilities:** The east side bikeway transition to the multi-use path does not contain a bike box or storage area.

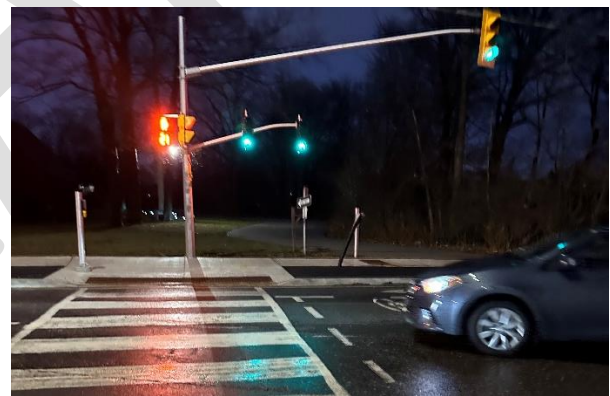
**Driving Behaviour:** Eastbound left turning vehicles often do not yield to pedestrians until they reach the median. There are 4 southbound lanes that eastbound pedestrians must traverse to reach the median. Meanwhile, westbound pedestrians must traverse only 2 lanes.

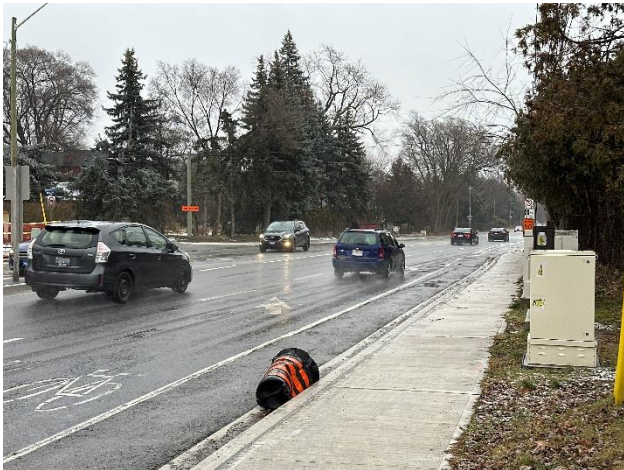
**Driving Behaviour:** Drivers frequently use the cycling facility tie-in to aggressively overtake slower vehicles.

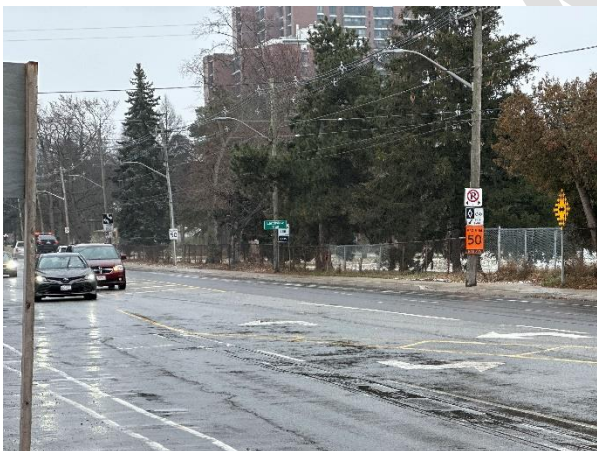
**Driving Behaviour:** Northbound left turning vehicles tend to encroach median very early, conflicting with southbound left turning traffic into Londonderry.

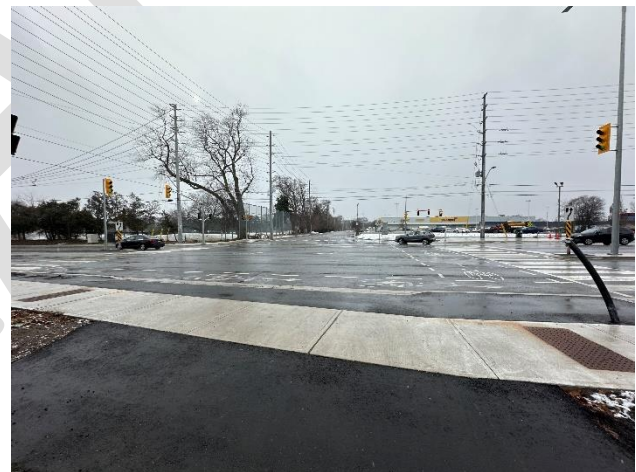
**Motor Vehicle Facilities:** The westbound approach is not signalized, as this leg is signed as a one-way route outbound of the intersection (eastbound traffic only).

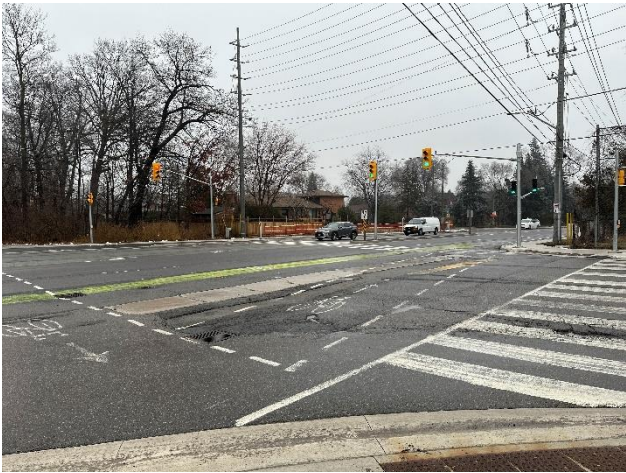
**Traffic Observations – AM Peak:** Light to moderate northbound traffic. Most vehicles traverse the intersection during green indication and queues are very short (~1-2 cars). No operational issues observed.

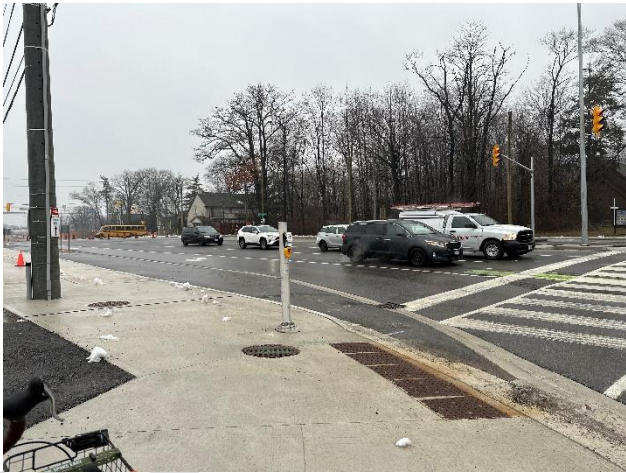
**Traffic Observations – AM Peak:** Light southbound traffic. No operational issues observed.

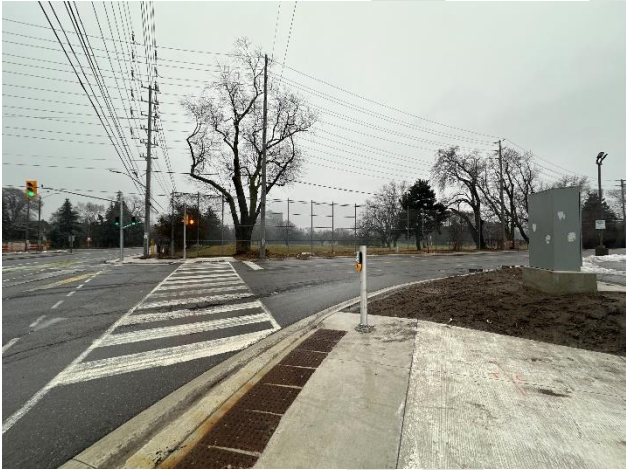
**Traffic Observations – AM Peak:** Light eastbound traffic. No operational issues observed.

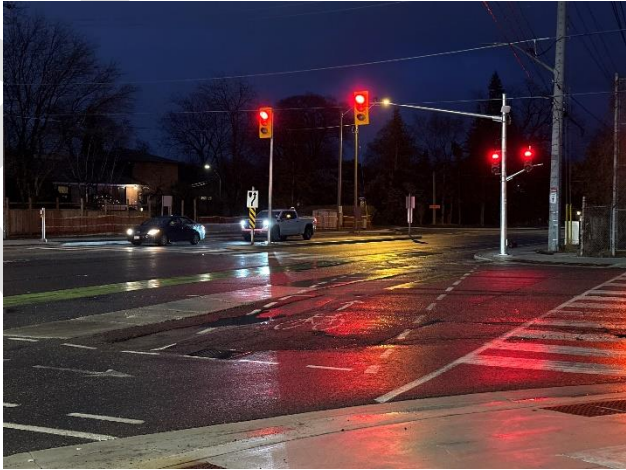
**Traffic Observations – PM Peak:** Light northbound traffic, with multiple permissive left turning opportunities. No operational issues observed.

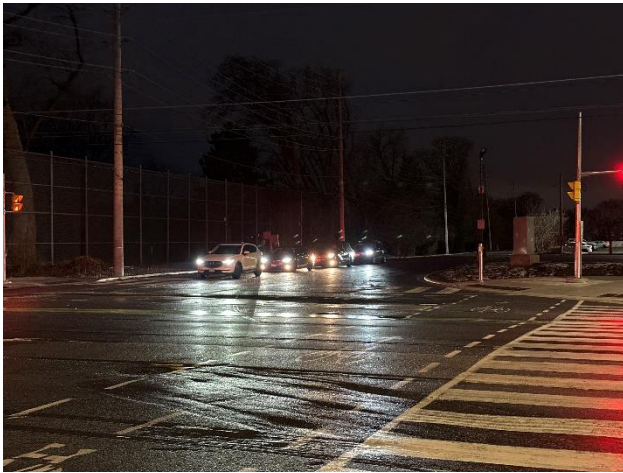
**Traffic Observations – PM Peak:** Light eastbound traffic which tends to be evenly distributed among left and right turn lanes. No operational issues observed.

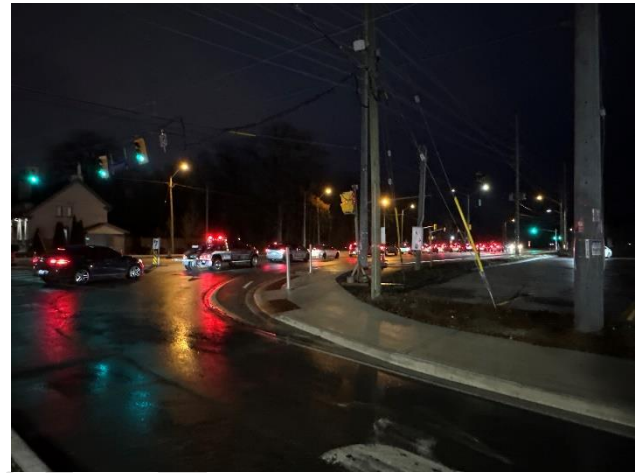
**Traffic Observations – PM Peak:** Occasional southbound spillbacks on green indication are observed, but queues clear quickly and in one cycle.

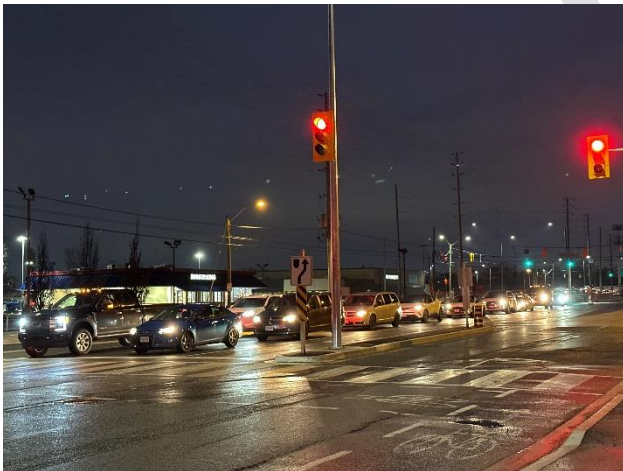
**Traffic Observations – PM Peak:** Heavy southbound traffic with queues that extend to the south end of Burger King. Little to no southbound left turning traffic. All queues, however, clear in one cycle.

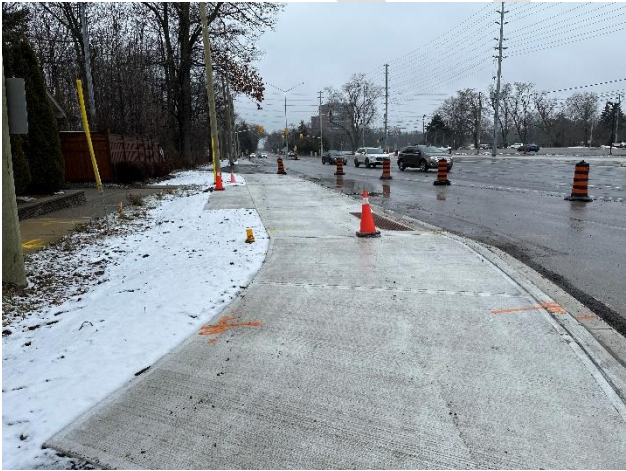
**Pedestrian Facilities:** Southeast sidewalk has recently been widened, with a new depressed curb and TWSI further from the intersection.

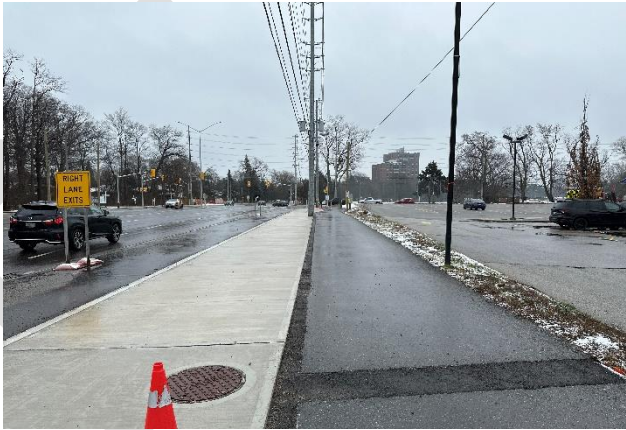
**Pedestrian Facilities:** West sidewalk has been significantly widened, with a new multi-use path added.

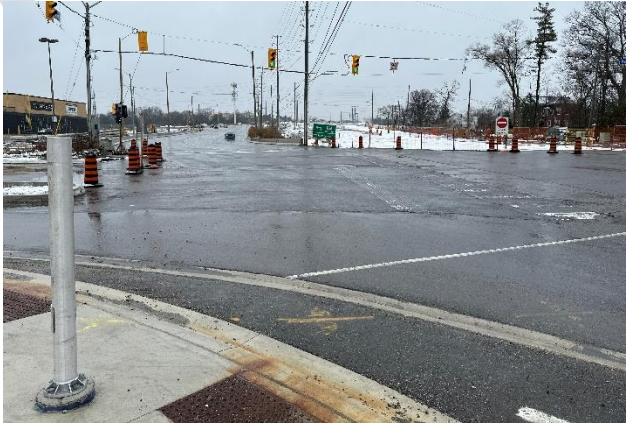
**Pedestrian Facilities:** There is currently no painted crosswalk on the west leg.

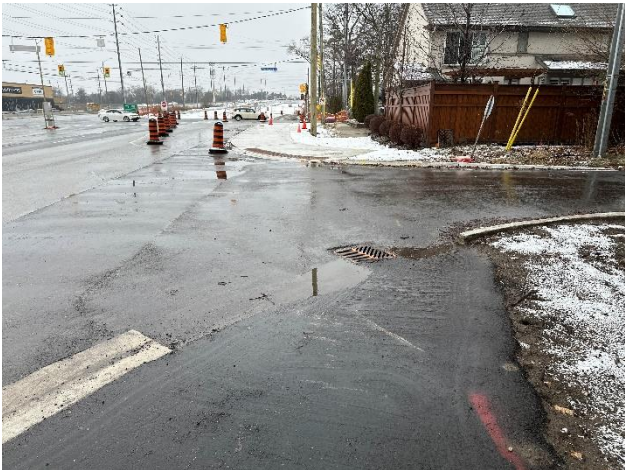
**Pedestrian Facilities:** TWSIs are currently installed on northeast corner, but not on the southeast corner.

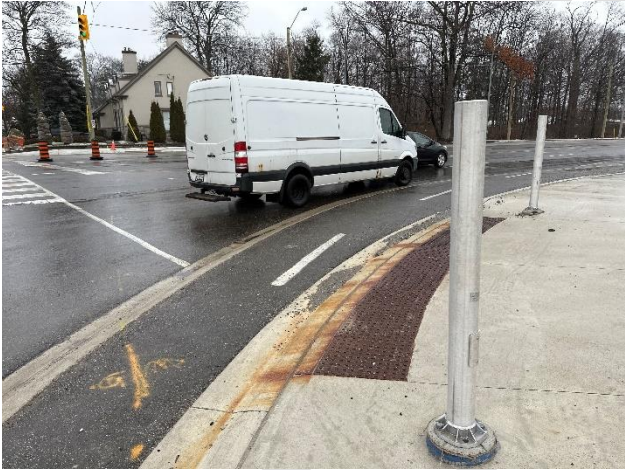
**Driving Behaviour:** Southbound through vehicles tend to drive over curb extension, or encroach on the leftmost lane to avoid it.

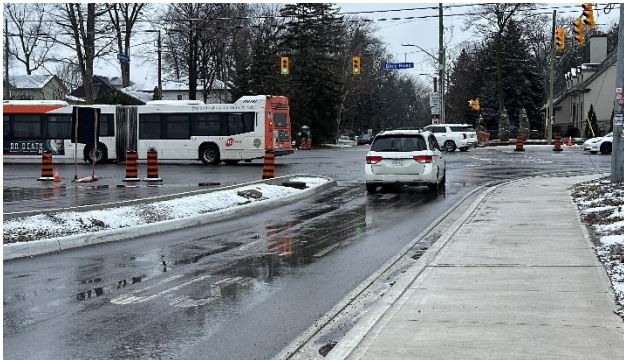
**Motor Vehicle Facilities:** The eastbound approach has bus markings painted in, indicating that a future bus lane from the Dixie Mall parking lot is to be added parallel to general traffic lanes. Note that no transit signals have been installed on the traffic masts as of the field reconnaissance date (January 11, 2024).

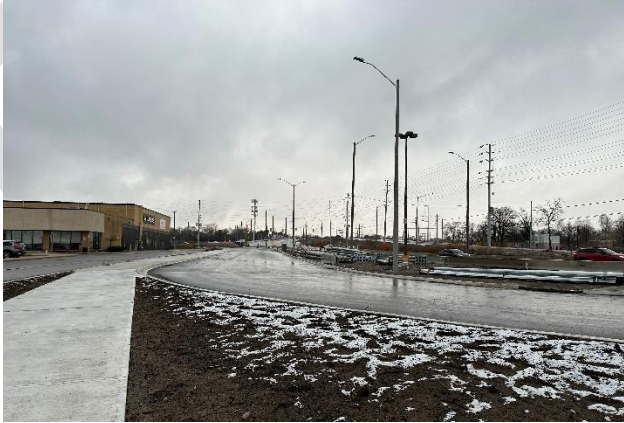
**Motor Vehicle Facilities:** General traffic lanes on the eastbound approach are no longer connected directly to Dixie Mall. This approach is now connected to South Service Road. No lane markings have been implemented as of the field reconnaissance date (January 11, 2024).

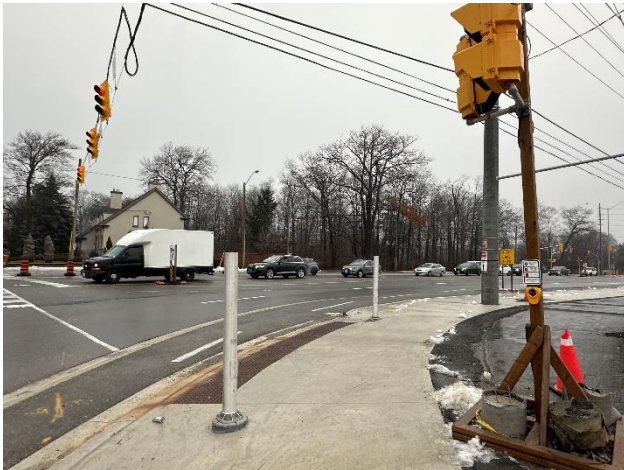
**Traffic Observations – AM Peak:** Moderate northbound traffic. Queues extend one car length short of the Dixie Mall South Access. Queues clear in one cycle.

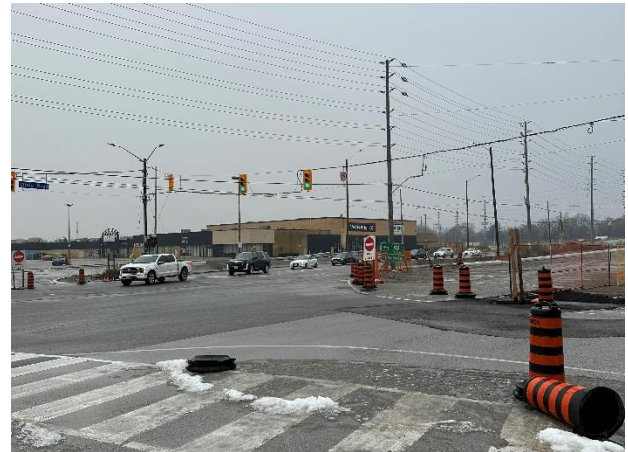
**Traffic Observations – AM Peak:** Light to moderate southbound traffic. Queues clear in one cycle

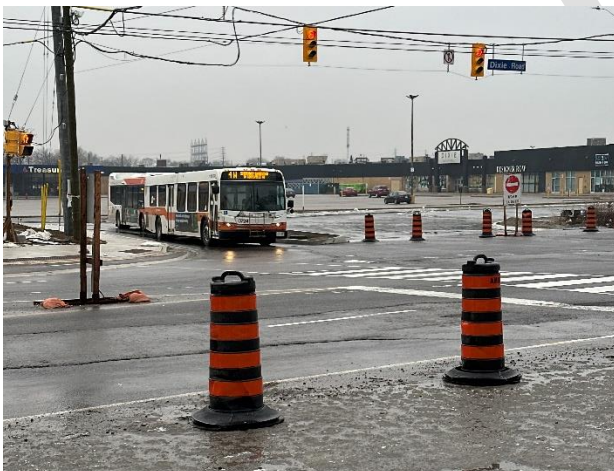
**Traffic Observations – AM Peak:** Light eastbound traffic generally composed of MiWay buses. Signal delay is high, as left turning buses must wait a long time before eastbound green indication is received, even with a pedestrian call at the beginning of the cycle.

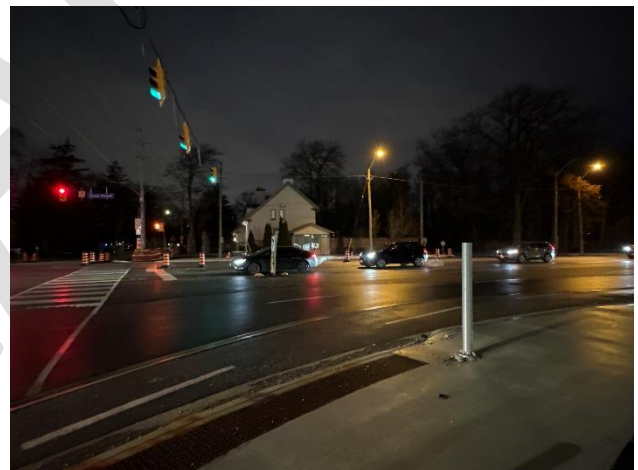
**Traffic Observations – PM Peak:** Light northbound traffic. No operational issues observed.

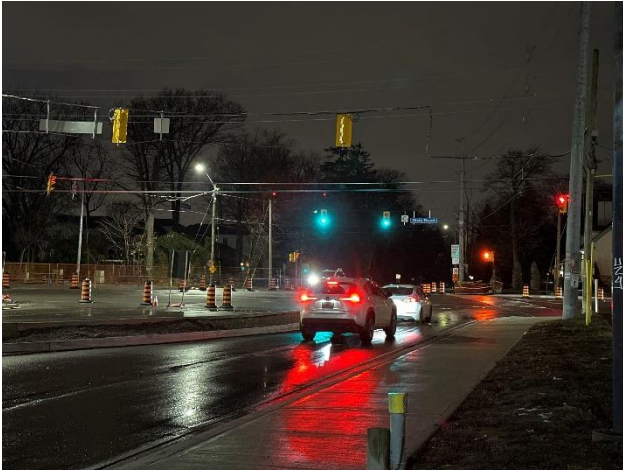
**Traffic Observations – PM Peak:** Light eastbound traffic which currently uses the bus lane as a temporary access measure. No operational issues observed.
