Region of Peel

Addendum to Environmental Study Report

**Improvements to Bovaird Drive, from Lake Louise Drive/Worthington
Avenue to 1.45 km west of Heritage Road in the City of Brampton**

May 2015

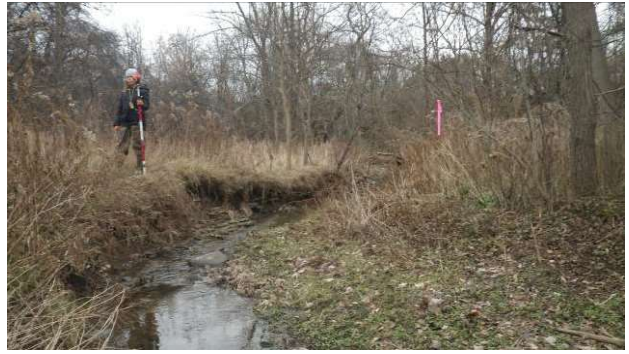
XS 10: View facing downstream. Note bank erosion along outside meander bend (left bank). Right bank has gradual slope.

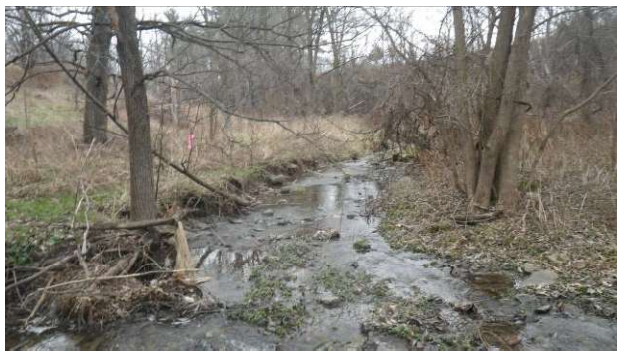
XS 8: View facing downstream. Minor woody debris accumulating around tree on left bank. Left bank also experiencing erosion.

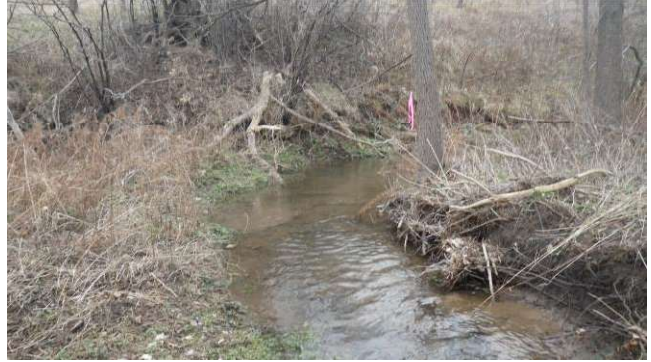
XS 7: View facing downstream. Bank erosion present along outside meander bends.

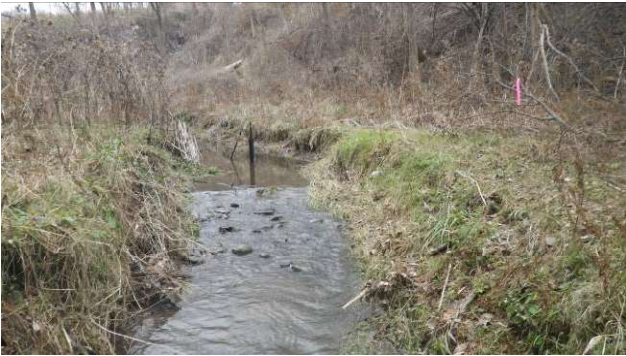
XS 6: View facing upstream. Bank erosion can be seen along both banks.

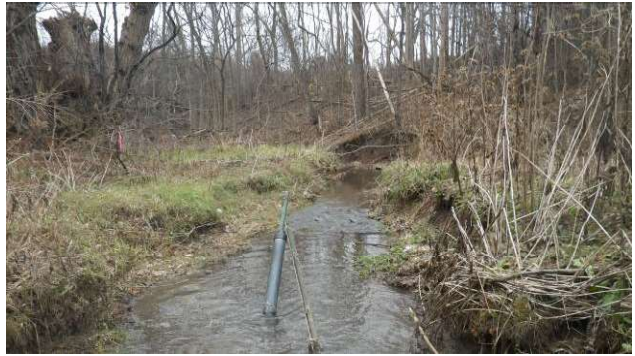
XS 6: View facing downstream. Slightly more substantial bank erosion along right bank. Valley constraints appearing at the downstream extent of the reach.

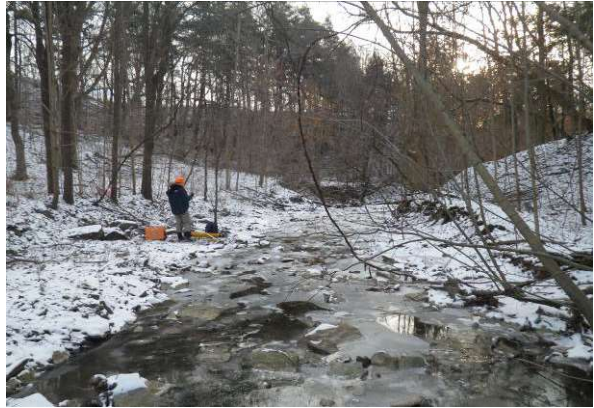
XS 5: View facing downstream. Channel slightly wider than downstream XS's. Scour along right bank resulting in leaning trees and exposure of roots.

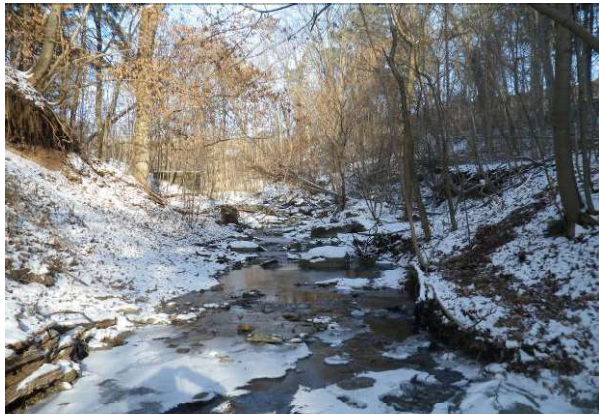
XS 4: View facing upstream. Exposed roots present along banks with overhanging vegetation observed on right bank (valley wall contact).

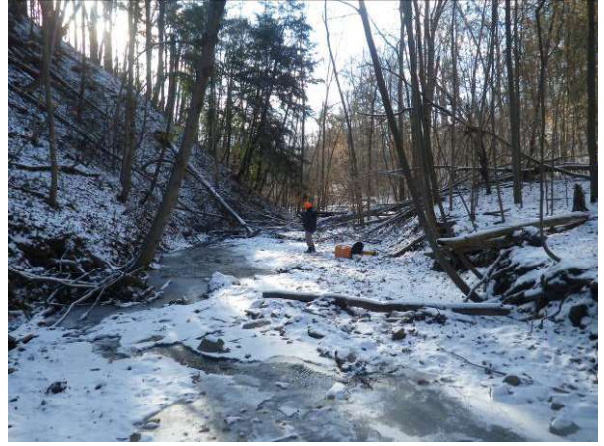
XS 3: View facing downstream. Valley wall contact on left bank. Exposed roots and J-shaped trees located on banks, indicative of widening.

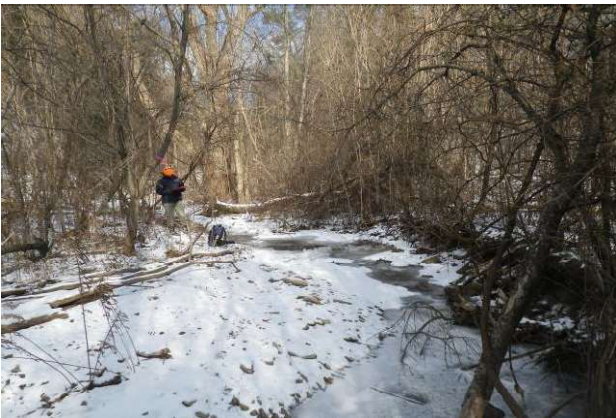
XS 1: View facing upstream. Located approx. 15m from Credit River confluence. Banks are much lower with some scouring occurring along outside meander bend (left bank).

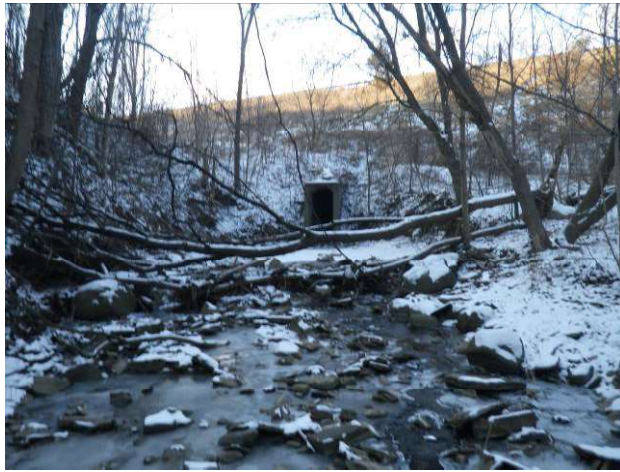
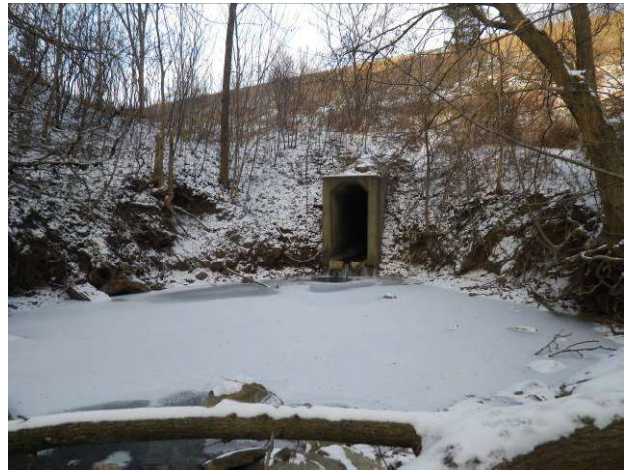
View facing upstream at the Bovaird Drive culvert outlet. It is evident that the culvert is undersized in relation to the existing watercourse. Scour along bed and banks of channel have resulted.

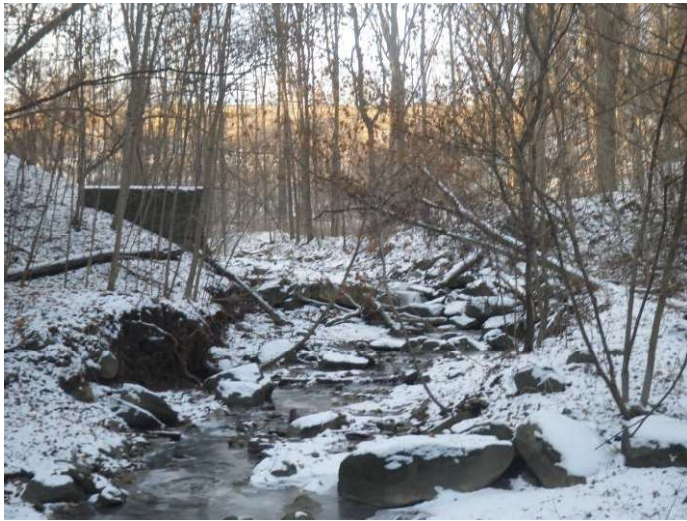
View facing upstream at remnants of an old weir located approximately 60m from the upstream reach extent. A sudden drop in bed elevation was observed at this location along with the inclusion of large boulders within the channel.
