FOR TYPICAL TOP SECTION AND FRAME AND COVER REHABILITATION OPTIONS REFER TO STD. DWGS. 2-8-4 TO 2-8-9

REHABILITATION TYPICAL EXISTING PRECAST MAINTENANCE HOLE JOINT REPAIR OPTION - NO EXCAVATION

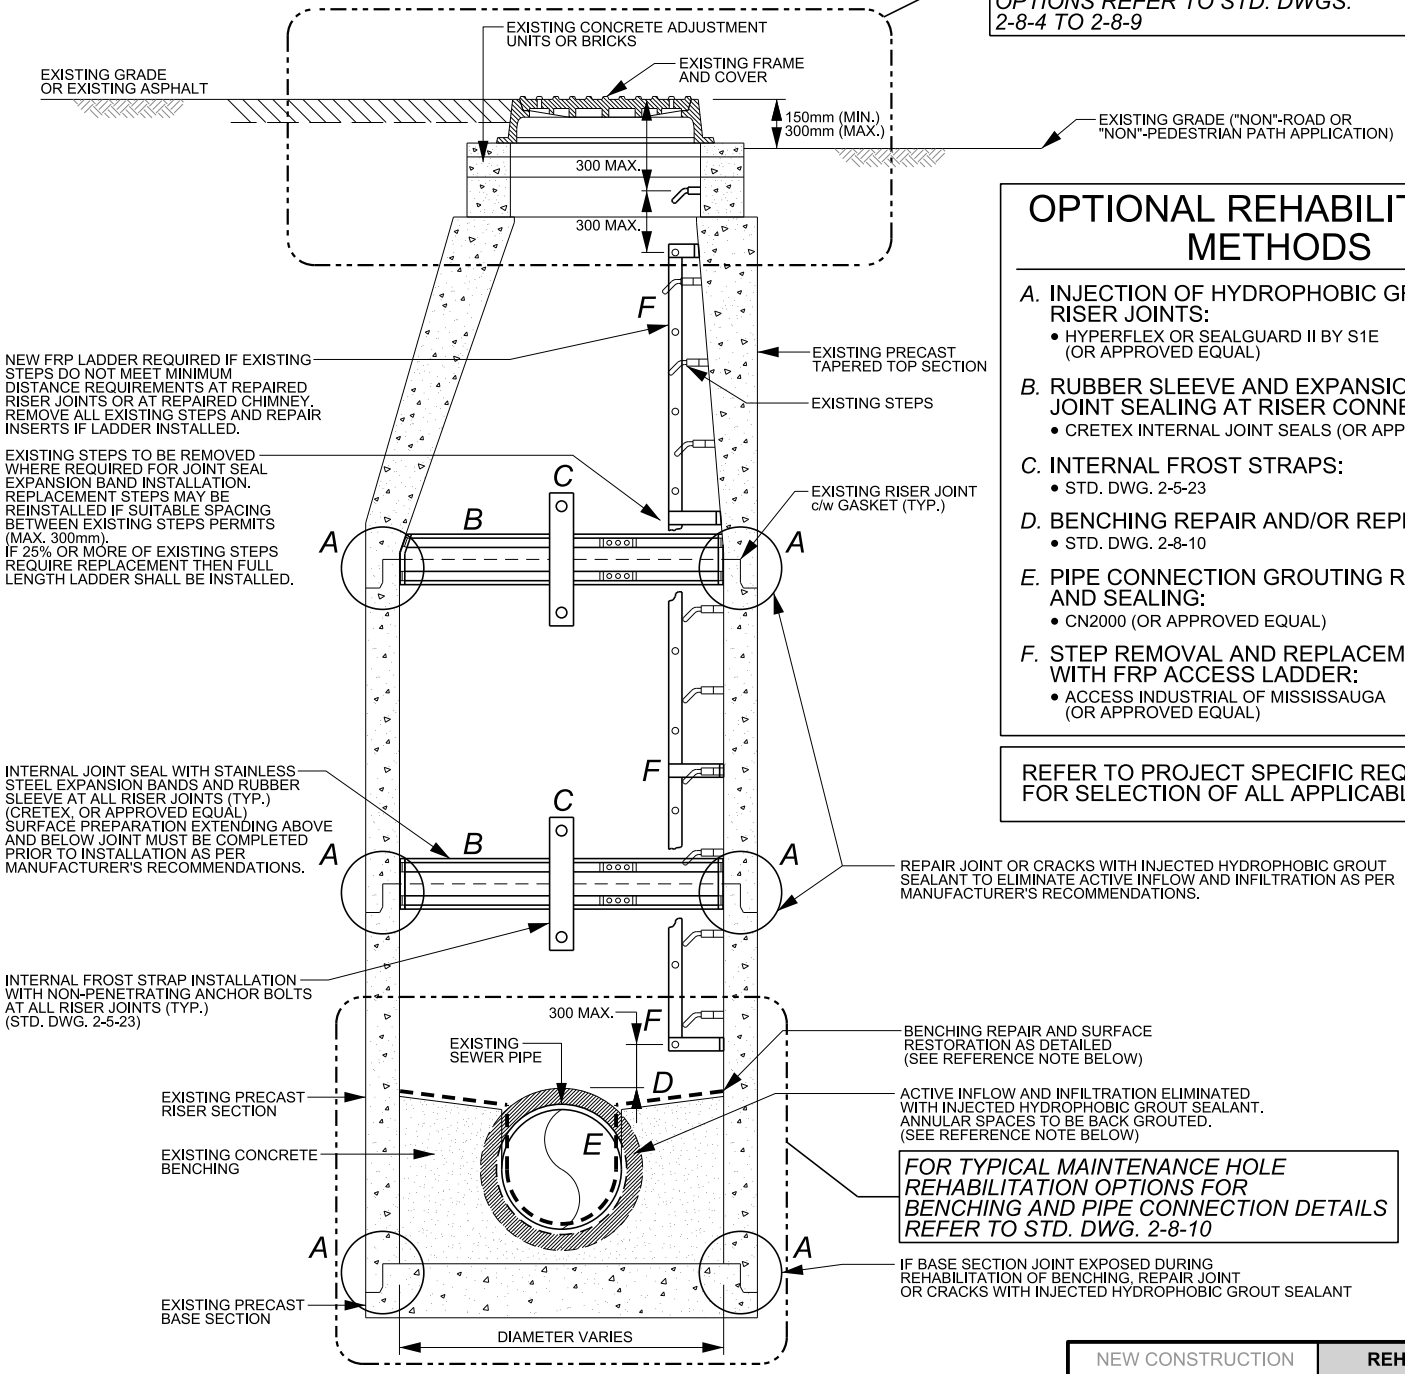
OPTIONS SHOWN ON THIS DRAWING ARE INTENDED FOR REHABILITATION OF INTERNAL COMPONENTS OF EXISTING MAINTENANCE HOLES WITHIN EITHER THE EXISTING R.O.W. OR WITHIN FLOOD PLAINS OR EASEMENTS. FOR DIFFERENT ALTERNATIVES TO THE TOP SECTION REHABILITATION WITHIN FLOOD PLAINS OR EASEMENTS REFER TO TYPICAL TOP SECTION AND FRAME AND COVER REHABILITATION OPTION DRAWINGS.

OPTIONAL REHABILITATION METHODS

- A. INJECTION OF HYDROPHOBIC GROUT AT RISER JOINTS:**
 - HYPERFLEX OR SEALGUARD II BY S1E (OR APPROVED EQUAL)
- B. RUBBER SLEEVE AND EXPANSION BAND JOINT SEALING AT RISER CONNECTIONS:**
 - CRETEX INTERNAL JOINT SEALS (OR APPROVED EQUAL)
- C. INTERNAL FROST STRAPS:**
 - STD. DWG. 2-5-23
- D. BENCHING REPAIR AND/OR REPLACEMENT:**
 - STD. DWG. 2-8-10
- E. PIPE CONNECTION GROUTING REPAIR AND SEALING:**
 - CN2000 (OR APPROVED EQUAL)
- F. STEP REMOVAL AND REPLACEMENT WITH FRP ACCESS LADDER:**
 - ACCESS INDUSTRIAL OF MISSISSAUGA (OR APPROVED EQUAL)

NEW FRP LADDER REQUIRED IF EXISTING STEPS DO NOT MEET MINIMUM DISTANCE REQUIREMENTS AT REPAIRED RISER JOINTS OR AT REPAIRED CHIMNEY. REMOVE ALL EXISTING STEPS AND REPAIR INSERTS IF LADDER INSTALLED.

EXISTING STEPS TO BE REMOVED WHERE REQUIRED FOR JOINT SEAL EXPANSION BAND INSTALLATION. REPLACEMENT STEPS MAY BE REINSTALLED IF SUITABLE SPACING BETWEEN EXISTING STEPS PERMITS (MAX. 300mm). IF 25% OR MORE OF EXISTING STEPS REQUIRE REPLACEMENT THEN FULL LENGTH LADDER SHALL BE INSTALLED.

INTERNAL JOINT SEAL WITH STAINLESS STEEL EXPANSION BANDS AND RUBBER SLEEVE AT ALL RISER JOINTS (TYP.) (CRETEX, OR APPROVED EQUAL) SURFACE PREPARATION EXTENDING ABOVE AND BELOW JOINT MUST BE COMPLETED PRIOR TO INSTALLATION AS PER MANUFACTURER'S RECOMMENDATIONS.

INTERNAL FROST STRAP INSTALLATION WITH NON-PENETRATING ANCHOR BOLTS AT ALL RISER JOINTS (TYP.) (STD. DWG. 2-5-23)

REPAIR JOINT OR CRACKS WITH INJECTED HYDROPHOBIC GROUT SEALANT TO ELIMINATE ACTIVE INFLOW AND INFILTRATION AS PER MANUFACTURER'S RECOMMENDATIONS.

BENCHING REPAIR AND SURFACE RESTORATION AS DETAILED (SEE REFERENCE NOTE BELOW)

ACTIVE INFLOW AND INFILTRATION ELIMINATED WITH INJECTED HYDROPHOBIC GROUT SEALANT. ANNULAR SPACES TO BE BACK GROUTED. (SEE REFERENCE NOTE BELOW)

IF BASE SECTION JOINT EXPOSED DURING REHABILITATION OF BENCHING, REPAIR JOINT OR CRACKS WITH INJECTED HYDROPHOBIC GROUT SEALANT
