NATURAL HERITAGE REPORT

HIGHWAY 50 FROM CASTLEMORE ROAD TO MAYFIELD ROAD
MAYFIELD ROAD FROM HIGHWAY 50 TO COLERAINE DRIVE
MUNICIPAL CLASS ENVIRONMENTAL ASSESSMENT STUDY

JANUARY 2012
LGL Project # TA4872

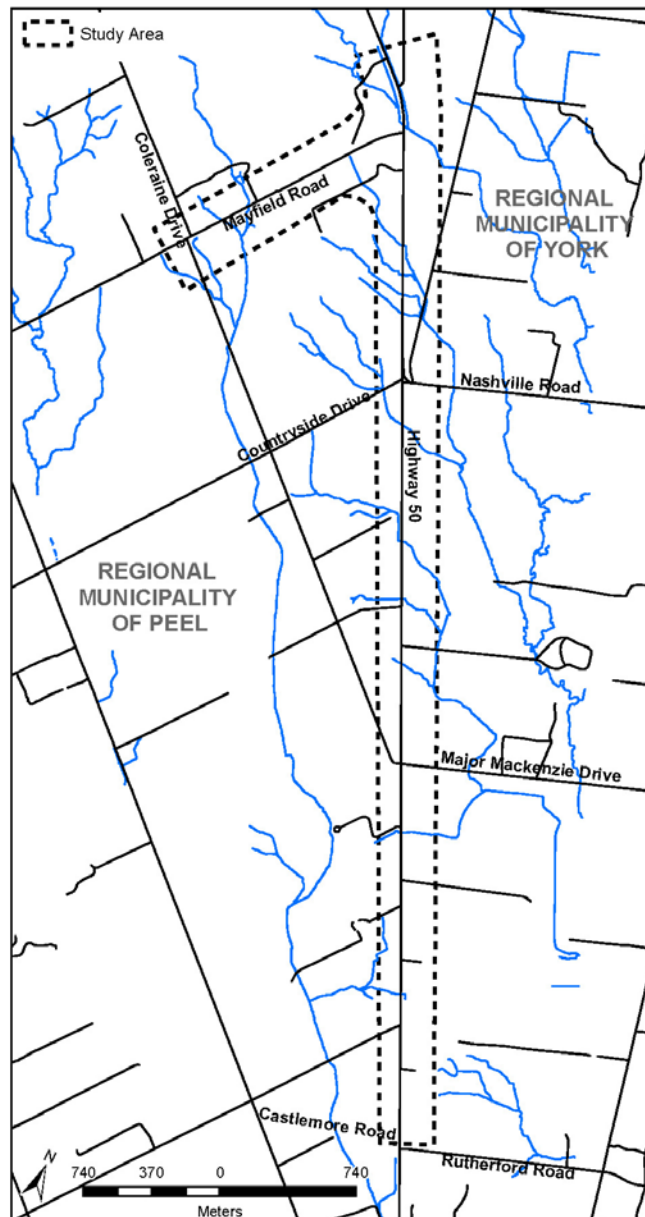
FIGURE 1. KEY PLAN

The Regional Municipality of Peel is undertaking a Schedule “C” Municipal Class Environmental Assessment (Class EA) for improvements to Highway 50 from Rutherford Road/Castlemore Road to Mayfield Road, and Mayfield Road from Highway 50 to Coleraine Drive. The study limits are presented in **Figure 1**.

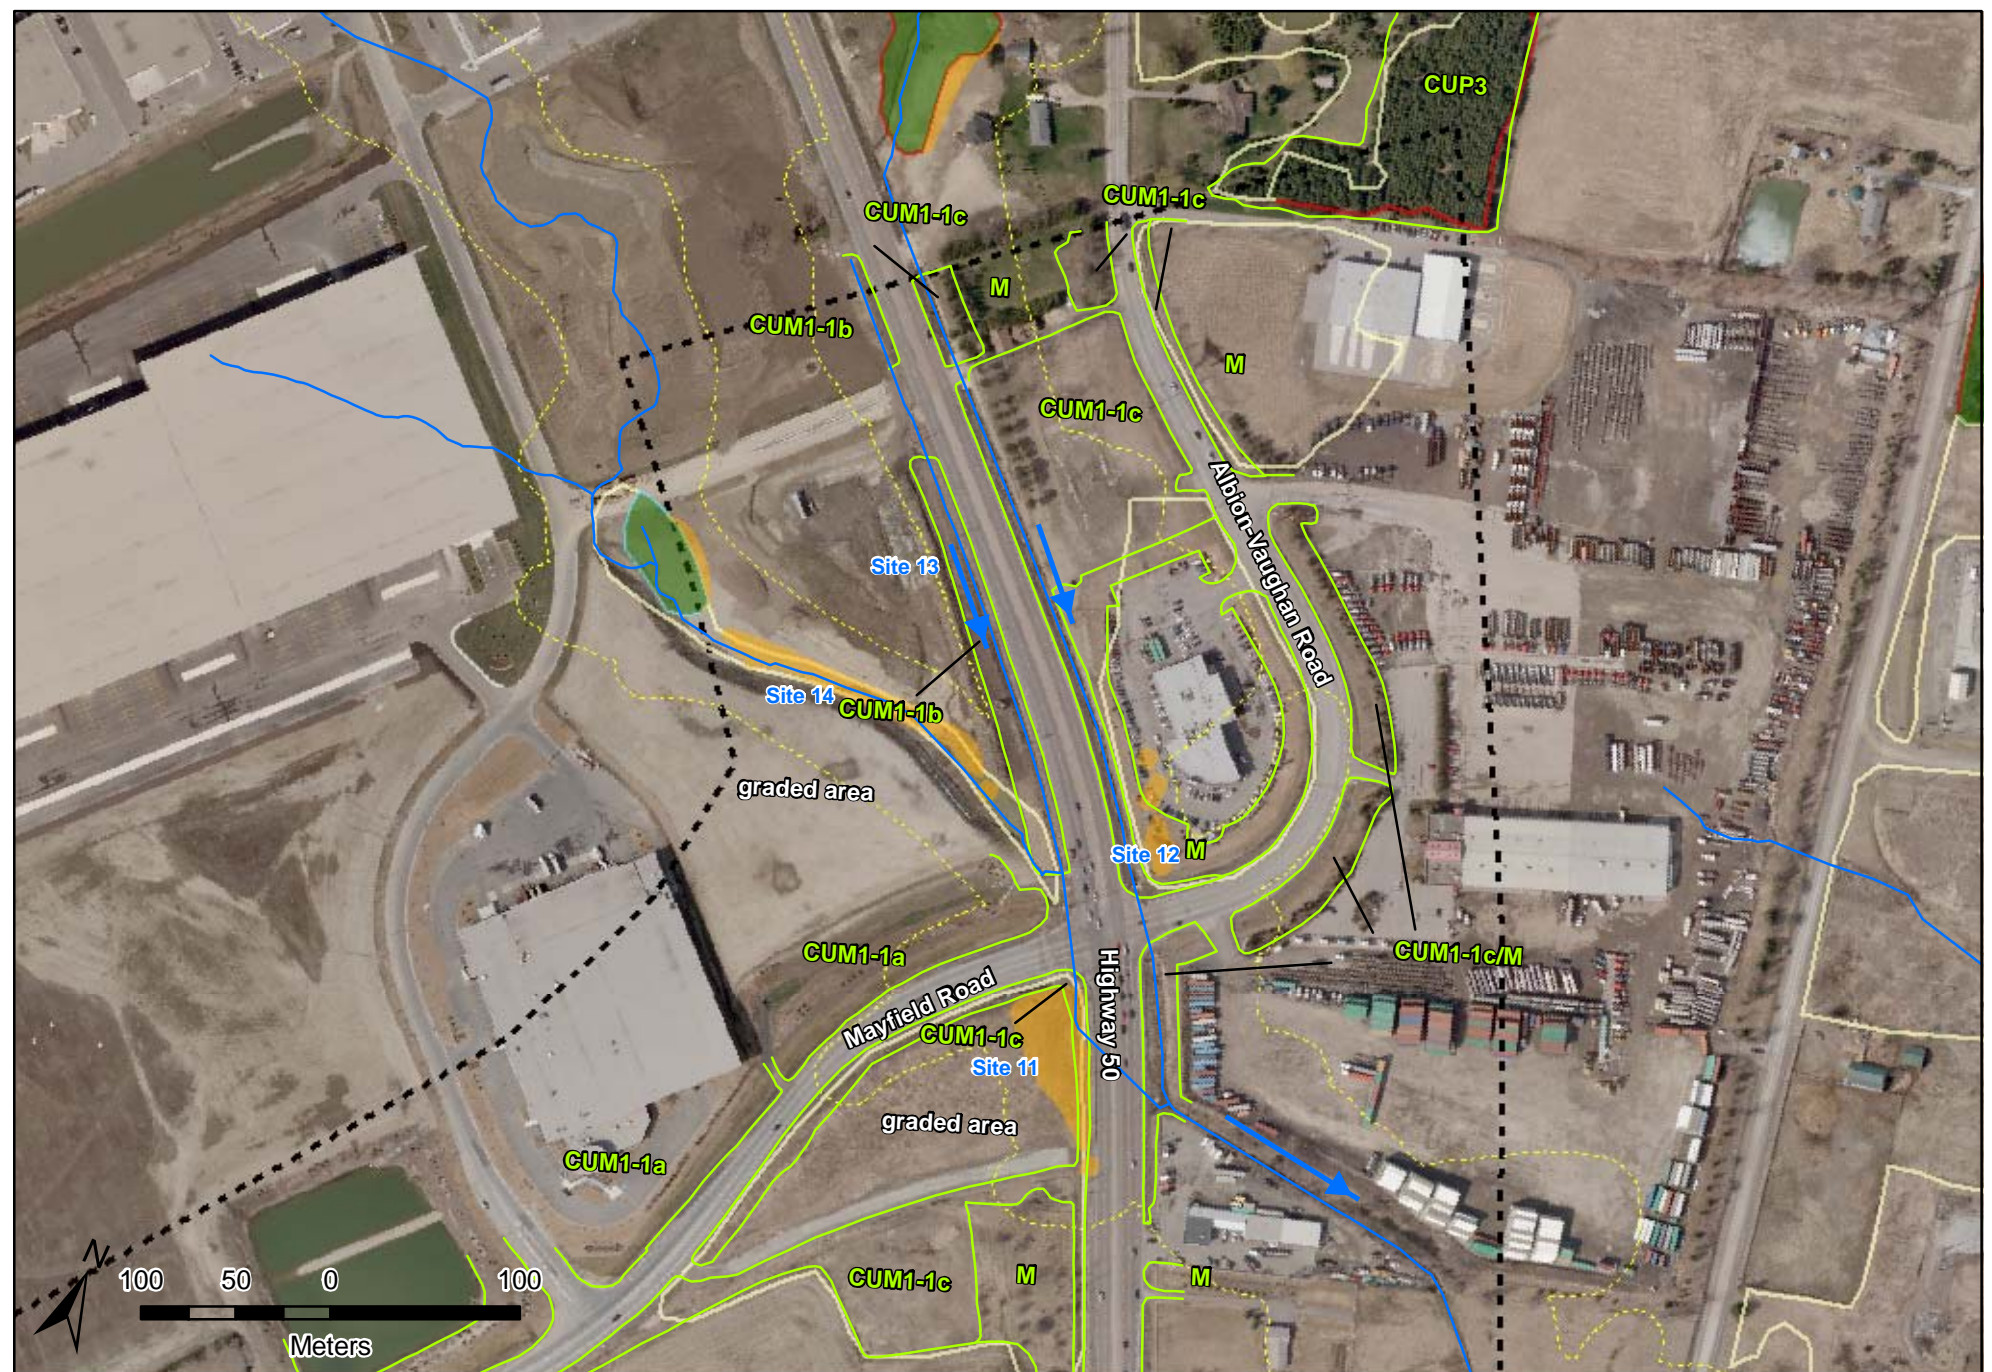
Project	TA4872	Figure	2A
Date	January 2010	Prepared By	KSM
Scale	1:6,000	Verified By	NMF

Natural Heritage Existing Conditions

- ELC Vegetation Community**
-   ELC Vegetation Community
- ELC Vegetation Communities**
-   CUM1-1a to f Dry-Moist Old Field Meadow
 -   CUP3 Coniferous Plantation
 -   M Manicured
 -   Ag Agriculture

The Toronto Region Conservation Authority (TRCA) provided LGL Limited with the boundaries of several areas of natural cover within the study area. During LGL's vegetation survey it was noted that several of these areas no longer contain natural vegetation cover; these changes have been noted on **Figures 2A** and **2B**.

There are several areas that are not identified by the ELC such as Manicured (M) areas which include mown lawns, gardens and planted trees. All vegetation communities identified within the study area are delineated on **Figure 2A** and **2B** and are described in **Table 1**.

Two of the watercourses within the project limits support direct fish habitat (at Sites 11, 12 and 13), two are not fish habitat (Sites 14 and 18) while the remainder constitute indirect fish habitat only. **Figures 2A** and **2B** present the locations of all Sites. Because the majority of the watercourses at the crossing locations constitute some form of fish habitat, the proposed culvert and channel works discussed above have the potential to result in a harmful alteration, disruption or destruction (HADD) of fish habitat due to the following effects:

The Toronto and Region Conservation Authority (TRCA) administers Ontario Regulation 166/06 *Regulation of Development, Interference with Wetlands and Alterations to Shorelines and Watercourses*. The limits of the Regulation Area are delineated on **Figures 2A** and **2B**. Permits under O. Reg. 166/06 will be required for the areas that are located within the Regulation Limits.

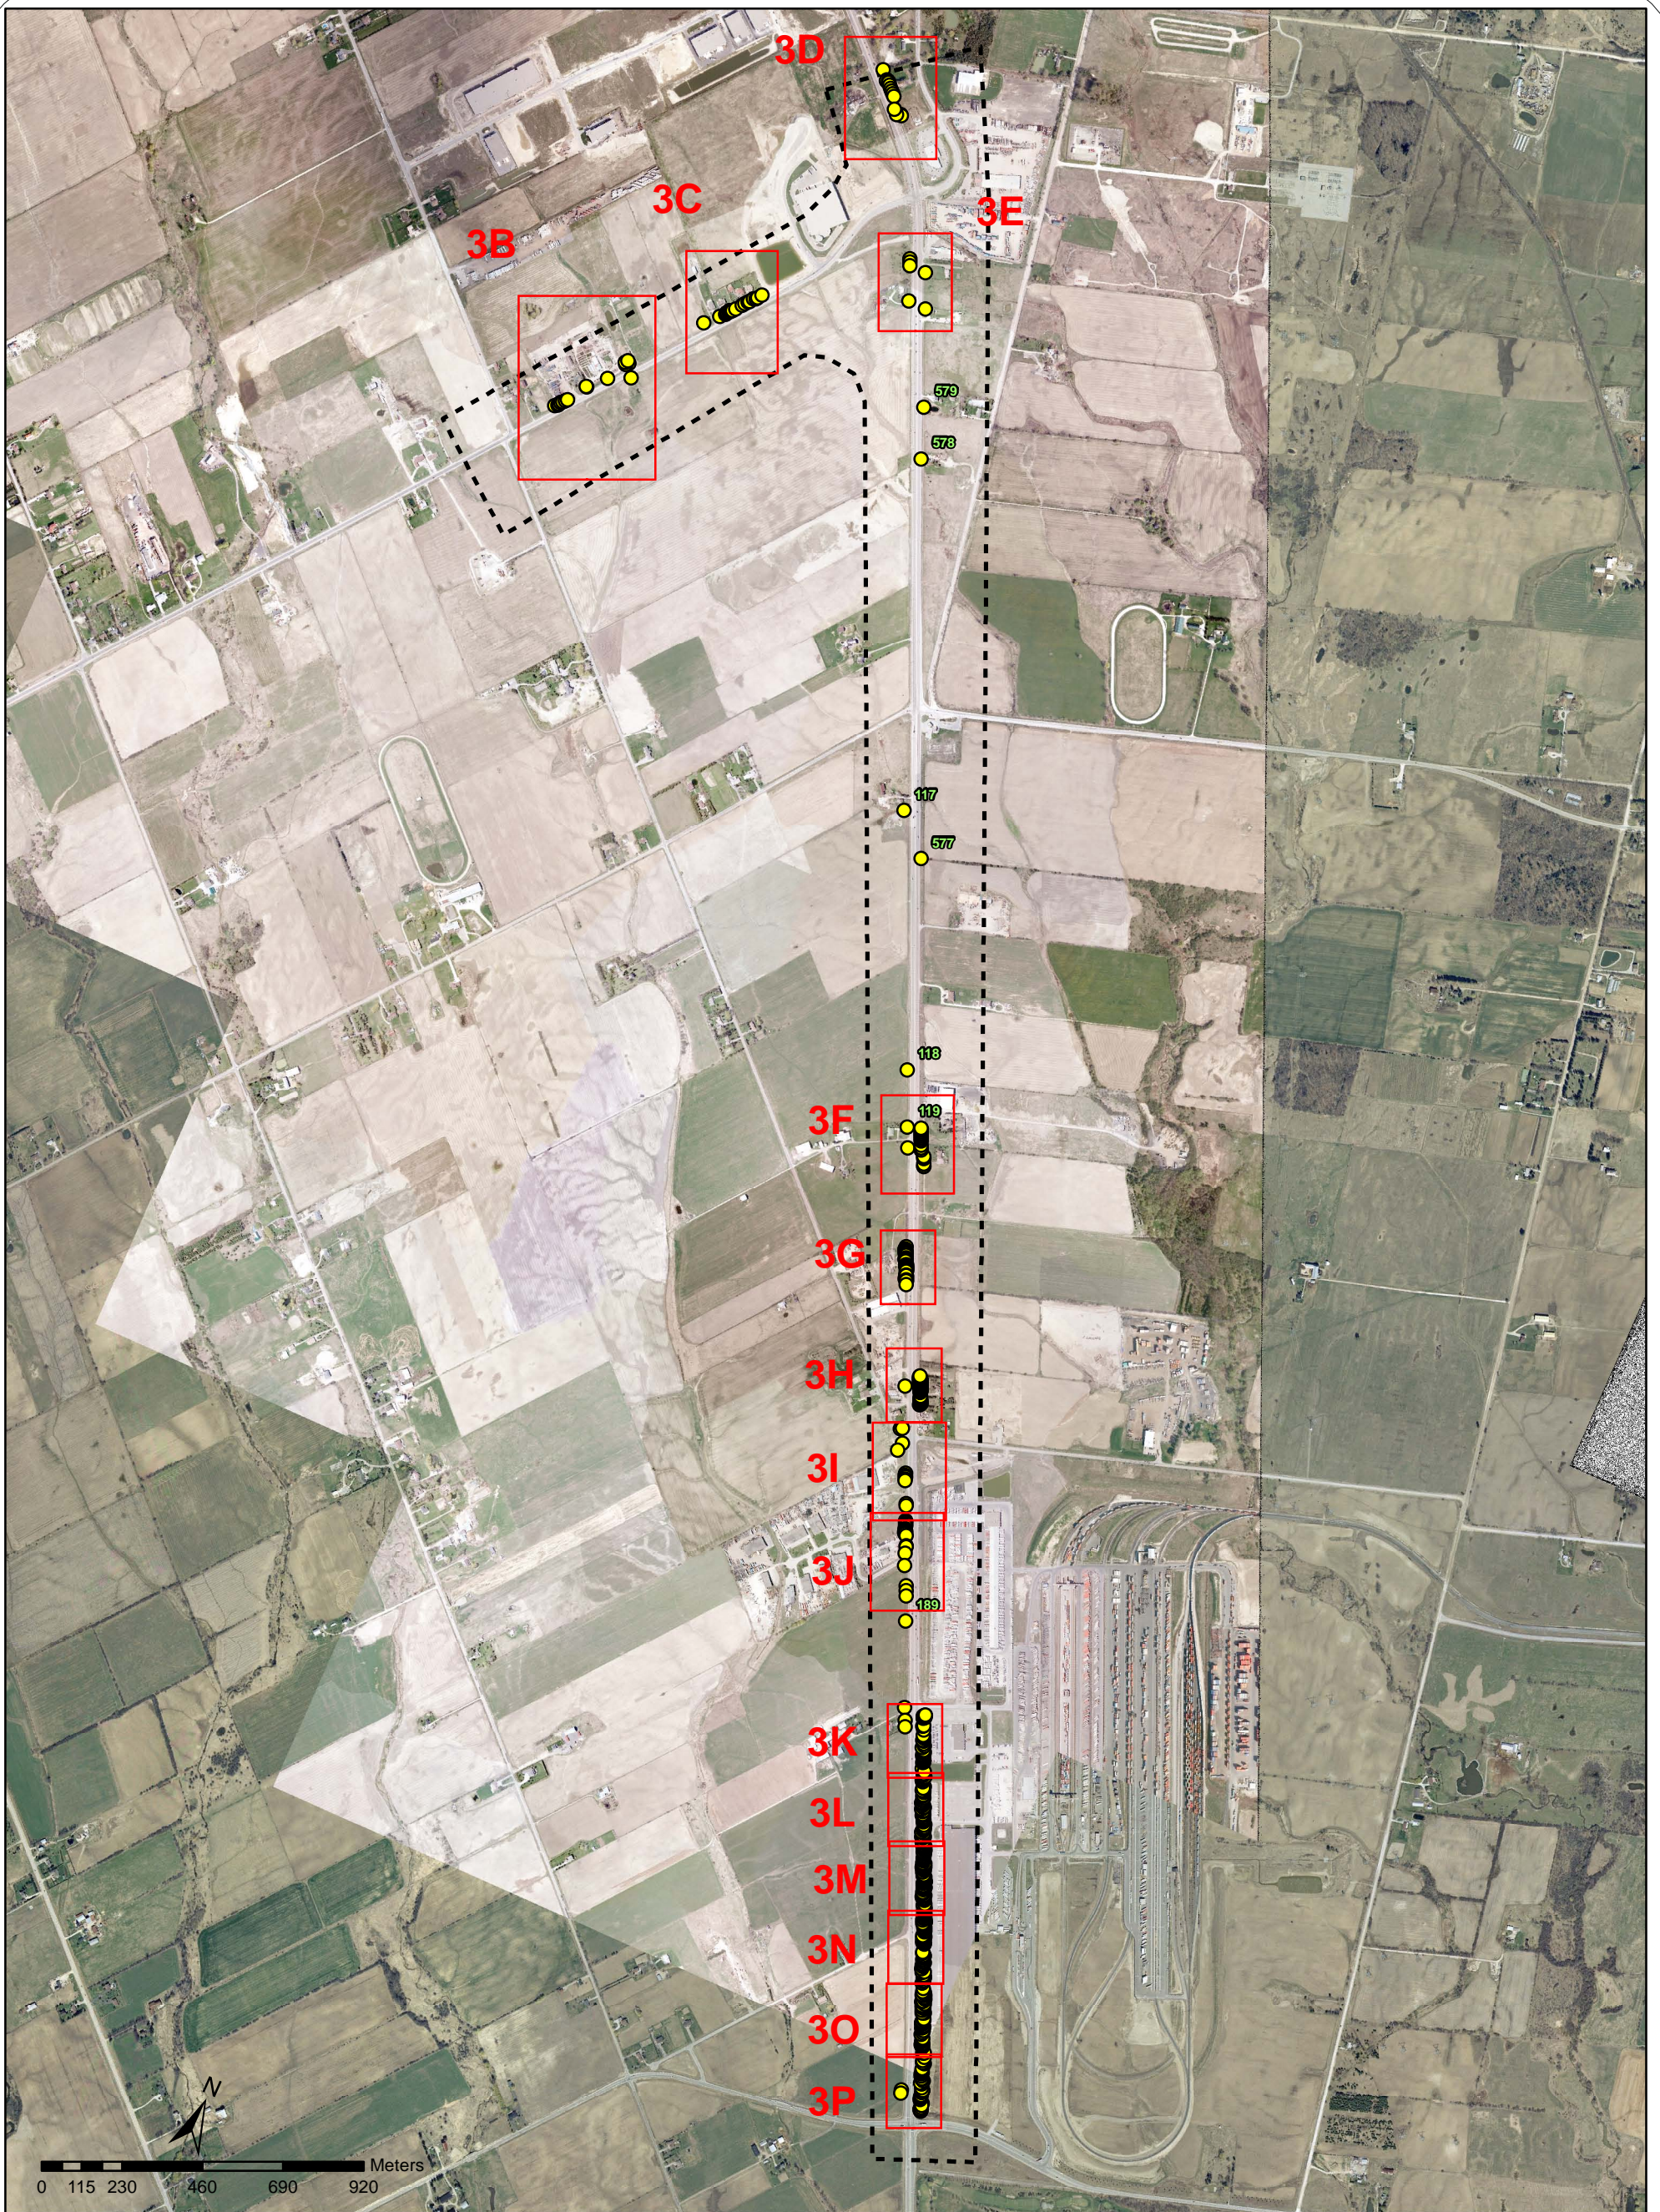
Highway 50

The following information was gathered during the tree inventory: species, diameter at breast height (DBH), and tree condition. Tree condition was determined using standardized methods of assessing tree condition, tree form, and trunk and twig condition. Tree locations were captured using a Lawrence IFinder GPS and the information was translated for geographical information system (GIS) mapping. All living trees that had a diameter at breast height greater than 10 cm were recorded. A list of the trees located within the study area is included in **Appendix D** and the location of these trees is presented on **Figure 3A**. For ease of reference, more detailed maps are provided in **Appendix D** for areas that have high concentrations of trees (**Figures 3B to 3P**). Trees are identified on **Figures 3A to P** using the Waypoint number rather than the tree number.

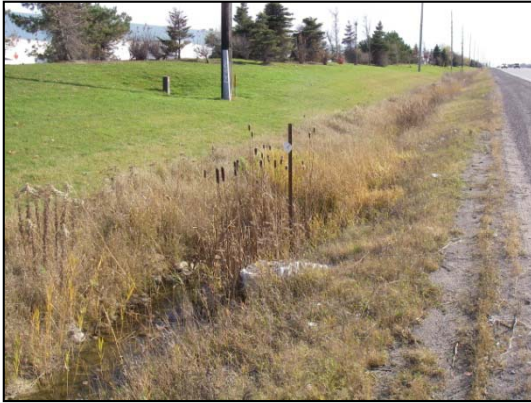
Site 1 upstream (east) of Highway 50 facing south at ditch

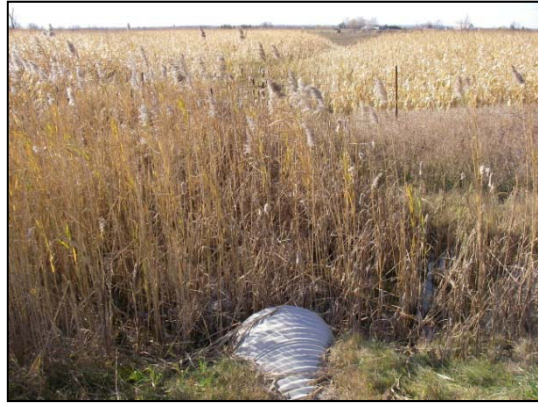
Site 1 downstream (west) of Highway 50 facing west at *Phragmites* within right-of-way and agricultural field beyond

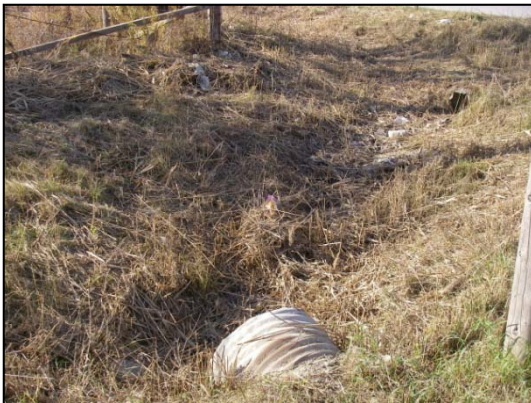
Site 2 upstream (west) of Highway 50 at Cadetta Road facing northwest

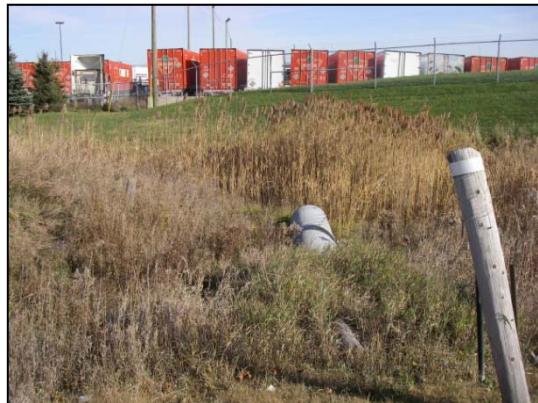
Site 2 downstream (east) of Highway 50 facing east at channel that has been diverted to the north and around the industrial facility

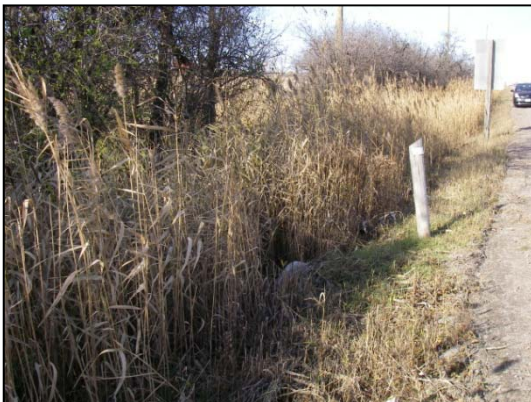
Site 3 upstream (west) of Highway 50 facing north at culvert and ditch

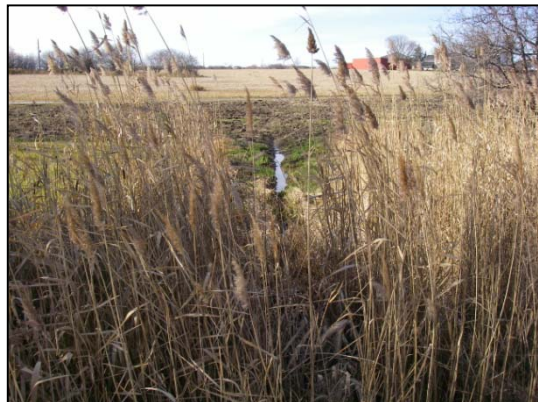
Site 3 upstream (west) of Highway 50 right-of-way facing west at channel leading to culvert

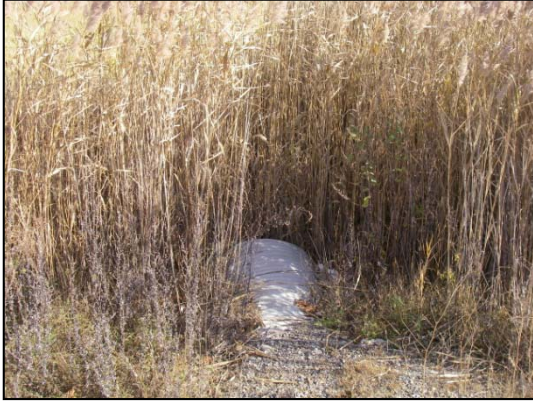
Site 3 downstream (east) of Highway 50 facing east

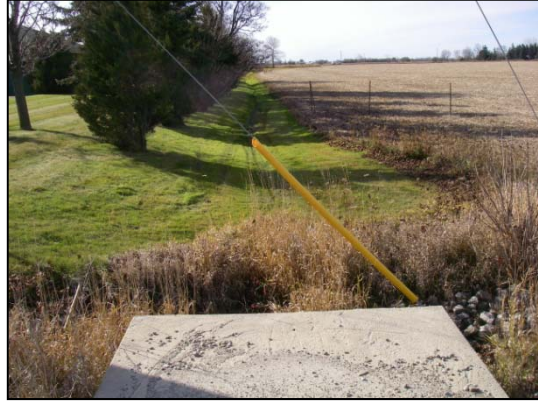
Site 4 upstream (west) of Highway 50 facing west

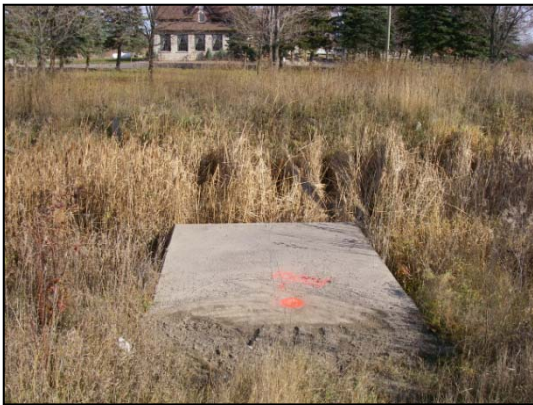
Site 4 downstream (east) of Highway 50 facing east: note berm that has blocked channel and forced it to the south in the ditch

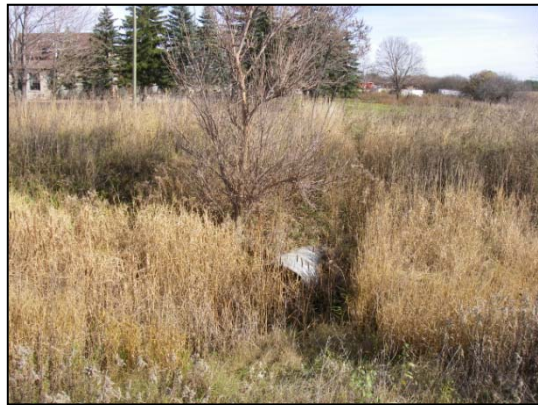
Site 4 downstream end of channel from Highway 50 culvert facing east at CSP through berm

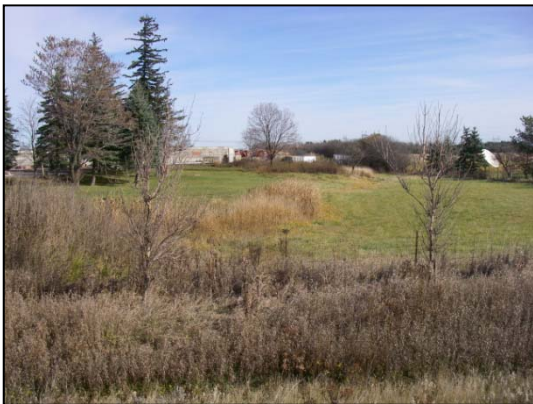
Site 4 channel downstream of berm culvert facing east over berm

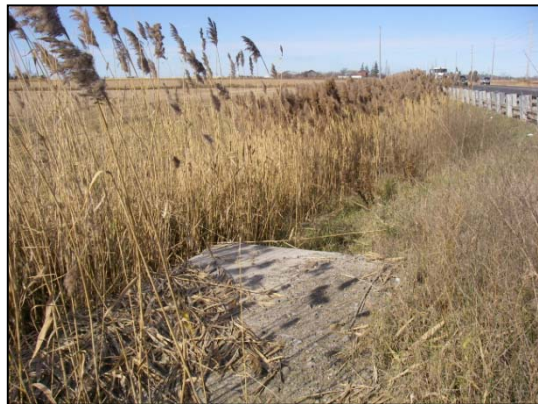
Site 5 upstream (west) of Highway 50 facing north from culvert at channel paralleling road

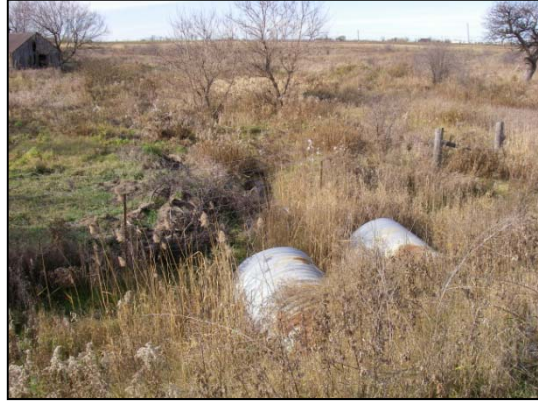
Site 6 upstream (west) of Highway 50 facing northwest at natural area surrounding watercourse

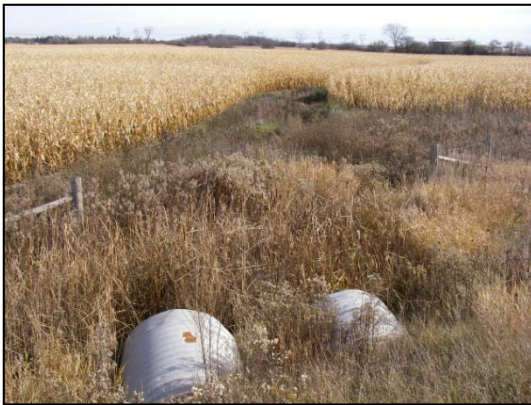
Site 6 downstream (east) of Highway 50 facing southwest at channel through agricultural field

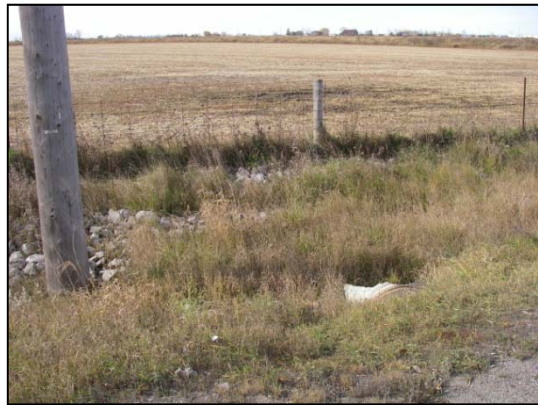
Site 7 upstream (west) of Highway 50 facing west at right-of-way and wet area in agricultural field

The drainage feature at Site 7 crosses Highway 50 through small diameter twin CSP culverts from west to east approximately 370 m north of Countryside Drive/Nashville Road. Upstream, the feature consisted of a dry, poorly defined swale through an agricultural field. Downstream of the roadway the watercourse consisted of a dry, poorly defined channel through old field vegetation. At the downstream end of the culvert, a stand of cattails was present within the ROW. No water flow was evident during the November 10, 2009 field visit, and no standing water was observed. The TRCA considers the feature at Site 7 to be a watercourse (warmwater) only on the downstream (east) side of Highway 50. It should be noted that water conveyed across the roadway at this crossing flows into Redside Dace habitat in Robinson Creek downstream. The downstream area around the watercourse is located within the Regulation Limit of the TRCA.

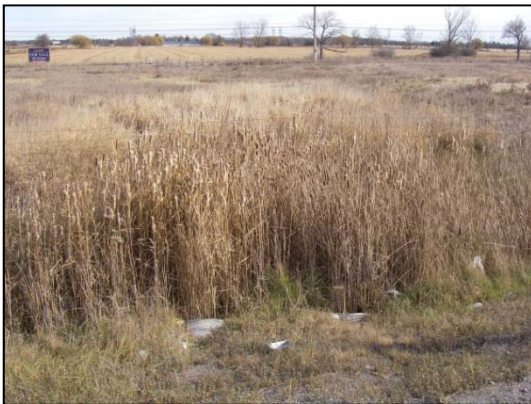
Site 7 downstream (east) of Highway 50 facing east at right-of-way and downstream habitat

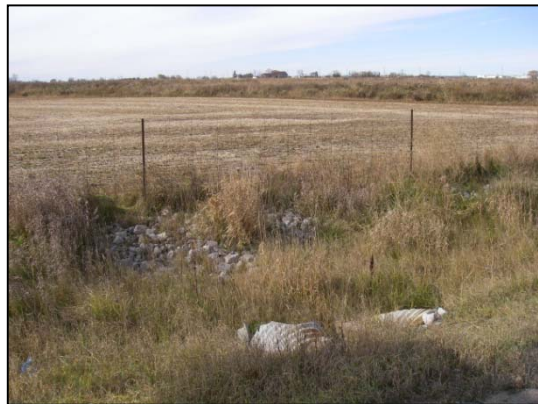
Site 8 upstream (west) of Highway 50 facing west at right-of-way and agricultural field

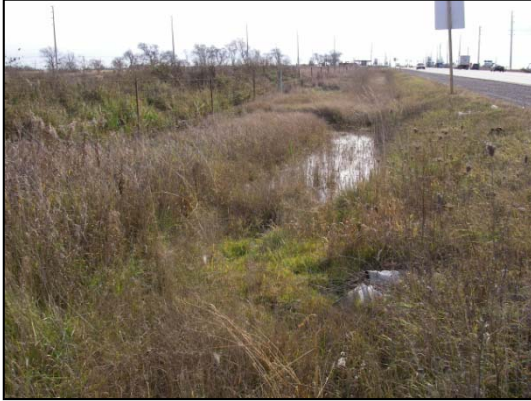
Site 8 downstream (east) of Highway 50 facing south along right-of-way at pooled area downstream of culvert: note berm just outside of right-of-way on left side of photo

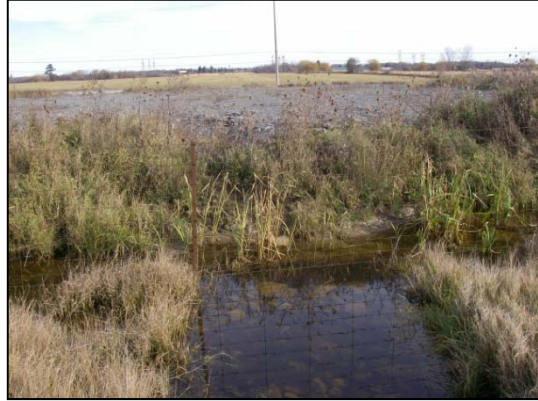
Site 8 downstream (east) of Highway 50 facing east at pooled area within and outside of right-of-way and berm and fill area outside of right-of-way

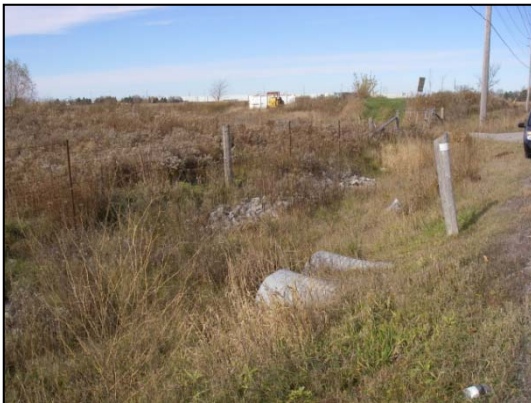
Site 9 upstream (west) of Highway 50 facing northwest at right-of-way and upstream natural area

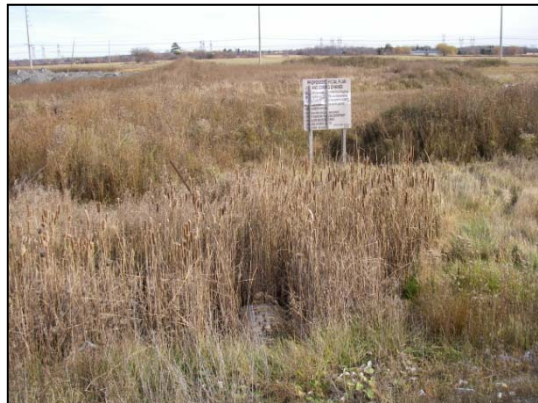
Site 9 downstream (east) of Highway 50 facing east at right-of-way and downstream habitat

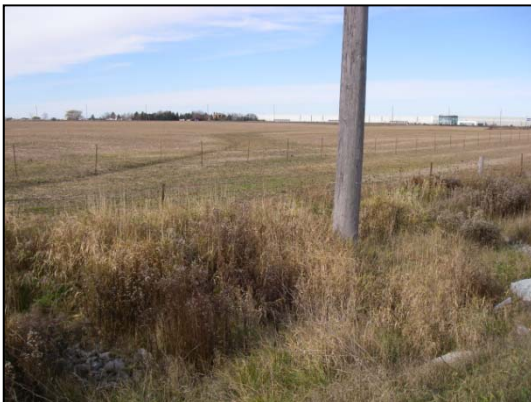
Site 10 upstream (west) of Highway 50 facing northwest at right-of-way and agricultural swale

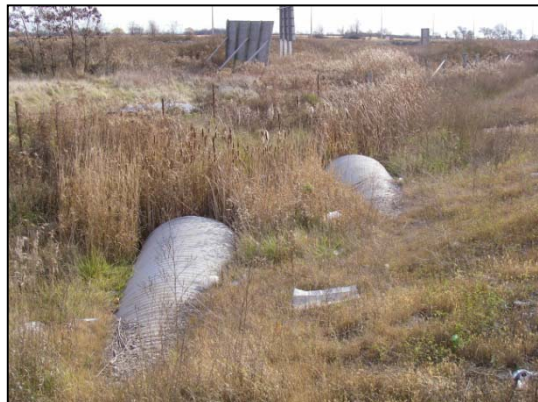
Site 10 downstream (east) of Highway 50 facing southeast at right-of-way and downstream habitat

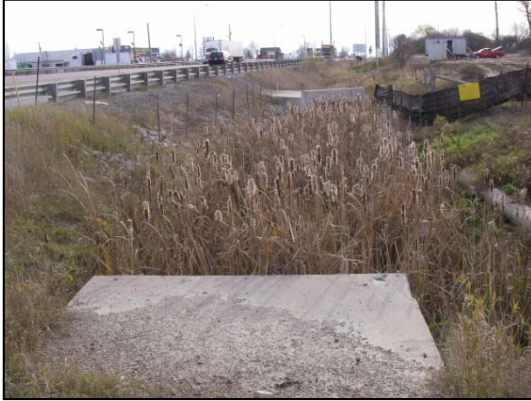
Site 11 facing downstream (south) from downstream end of Mayfield Road culvert

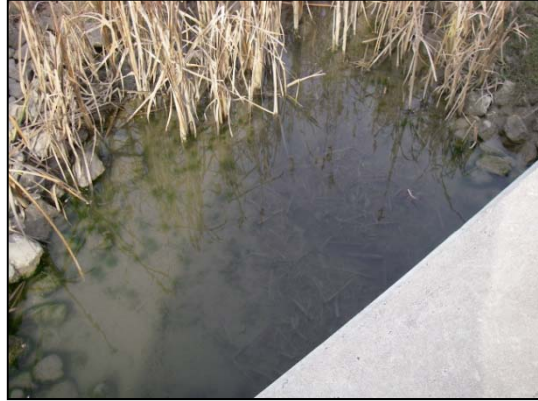
Site 11 pool at upstream end of culvert under Highway 50 where fish were observed during November 23, 2006 and November 10, 2009 field investigations

A small pool was present at the downstream end of the channel where it entered the concrete culvert that conveyed flows under Highway 50. This pool did not contain cattails and was approximately 2.5 m wide with a water depth that varied from 10 cm to 25 cm. Several cyprinids were observed during previous (November 23, 2006) and current field work, and at least one was identified as a Creek Chub (*Semotilus atromaculatus*). As such, Site 11 constitutes direct fish habitat.

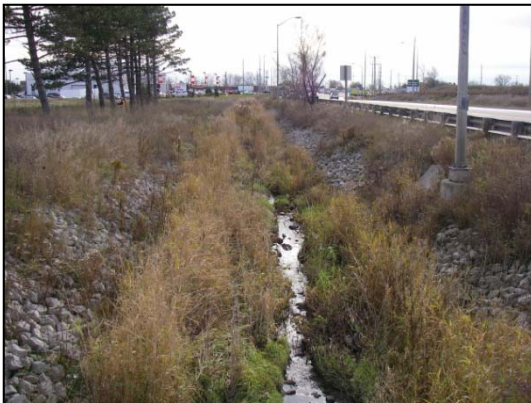
Site 12 facing downstream (south) from northern edge of study limits at ditched channel running parallel to Highway 50

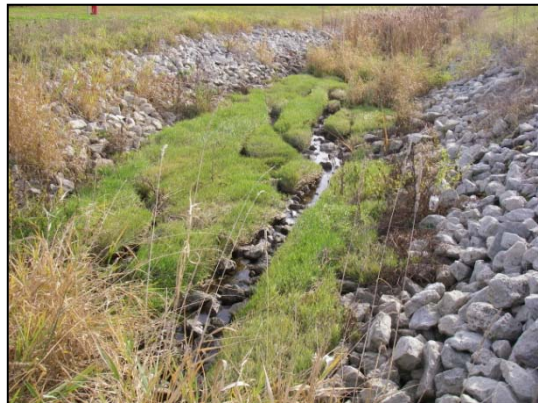
Site 12 facing downstream between northern limit of study area and Albion-Vaughan Road crossing: note rip rap substrates and mixed instream vegetation (short & tall grasses, cattails)

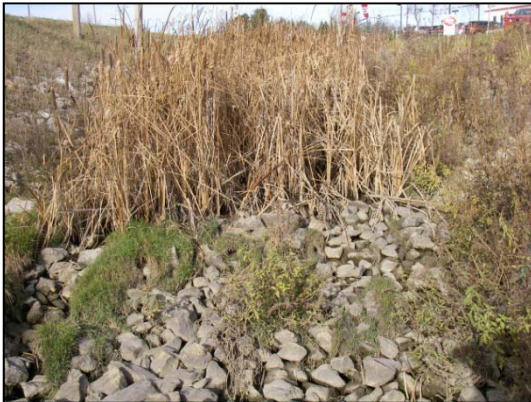
Site 12 facing upstream (north) from Albion-Vaughan Road culvert at rip rap rock check that allows only diffuse flow through when water conditions are low

At the downstream end of the channel in the northeast quadrant of the intersection (i.e., directly upstream of the Albion-Vaughan Road culvert), a rip rap berm exists across the channel through which water was diffusely flowing during both the November 10, 2009 field visit and previous field work (November 23, 2006). This berm likely forms a barrier to fish passage during low flow conditions. Directly downstream of the berm, a pool existed that was contiguous with pooled open water which ran through the culvert and

throughout the channel in the southeast quadrant of the intersection. Several fish were observed during the November 23, 2006 site investigation inside the culvert and one (which was captured) was identified as a Brook Stickleback (*Culaea inconstans*). Similarly, Brook Stickleback were observed during the November 10, 2009 site investigation in the same location. In addition, cyprinids and Brook Stickleback were observed in many places throughout the channel in the northeast quadrant upstream of the berm. As such, Site 12 constitutes direct fish habitat.

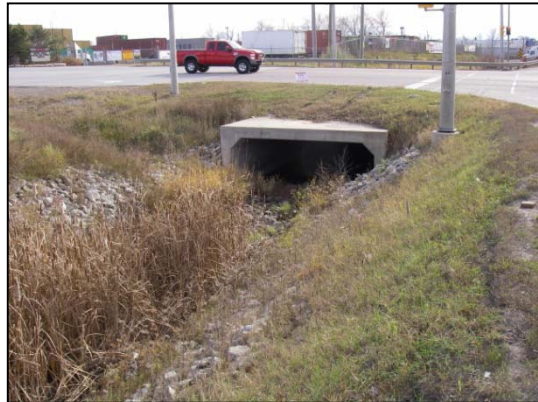
Site 12 facing downstream (south) at upstream end of Albion-Vaughan Road culvert

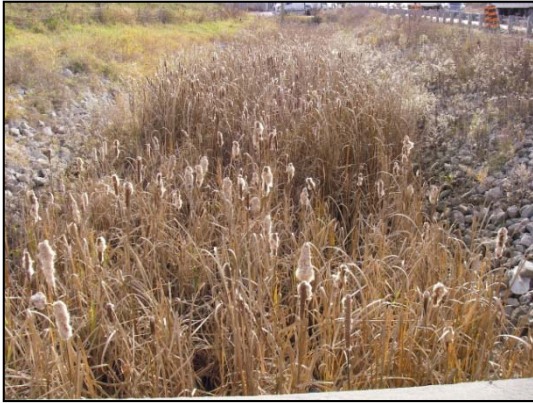
Site 12 downstream (south) of Albion-Vaughan Road facing south

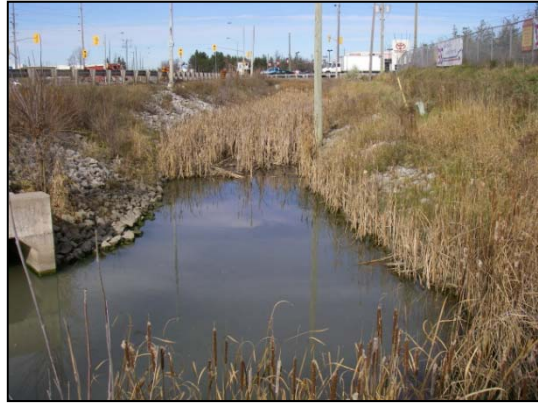
Site 12 facing upstream (north) from where water from Site 11 enters (note culvert to left) and where channel bends to southeast (bottom right of photo)

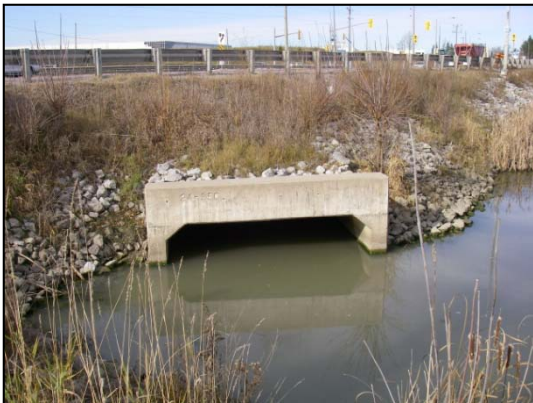
Site 12 facing northwest at downstream end of culvert under Highway 50 conveying water from Site 11

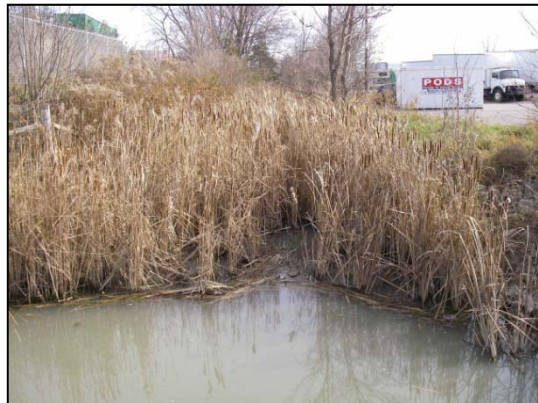
Site 12 facing downstream (southwest) at location where channel bends to southwest: note photo was taken from downstream end of culvert from Site 11

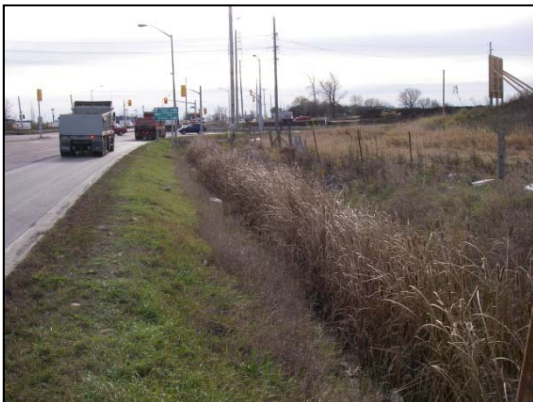
Site 13 facing downstream (south) along channel/ditch within right-of-way

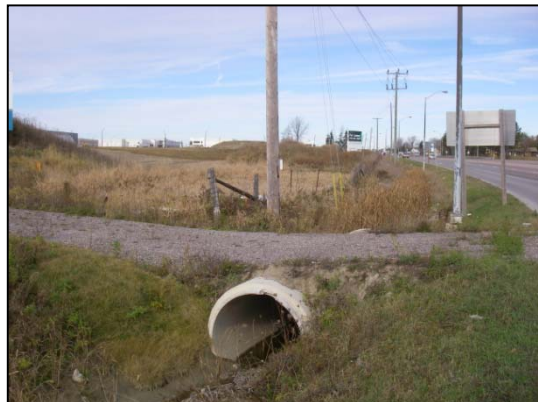
Site 13 facing upstream (north) at new pipe culvert that provides access to new pond that likely receives from Site 14

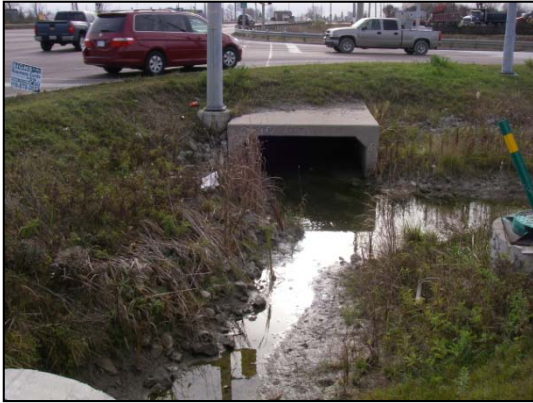
Site 13 facing downstream (south) from new pipe culvert at upstream end of Mayfield Road culvert: note water to right of culvert likely from Site 14

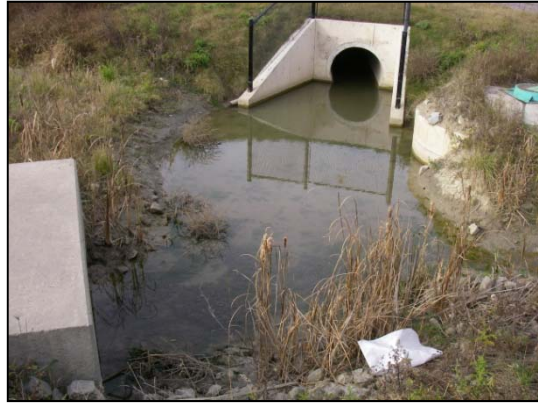
Site 13 facing west at pool upstream of Mayfield Road culvert (left side of photo) and at pipe likely conveying flows from Site 14: note submerged vegetation in foreground of pool

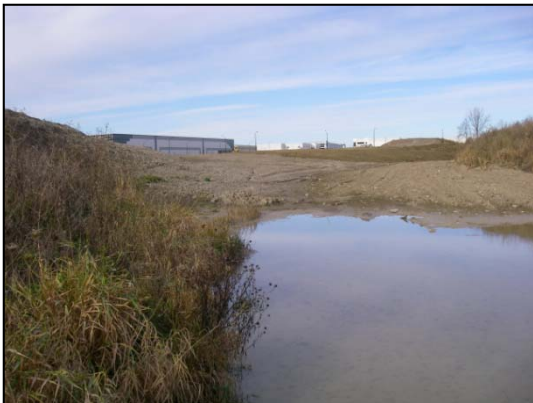
Site 14 location where watercourse was in which grading has been modified

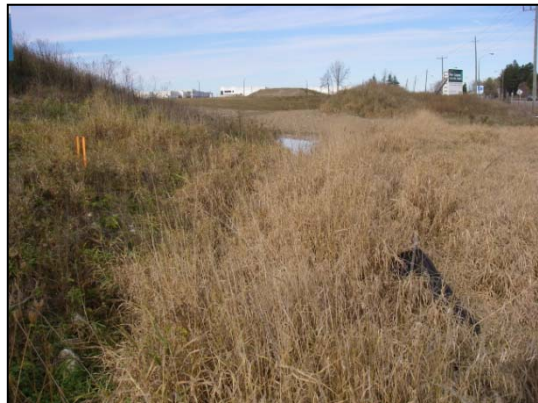
Site 14 remnant of historic channel facing northwest from access to new pond

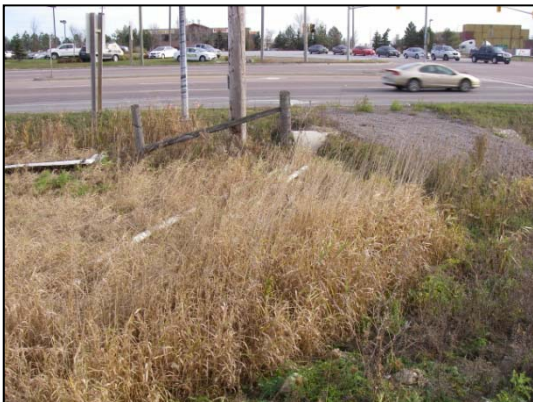
Site 14 location where channel used to connect with Site 13 facing east

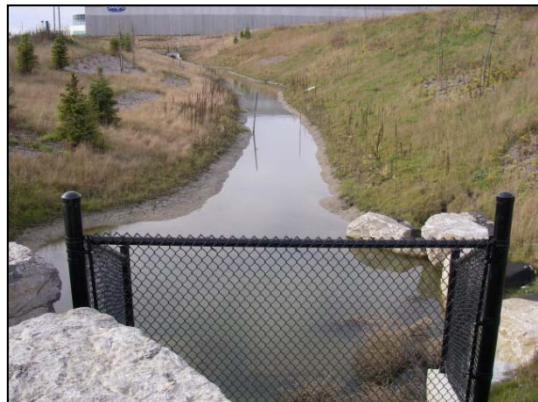
Site 14 new pond that likely receives flows from historic watercourse facing upstream (west) from pool area in Site 13

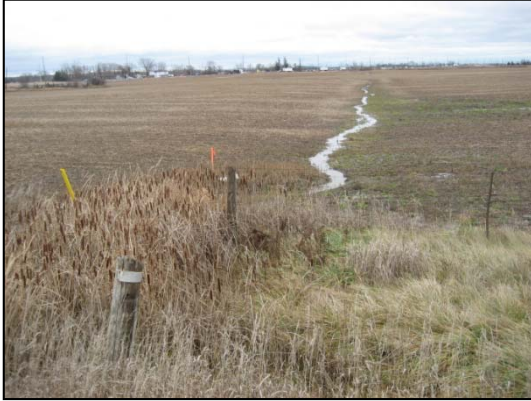
Site 15 facing downstream (south) from Mayfield Road at right-of-way and agricultural swale

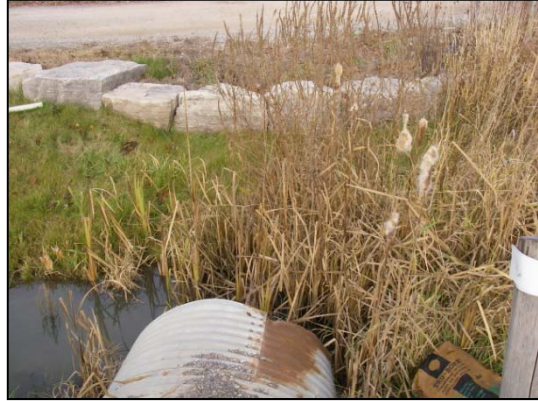
Site 16 facing upstream (north) of Mayfield Road at roadside ditch and armourstone retaining wall: note watercourse flows from right side of photo

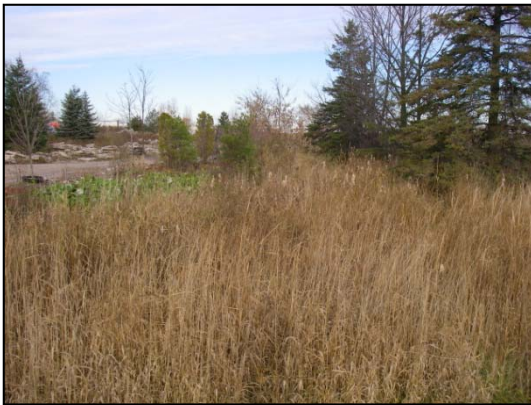
Site 16 facing upstream (north) of Mayfield Road from east of culvert at natural area surrounding watercourse

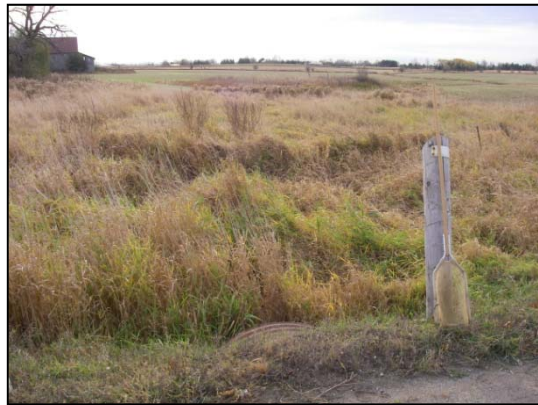
Site 16 downstream (south) of Mayfield Road at natural area and downstream agricultural fields

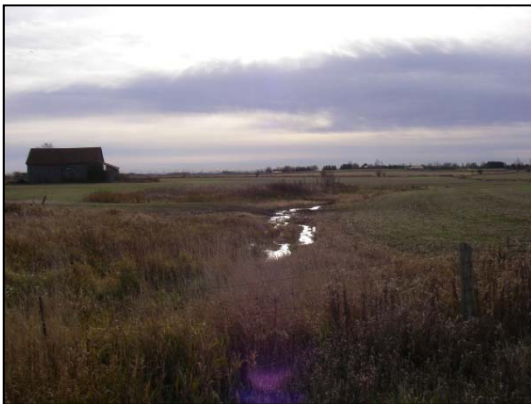
Site 16 channel downstream (south) of Mayfield Road right-of-way facing south

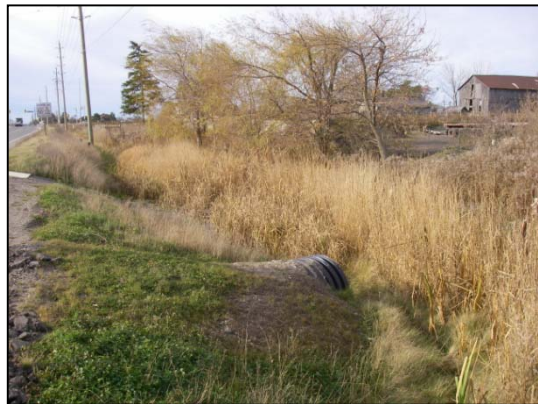
Site 17 upstream (north) of Mayfield Road facing northwest at roadside ditch

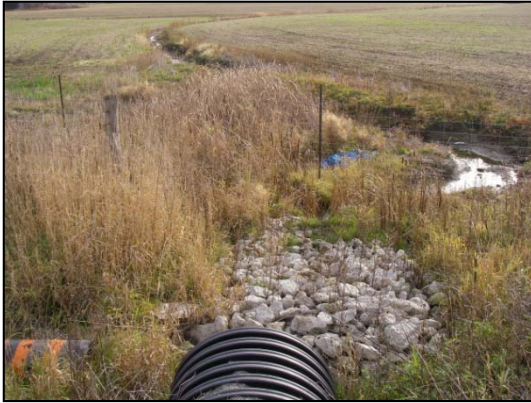
Site 17 downstream (south) of Mayfield Road facing south at right-of-way and channel through agricultural fields

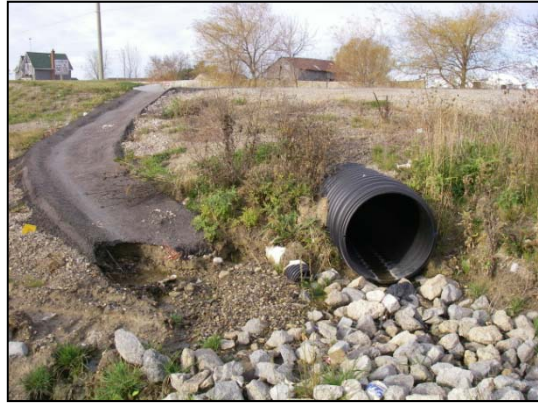
Site 17 storm water outfall and surface drainage chute from Mayfield Road located to south of roadway just west of the Site 17 crossing

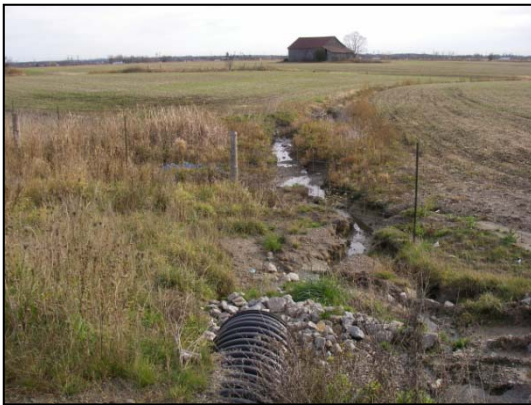
Site 17 facing downstream (southeast) from storm water outfall pipe at Site 17 channel: note water from Mayfield Road culvert enters channel from left of photo

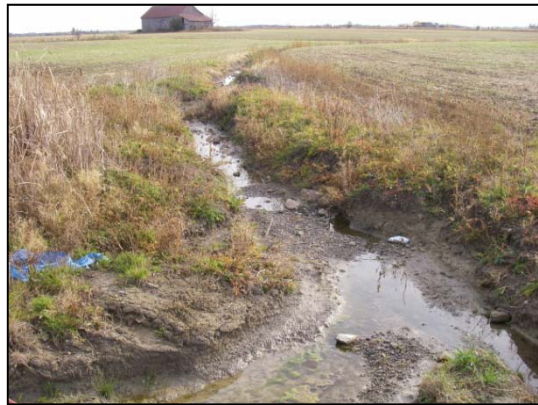
Site 17 downstream (south) of Mayfield Road right-of-way where water from Mayfield Road crossing and storm water outfall join

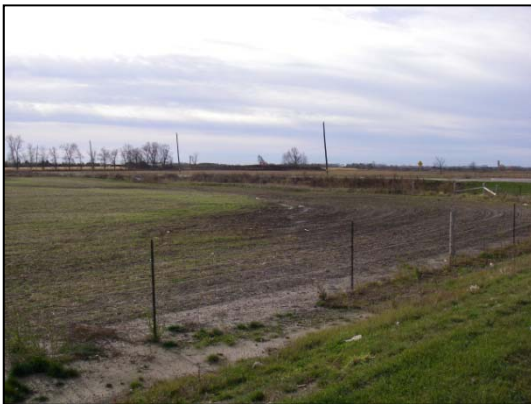
Site 18 wet patch and swale in agricultural field south of Mayfield Road at Coleraine Drive intersection facing southwest
