STORMWATER MANAGEMENT REPORT

ENVIRONMENTAL ASSESSMENT (EA) AND PRELIMINARY DESIGN FOR DRAINAGE IMPROVEMENTS OF HIGHWAY 50 FROM MAYFIELD ROAD TO HEALEY ROAD

December 1, 2022

Region of Peel

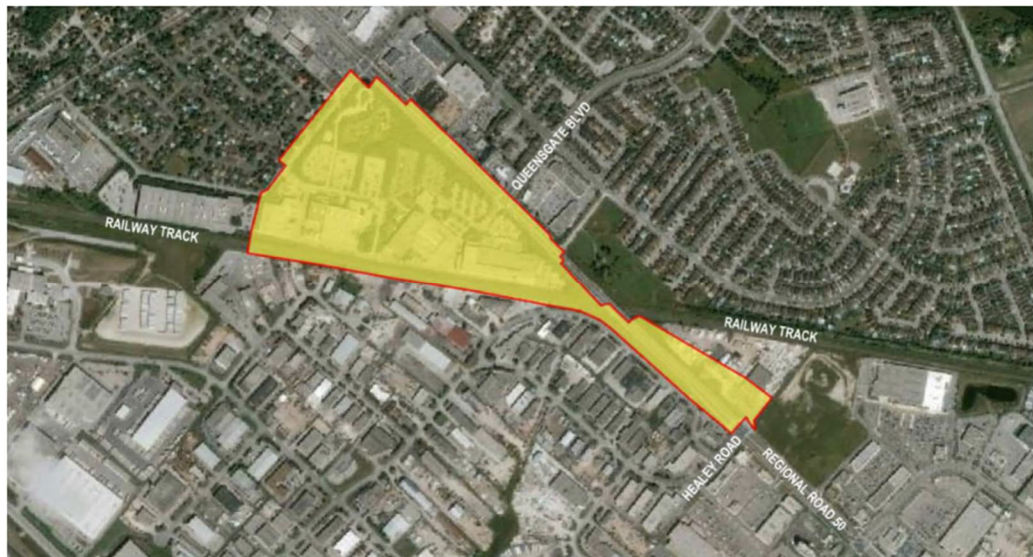
Figure 4.1: External Drainage Area That Contributes into Study Area

To the north of Healey Road there is a railway track that crosses Highway 50. The ditches along the railway track west of Highway 50 and the external drainage area draining to those ditches, were added to the Region's InfoWorks model since they contribute runoff and flows into the study area. Flows from these additional drainage areas contribute to the west side road ditch and enter the Robinson Creek culvert at George Bolton Parkway.

RVA performed an onsite investigation to determine the approximate external drainage areas that drain to these ditches and included them in the InfoWorks model. Since limited information about the outside drainage areas was available, runoff surface area parameters, such as imperviousness and runoff factors, were estimated. Flows from these areas were limited to a maximum runoff value into the west side ditch based on available rail crossing culvert capacity (750 mm diameter culvert, pfc = 1.08 m³ / s, restricted 1 - year flows to approximately 500 l / s peak flow). This estimate was made based on the assumption that the rail line should not flood for a 10 - year design storm. **Figure 4.1** below show the extent of the described external drainage area.

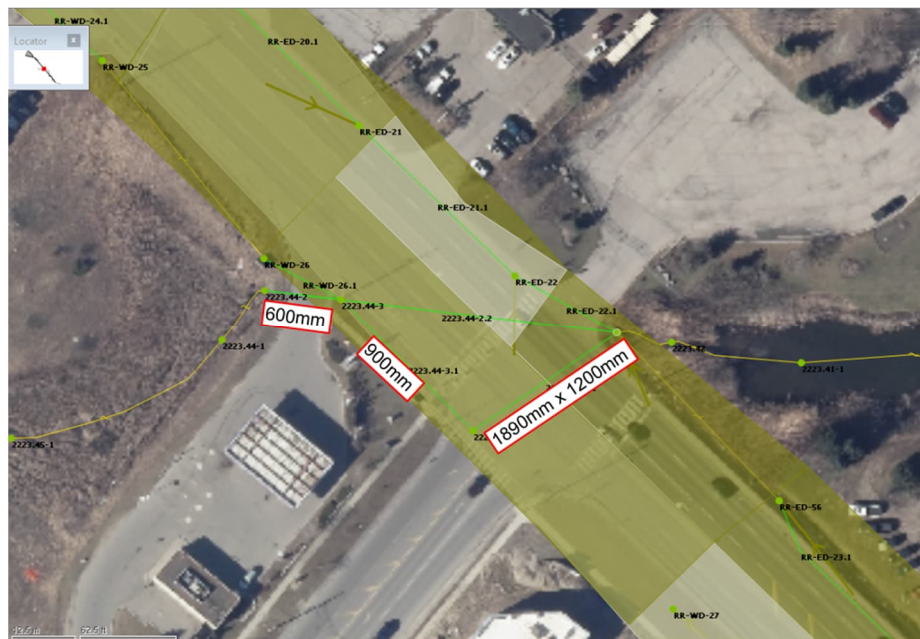
Figure 5. 1: George Bolton Parkway and -Highway 50 Intersection Culverts

The results indicate that under a 10 - year storm the culverts under George Bolton Parkway and Highway 50 flood. The existing culverts at this intersection are a 600 mm diameter PVC pipe (EX Culvert #17), which is connected to a 900 mm diameter CSP culvert (EX Culvert #18). The 900 mm diameter pipe connects to an 1800 mm x 1200 mm concrete box culvert (EX Culvert #19) that crosses Highway 50 and outlets into the online pond. Robinson Creek flows through this pipe/culvert arrangement. Based on the existing conditions InfoWorks model results, there is overtopping of the road to a depth of 230 mm and 311 mm under 10-year and 100-year storm conditions respective. **Figure 5.1** represents the culverts under the George Bolton Parkway and Highway 50 intersection. Based on TRCA's HEC - RAS model, the 10 - year flow at the intersection is 5.10 m³ / s and the InfoWorks model predicts hydraulic restrictions due to the small culverts (600 mm and 900mm) under the intersection.

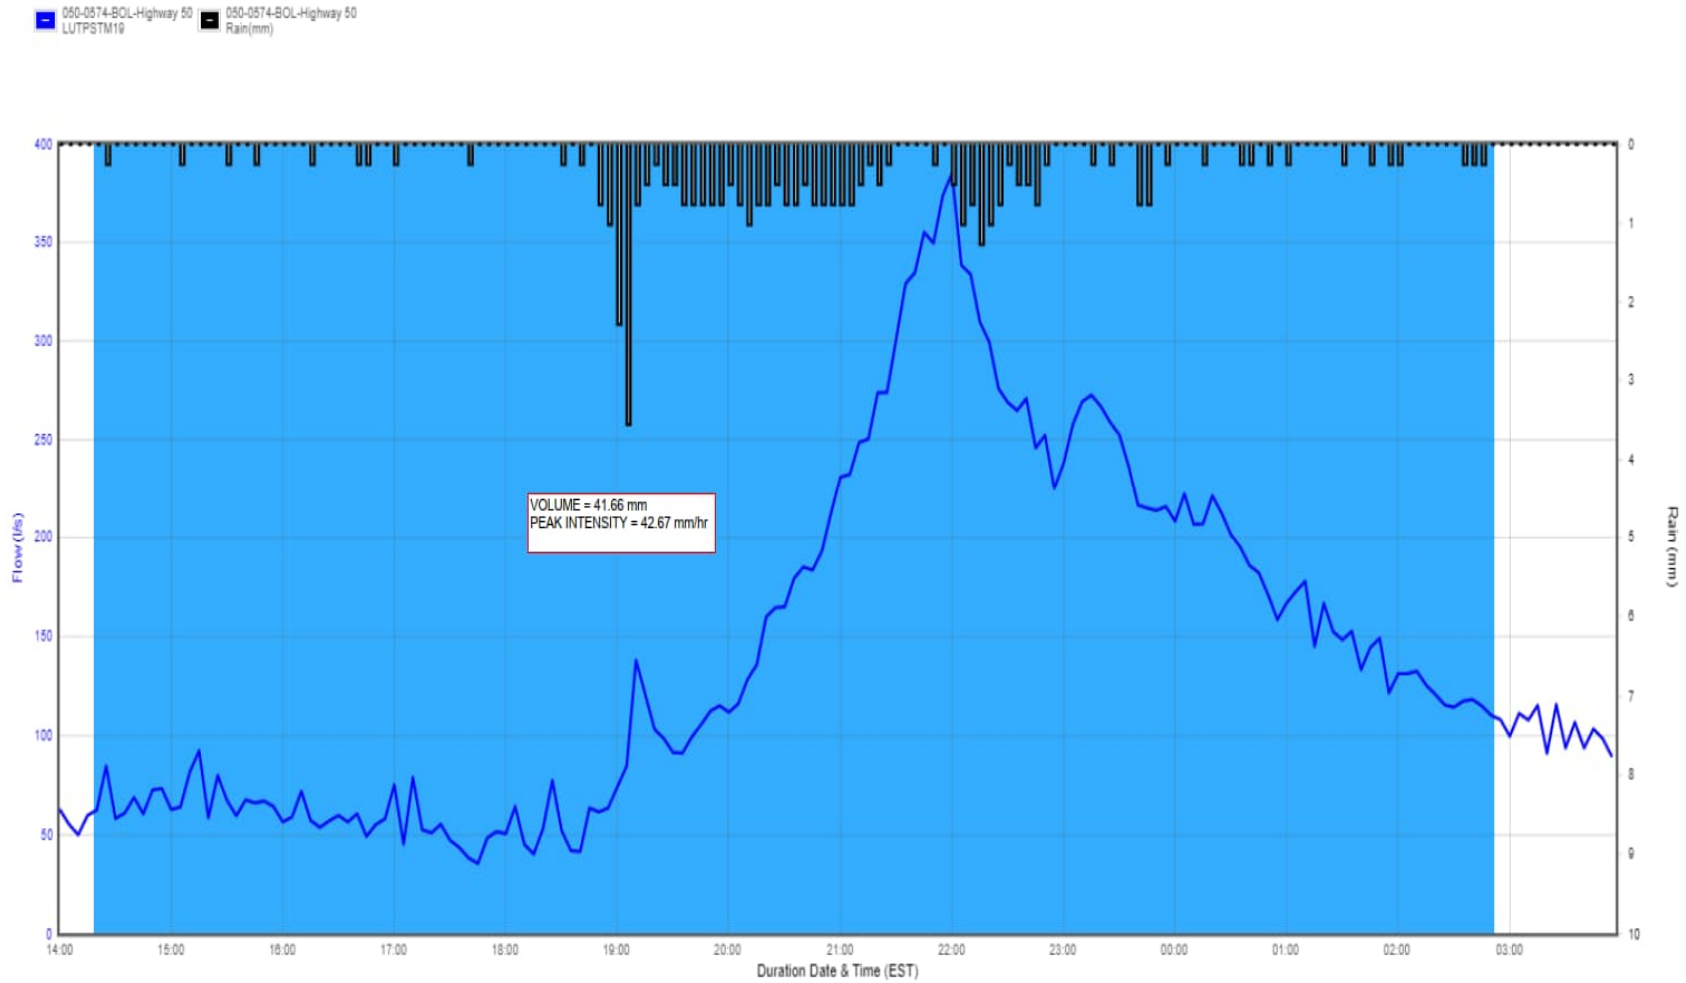
Figure 8.3: 12-Hour Rainfall and Measured Flow Data During September 22, 2021

The resulting recorded peak flow for this rainfall event was only ~375 L/s, nearly 10% of the anticipated peak flow based on the TRCA model. **Figure 8.3** below shows the accumulated rainfall (total depth) and observed flow under an approximately 12-hour storm duration. Based on this observation and the flow results from the smaller storms described above the TRCA estimated peak flows are appeared to be over estimated. This over estimation of the peak flow is likely a result of the high-level, lumped catchment, model approach utilized in the TRCA hydrology model which is typical for a watershed level analysis. A more discretized model, with additional routing and surface and lot level storages accounted for would likely result in lower peak flows. Such an analysis is outside the scope of this project and at this time the revised TRCA flows have been used for analysis purposed with the understanding that they represent a very conservative approach.

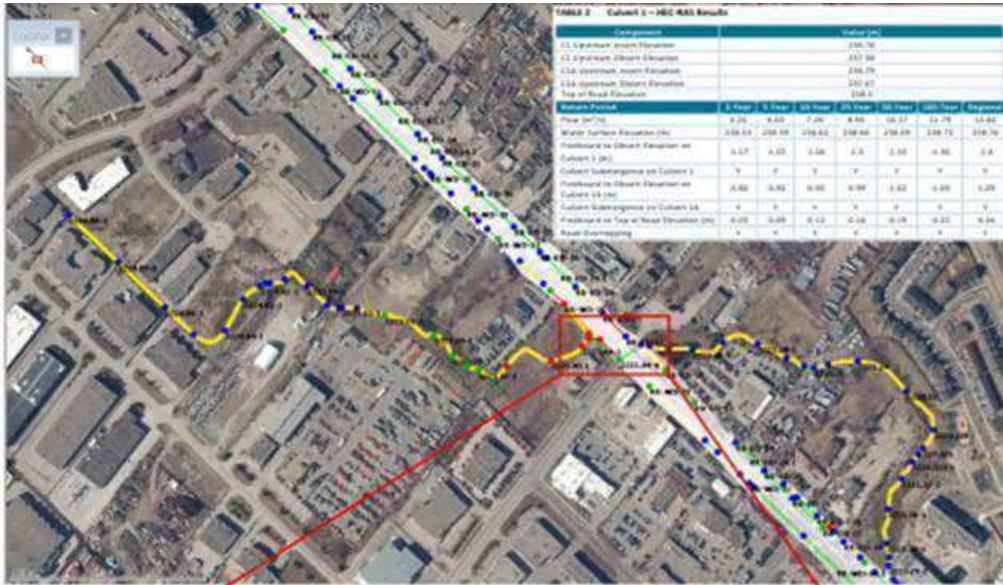
We'd like to arrange for a meeting with the TRCA to discuss HEC-Ras hydraulics and flows in Rainbow Creek. Specifically, why creek flows to the west side of RR50 are so high so that road flooding is predicted from a 2-year storm event onwards (see insert below and Figure 2 writeup attached). Kindly let us know your availability to meet (digitally)... hopefully some time next week. Feel free to include other staff as required.

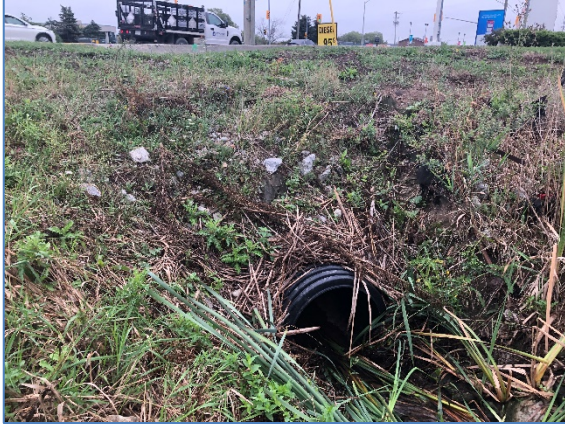
The upstream end is comprised of two protruding culvert barrels; one oriented westerly to convey approaching watercourse flows (Culvert 1) and one oriented northerly to convey approaching roadside ditch flows (Culvert 1A). Culvert 1 is a 600 mm dia. High Density Polyethylene (HDPE) pipe with vegetated embankments and no formalized end treatment (Figure 1). Culvert 1A is a 900 mm Corrugated Steel Pipe (CSP) with riprap stone embankments and no formalized end treatment (Figure 2).

FIGURE 1 Culvert 1 Upstream End

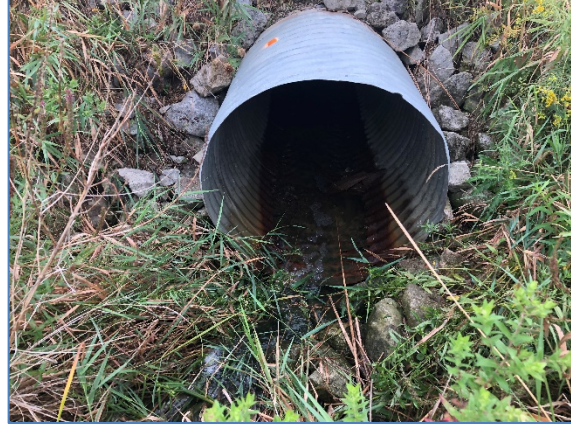
FIGURE 2 Culvert 1A Upstream End

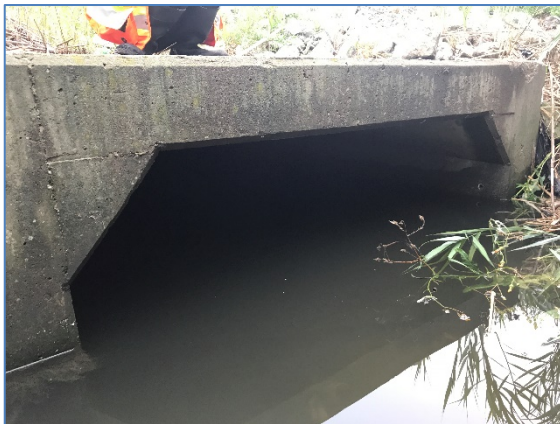
The downstream end is a single span cast in place concrete box culvert. The culvert was significantly backwatered and silted-in at the time of the site visit, but it is presumed to be an open bottom structure with span of 1.88 m and rise of 1.05 m (Figure 3, Figure 4).

FIGURE 2 Culvert 1 Downstream End

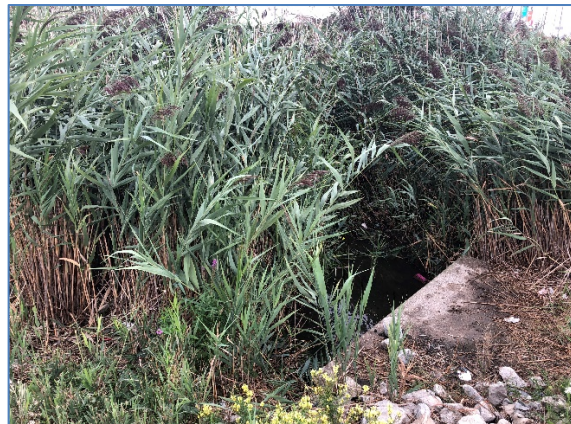
FIGURE 3 Culvert 1 Downstream End

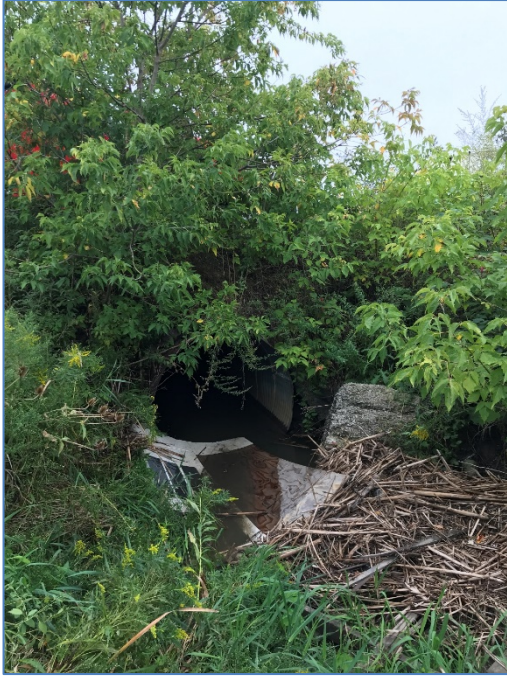
The upstream end is comprised of a protruding culvert barrel; oriented northerly to convey approaching watercourse flows with vegetated embankments and concrete block endwalls. The upstream end is partially obstructed by debris (both natural and “urban” debris), slumping slopes and overhanging vegetation (Figure 5). The downstream end is comprised of a protruding culvert barrel with vegetated embankments and no formalized end treatments (Figure 6).

FIGURE 4 Culvert 2 Upstream End

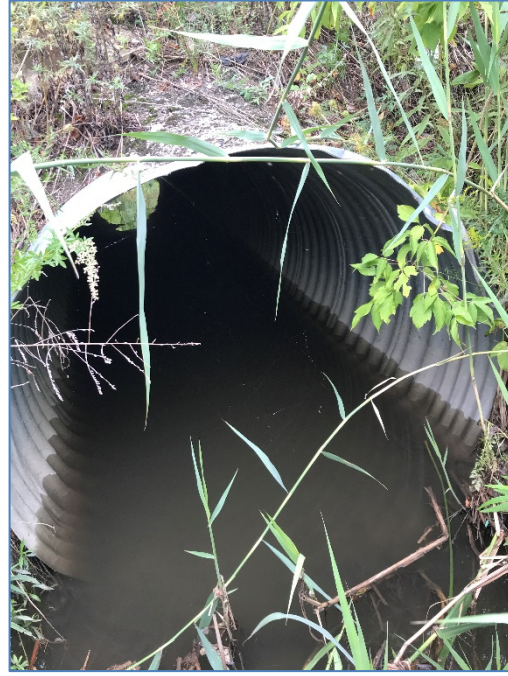
FIGURE 5 Culvert 2 Downstream End

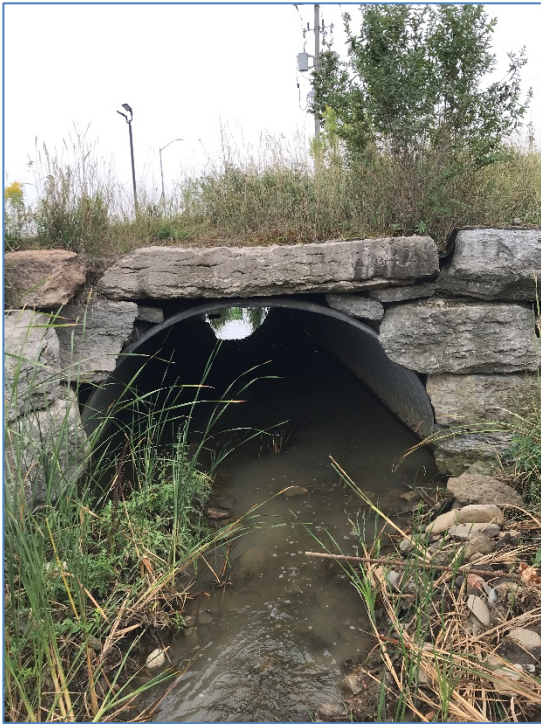
The upstream end is comprised of an open culvert span; oriented northerly to convey approaching watercourse flows with armourstone wingwalls/headwall (Figure 7). The downstream end is comprised of an open culvert span with armourstone wingwalls/headwall (Figure 8).

FIGURE 6 Culvert 3 Upstream End

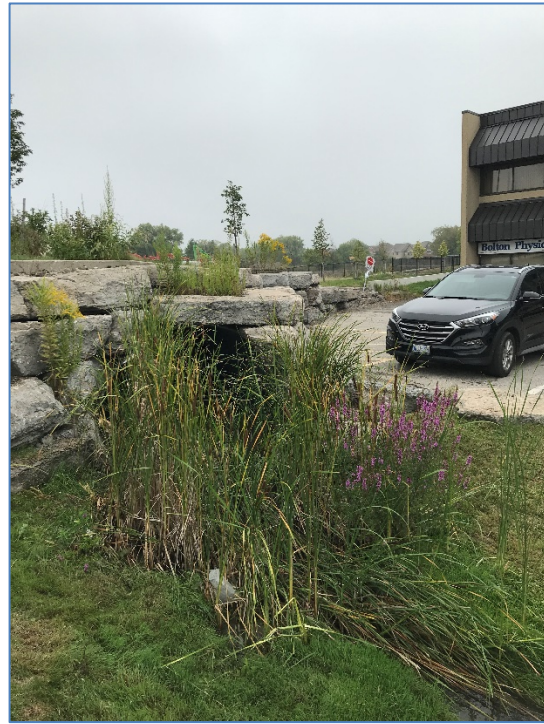
FIGURE 7 Culvert 3 Downstream End

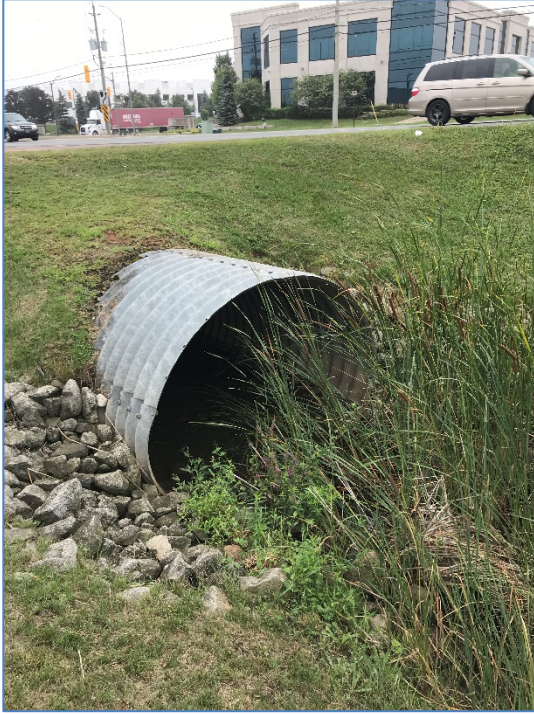
The upstream end is comprised of a protruding culvert barrel; oriented northerly to convey approaching watercourse flows with riprap stone/manicured grass embankments and no formalized end treatment (Figure 9). The downstream end is comprised of a protruding culvert barrel with manicured grass embankments and no formalized end treatment (Figure 10).

FIGURE 8 Culvert 4 Upstream End

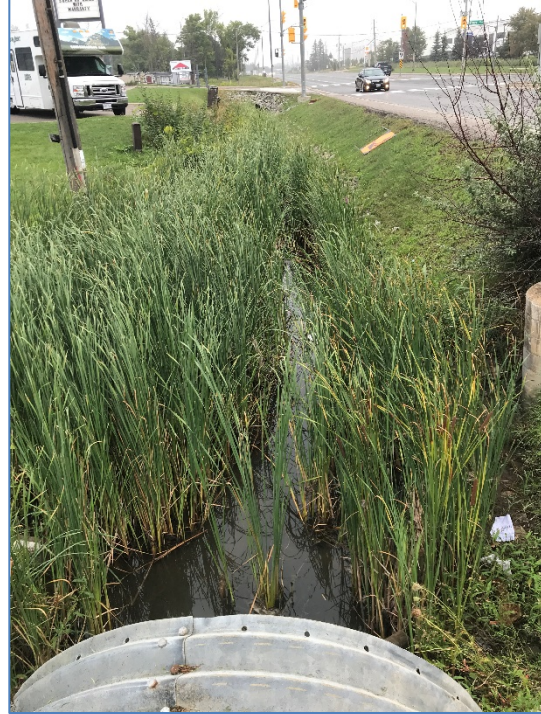
FIGURE 9 Culvert 4 Looking Downstream

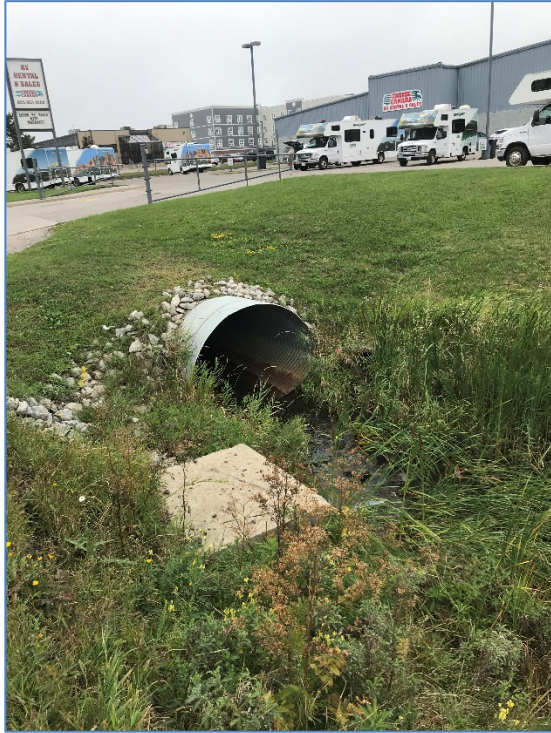
The upstream end is comprised of a protruding culvert barrel; oriented northerly to convey approaching watercourse flows with riprap stone/manicured grass embankments and no formalized end treatment. The downstream end is comprised of a protruding culvert barrel with riprap stone/manicured grass embankments and no formalized end treatment (Figure 11, Figure 12).

FIGURE 10 Culvert 5 Downstream End

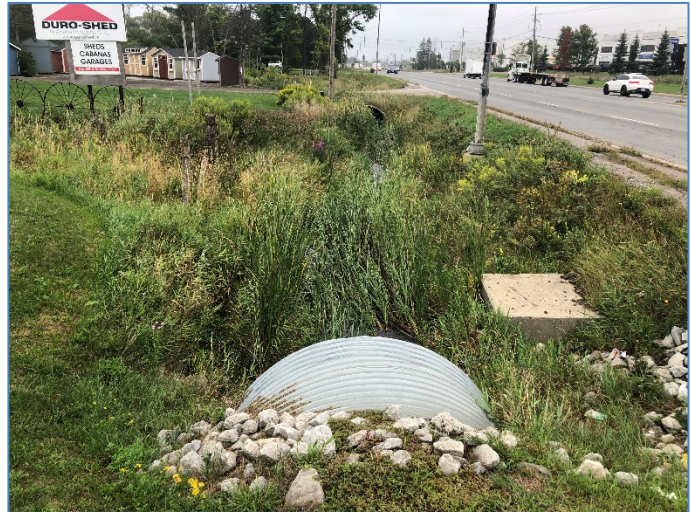
FIGURE 11 Culvert 5 Looking Downstream

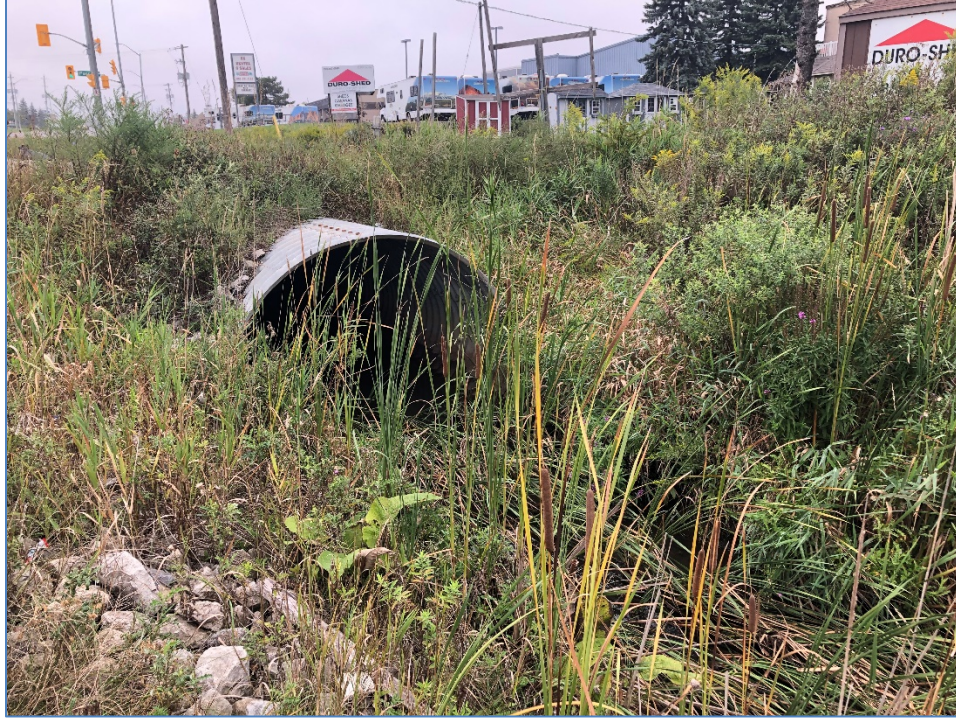
The upstream end is comprised of a protruding culvert barrel; oriented northerly to convey approaching watercourse flows with riprap stone/vegetated embankments and no formalized end treatment. The downstream end is comprised of a protruding culvert barrel with riprap stone/vegetated embankments and no formalized end treatment (Figure 13).

FIGURE 12 Culvert 6 Downstream End

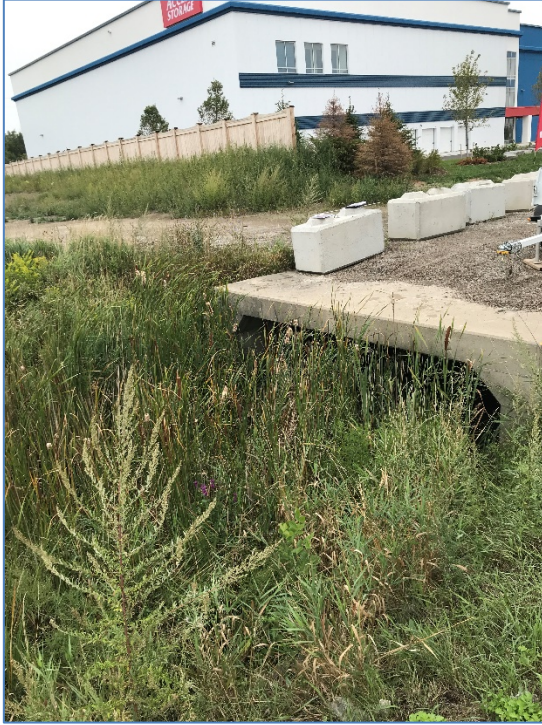
The upstream end is comprised of an open culvert span; oriented northerly to convey approaching watercourse flows with vegetated embankments and no formalized end treatment (Figure 14). The downstream end is comprised of an open culvert span with vegetated embankments and no formalized end treatment (Figure 15).

FIGURE 13 Culvert 7 Upstream End

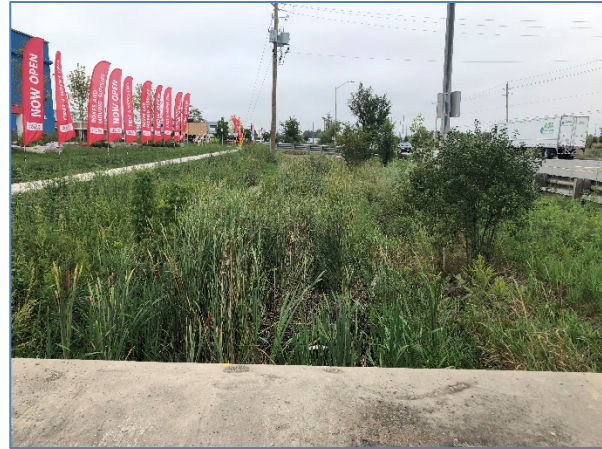
FIGURE 14 Culvert 7 Looking Downstream

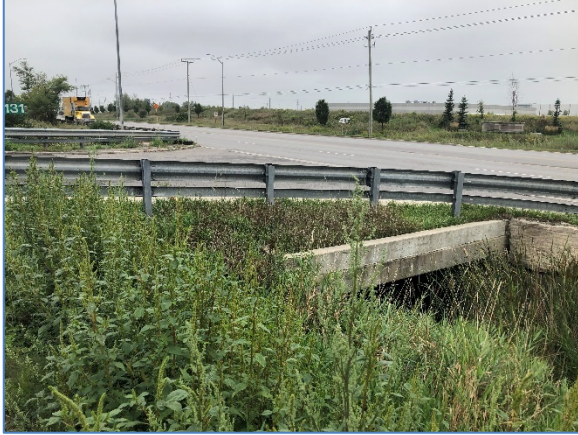
The upstream end is comprised of an open culvert span; oriented northerly to convey approaching watercourse flows with riprap/vegetated embankments, a concrete headwall and armour stone wingwall along the roadside embankment (Figure 14). The downstream end is comprised of an open culvert span with riprap/vegetated embankments, a concrete headwall and armour stone wingwall along the roadside embankment (Figure 15).

FIGURE 15 Culvert 8 Upstream End

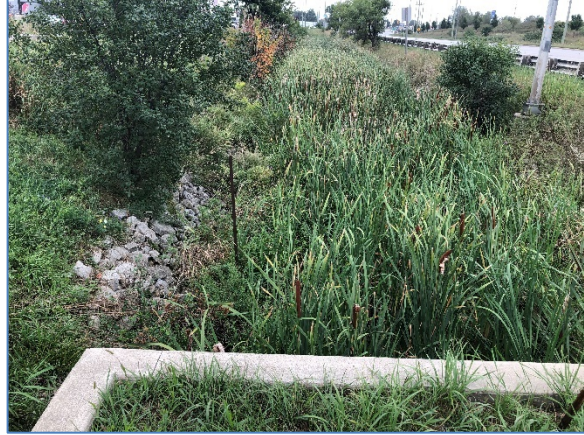
FIGURE 16 Culvert 8 Looking Downstream

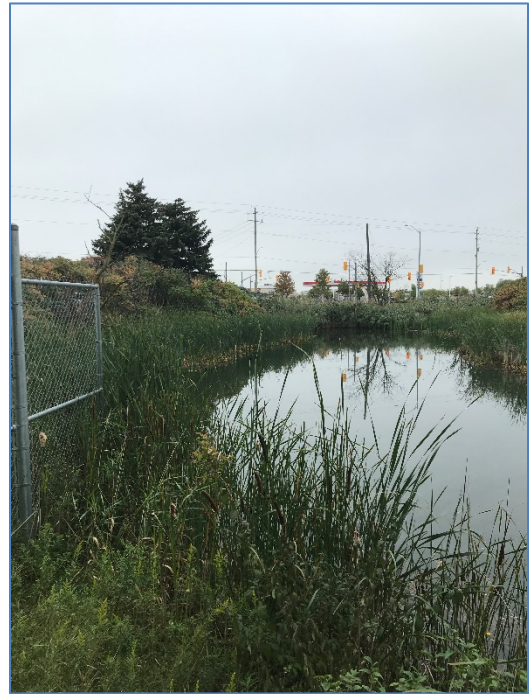
An online pond exists immediately downstream of Culvert 1. The pond appears to have no formalized inlet/outlet controls and appears largely unmaintained, with heavy siltation and overgrown invasive vegetation (**Figure 18**). Although the pond is not delineated by security fence along the RR50 boundary, the pond appears to be situated largely beyond the RR50 Right-of-Way. In addition to the upstream watercourse areas contributing to the pond, one small diameter inlet from the eastern side was located; presumed to provide some function of stormwater servicing to the adjacent private OPP property.

FIGURE 17 Existing Pond Looking Upstream

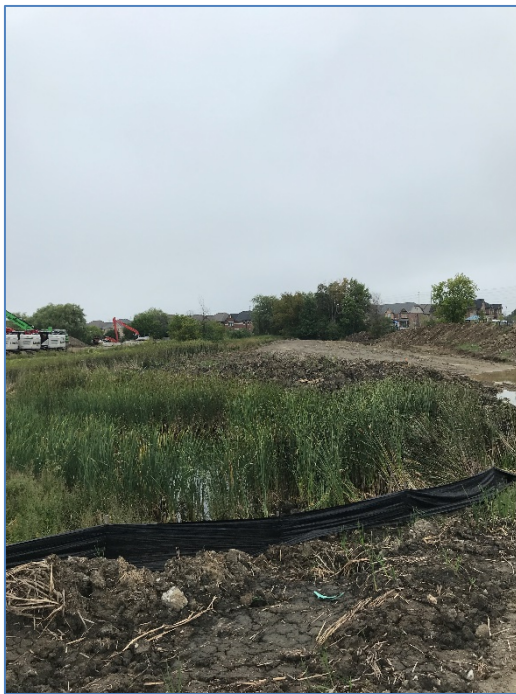
In consultation with the Project Team it has been identified that an approximate 200 m length of the watercourse upstream of Culvert 3 is currently under the process of being re-aligned by a private landowner (Figure 19).

FIGURE 18 Current Channel Re-Alignment
Looking Upstream

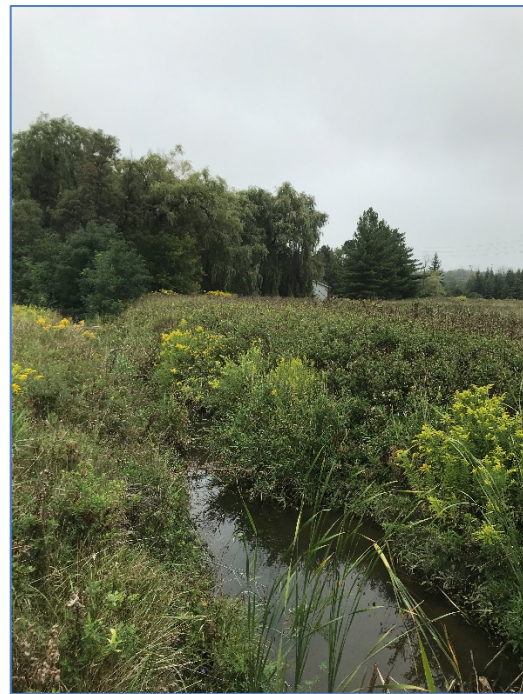
In consultation with the Project Team it has been identified that an approximate 80 m length of the watercourse upstream of Culvert 7 has been historically re-aligned by a private landowner (Figure 20); for which TRCA is currently involved and pursuing restitution.

FIGURE 19 Previous Channel Re-Alignment
Looking Upstream

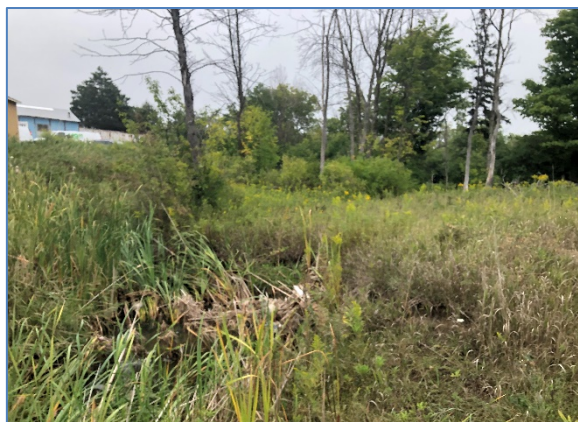
FIGURE 20 Looking Downstream from Culvert 6 (Subject Property on Right)

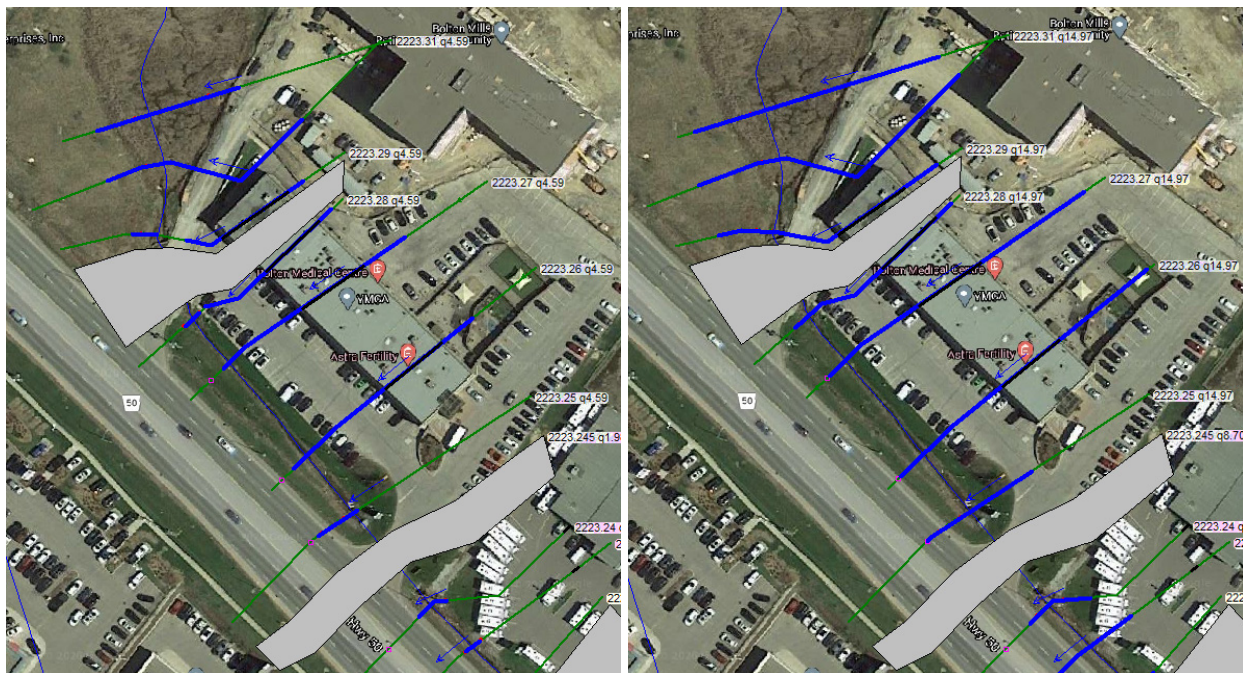
Figure 24 plots water extents on cross-sections adjacent to Culvert 3 and 4 for the 2-year and regional events. The watercourse in this area experiences high water level during the 2-year through the regional event. The multi-unit commercial property and its parking lot, which is on the east bank of the watercourse, experience flooding during the 2-year event and greater. RR50, which is on the west bank of the watercourse, does not experience flow on the road, except for the one cross-section upstream end of Culvert 4. During the 2-year event and greater, this cross-section indicates that water encroaches on RR50 but does not overtop the road crown or spill to other side of RR50.

FIGURE 24 Culvert 3 and 4 – Water Extents on Cross-sections during the 2-Year (Left) and Regional Event (Right)

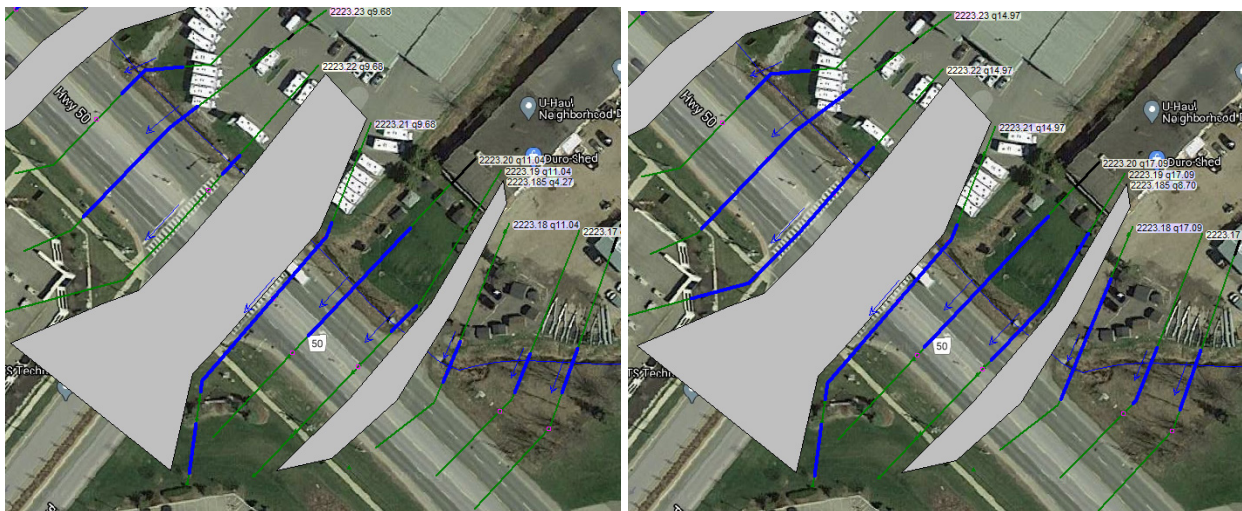
FIGURE 26 Culvert 5 and 6 – Water Extents on Cross-sections during the 25-Year (Left) and Regional Event (Right)

Figure 25 plots water extents on cross-sections adjacent to Culvert 5 and 6 for the 5-year and 10-year event, and Figure 26 for the 25-year and the regional event. In this section of the watercourse, flooding is subject to the west bank spilling across RR50. During the 5-Year event, water is contained in the channel and does not encroach on RR50, except for the cross-section in the middle between Culvert 5 and 6. This cross-section indicates that water encroaches on RR50 but not overtop the road crown or spill to other side of RR50. During the 10-year event, several cross-sections indicate water encroaches on west shoulder of RR50 but not overtop the road crown or spill to other side of RR50. During the 25-year event and greater, water spills across RR50 with overtopping of the road crown.

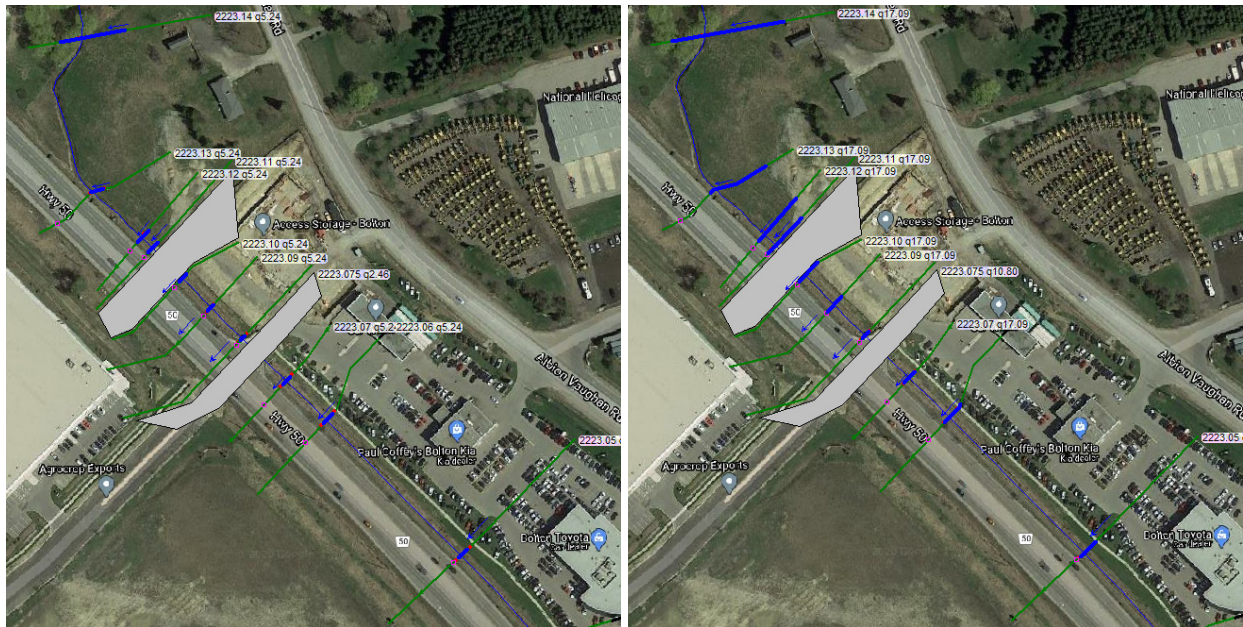
FIGURE 27 Culvert 7 and 8 – Water Extents on Cross-sections during the 2-Year (Left) and Regional Event (Right)

Figure 27 plots water extents on cross-sections adjacent to Culvert 7 and 8 for the 2-year and regional event. For the watercourse along RR50 (three cross-sections upstream of Culvert 7 to three cross-sections of Culvert 8, approximately 285 m), water is contained in the channel without spilling on RR50 during the 2-year to the regional event.

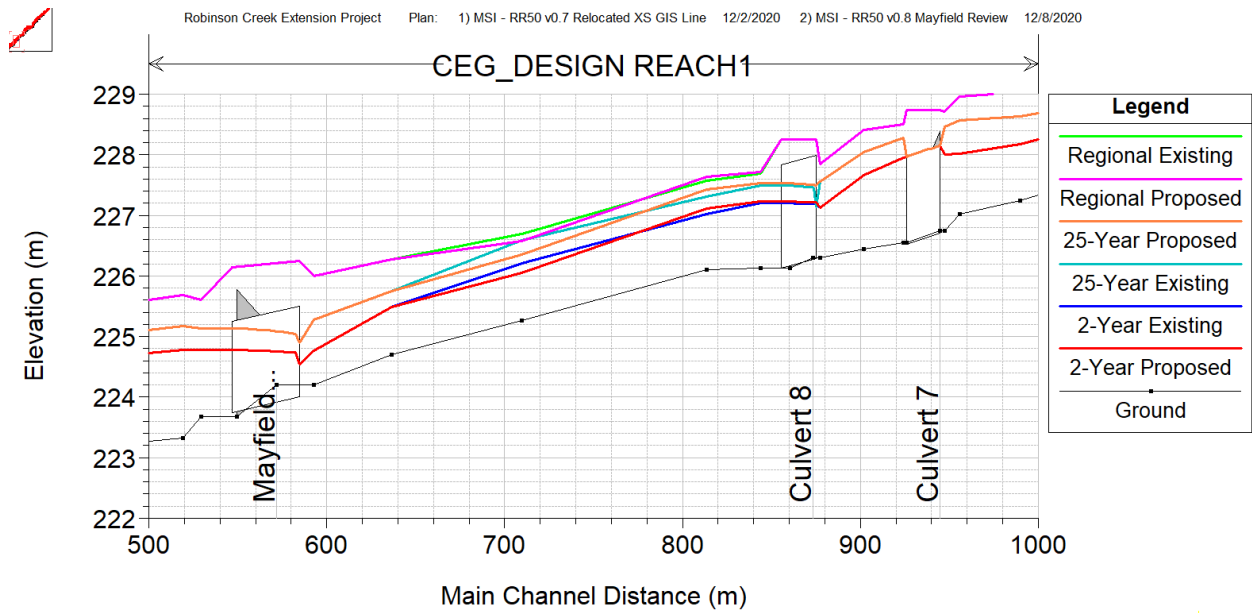
FIGURE 28 Water Level Profile for Existing Mayfield Rd Culvert and Proposed Mayfield Rd Culvert during the 2-year, 25-year, and the regional events.

Matrix was informed by RVA that the Mayfield Road Culvert, which is located approximately 290 m downstream of Culvert 8, will be replaced with a new dimension during future construction. Matrix received a HEC-RAS model provided by RVA specific to this culvert. This model was used for the purpose of future culvert design including the proposed Mayfield Road Culvert and associated watercourses. To verify the proposed Mayfield Rd Culvert does not alter the general hydraulic performances of Culvert 8 and watercourse nearby, a sensitivity analysis was carried out to examine the hydraulic impact of proposed Mayfield Road Culvert. A rating curve, which represents the proposed hydraulic condition on the watercourse between Culvert 8 and Mayfield Rd, was derived from the RVA model and setup up in Matrix model in cross-section 2223.05. **Figure 28** shows the water level profiles for existing condition and the condition with proposed Mayfield Road Culvert. The figure shows water levels for three storm events including the 2-year, 25-year, and the regional events. The results show the proposed Mayfield Road Culvert has insignificant impact on water level from the 2-year through regional events. The maximum rise of water level is 13 cm difference on cross-section 2223.06 during the 25-year event. Overall, the proposed Mayfield Road Culvert does not alter the hydraulic performance of Culvert 8, and does not alter spill conditions on RR50 during any of the modelled events.

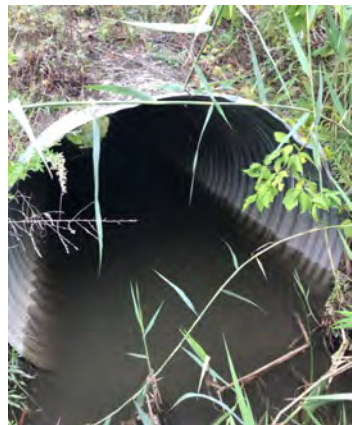
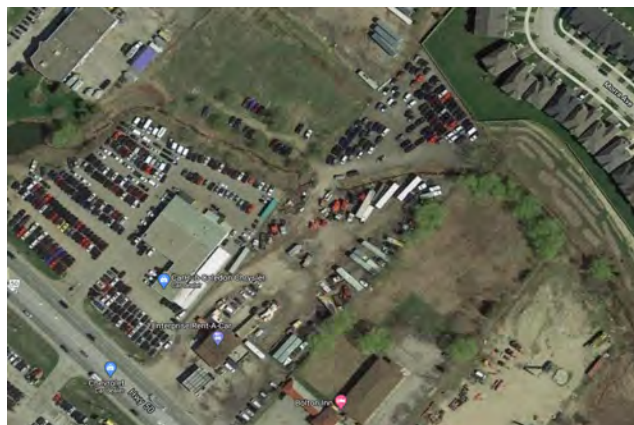
Cross-sectional Sketch:

Channel Disturbance Old concrete blocks around culvert sides (failing)

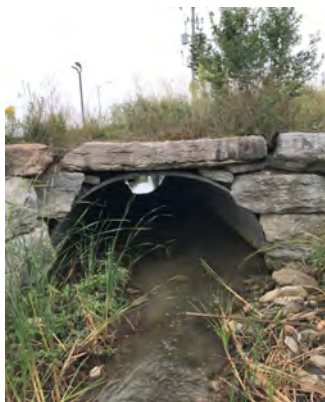
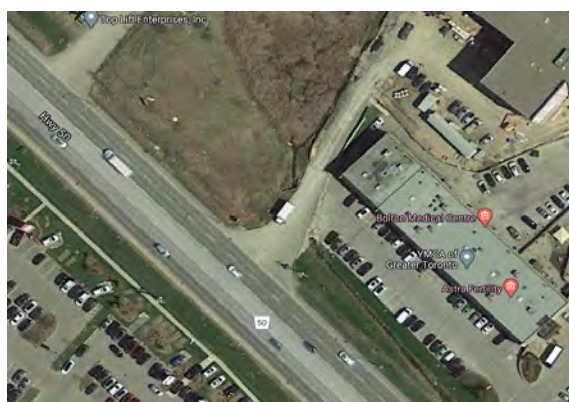
Cross-sectional Sketch:

Bankfull Width (m) no bankfull upstream (design) Bankfull Depth (m) no bankfull upstream (design)
1.2 m
Wetted Width (m) 2.95 at culvert Wetted Depth (m) 0.5 m in culvert
0.6 m 0.15 m
Gradient Low Medium High Entrenchment Low Medium High
Sinuosity Low Medium High Valley Setting unconfined
Riparian Vegetation Width (m) ~10 m Type cattails, grass
Channel Disturbance Channel being realigned upstream (ongoing construction)

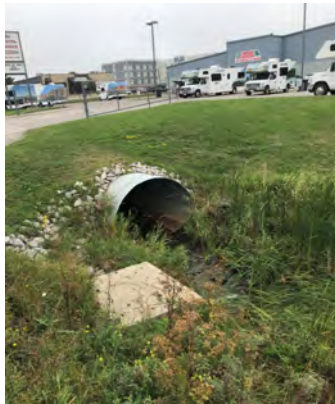
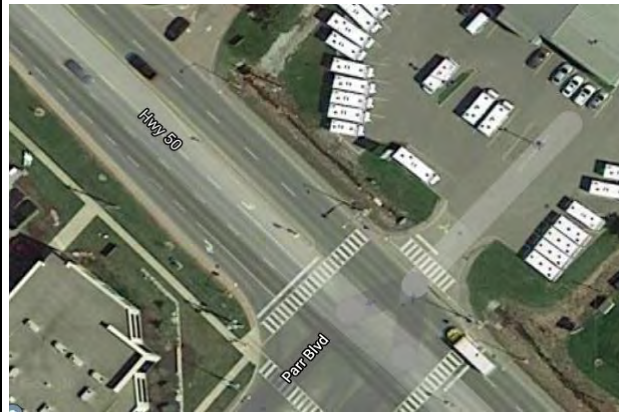
Cross-sectional Sketch:

Channel Disturbance riprap at crossing on banks and road embankment

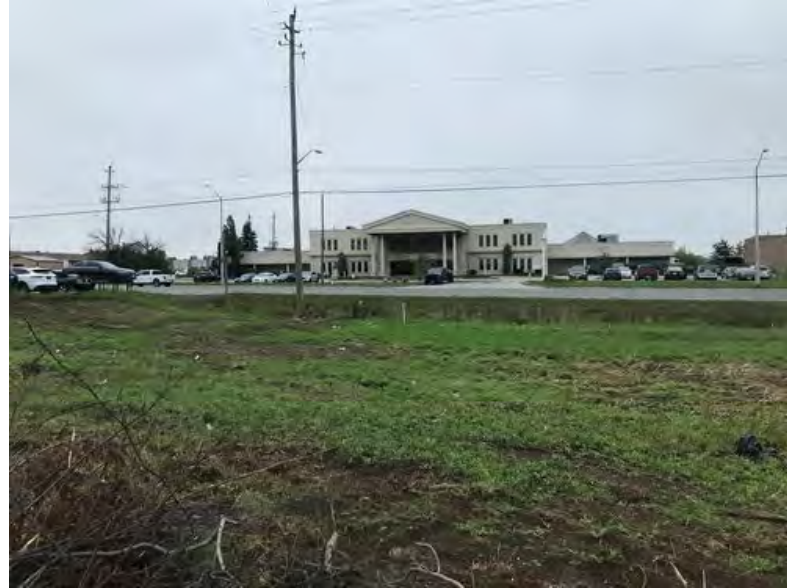
1. Upstream of Culvert 1

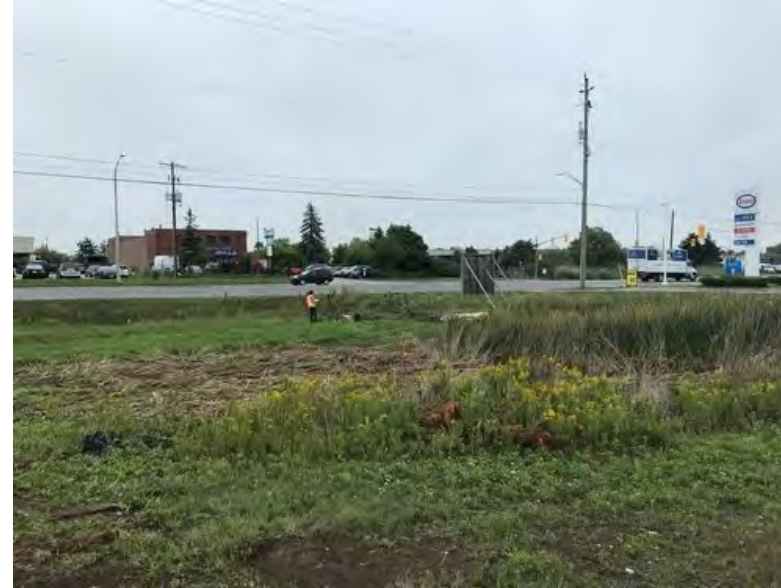
2. Upstream of Culvert 1

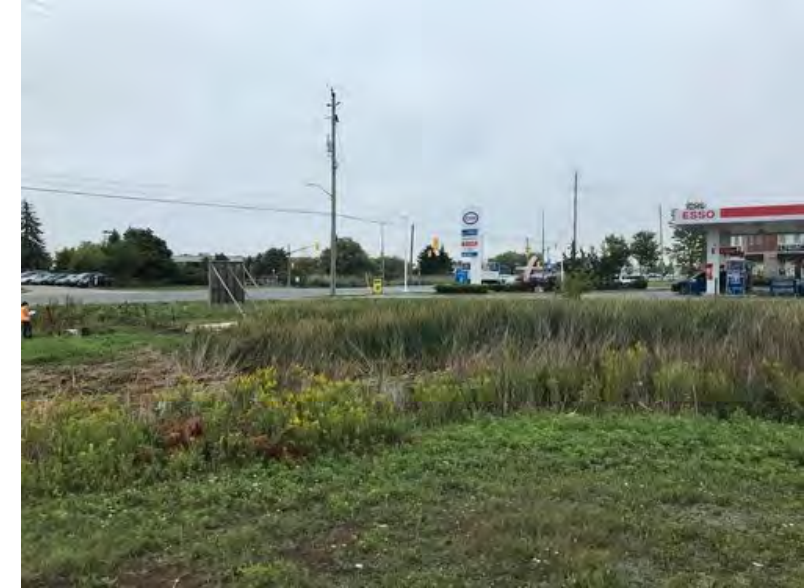
3. Upstream of Culvert 1

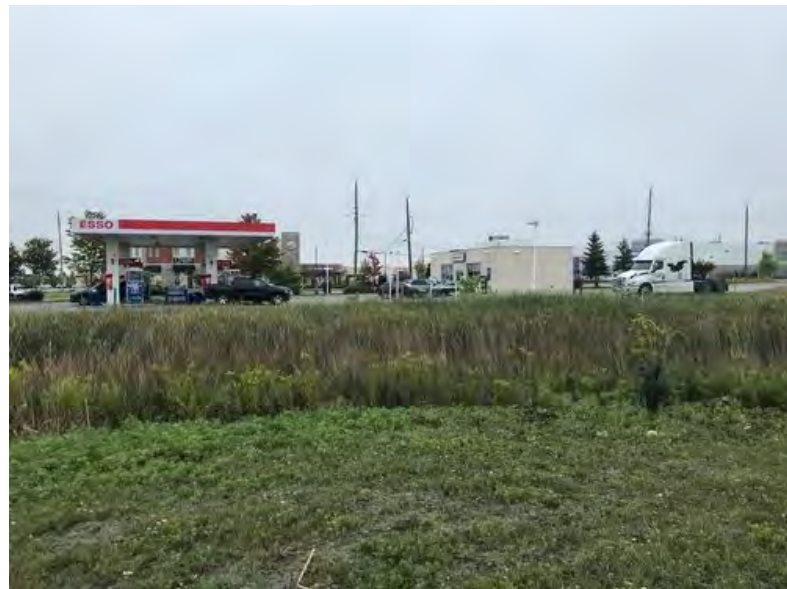
4. Upstream of Culvert 1

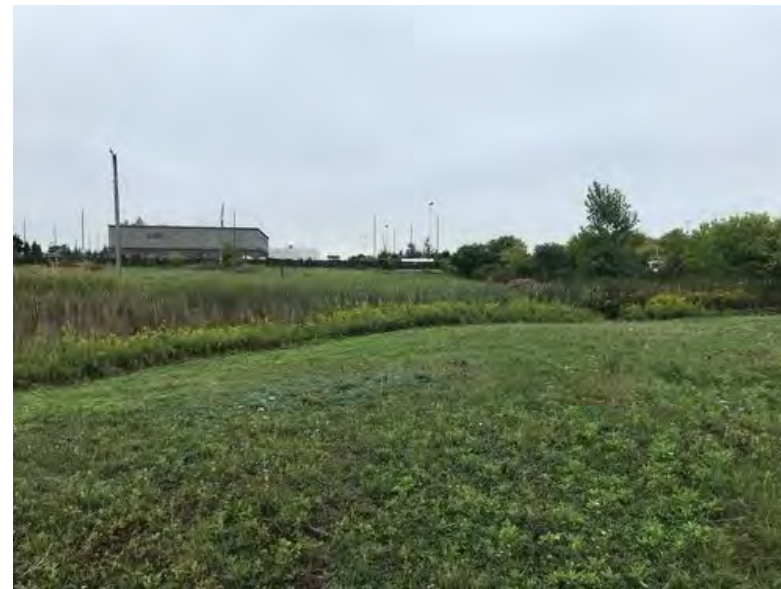
5. Upstream of Culvert 1

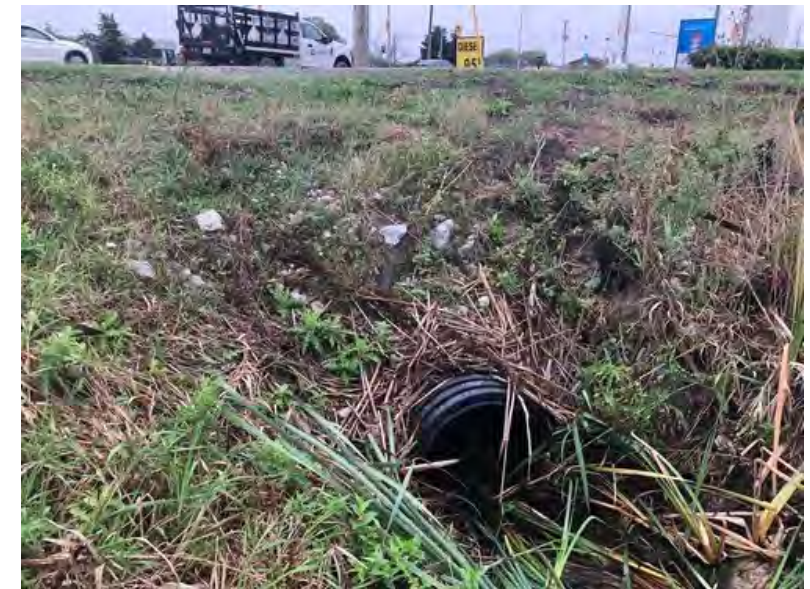
6. Culvert C1 (Inlet)

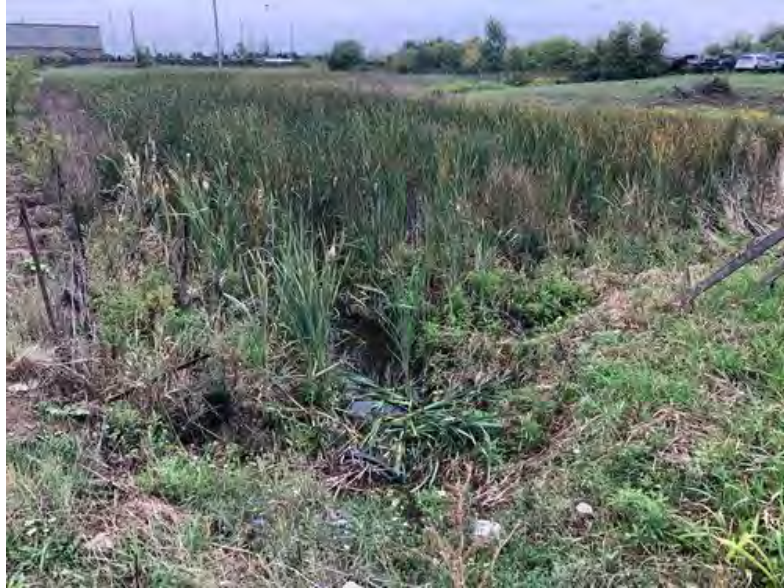
7. Culvert C1 (Inlet)

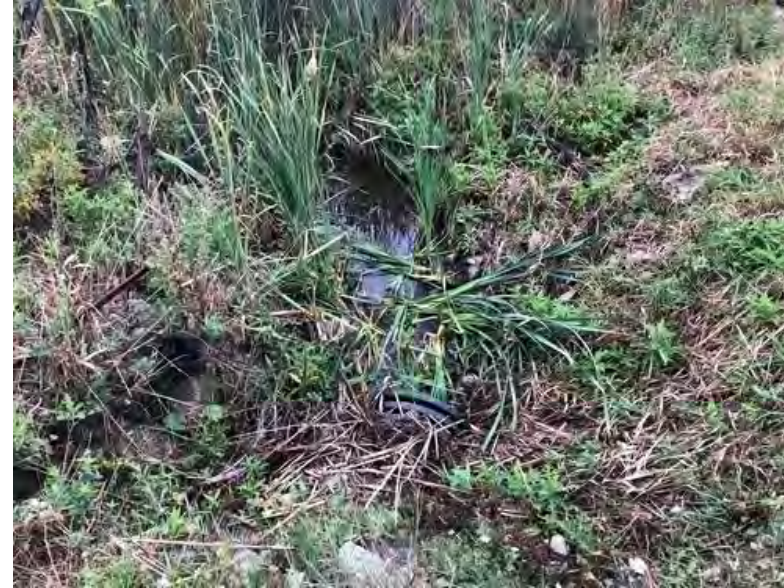
8. Culvert C1 (Inlet)

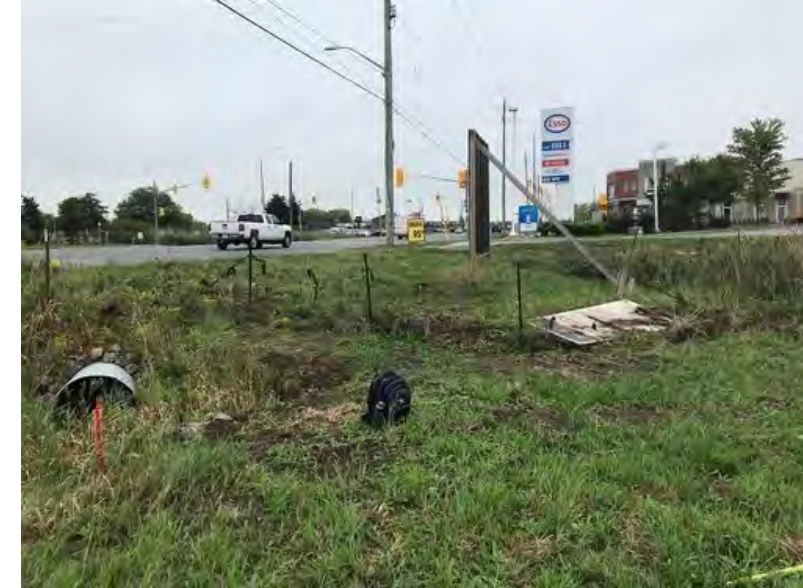
9. Culvert C1a (Inlet)
