STORMWATER MANAGEMENT REPORT

ENVIRONMENTAL ASSESSMENT (EA) AND PRELIMINARY DESIGN FOR DRAINAGE IMPROVEMENTS OF HIGHWAY 50 FROM MAYFIELD ROAD TO HEALEY ROAD

December 1, 2022

Region of Peel

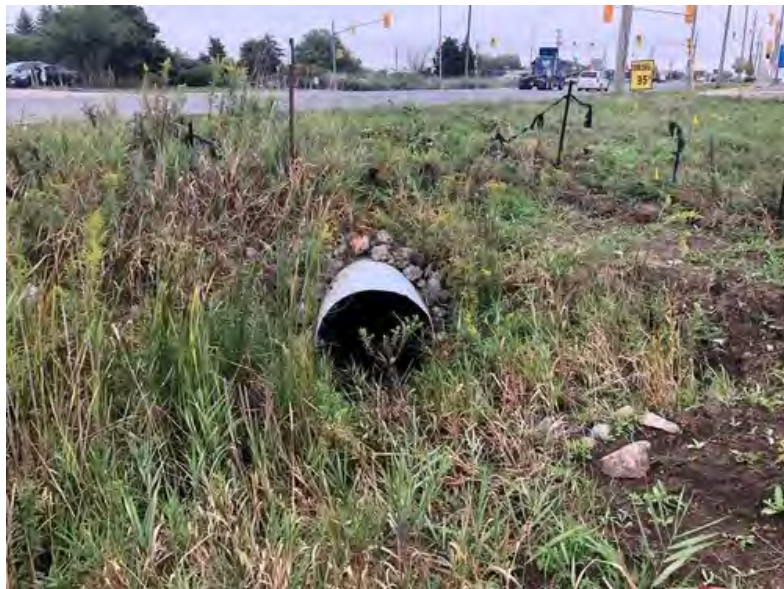
10. Culvert C1a (Inlet)

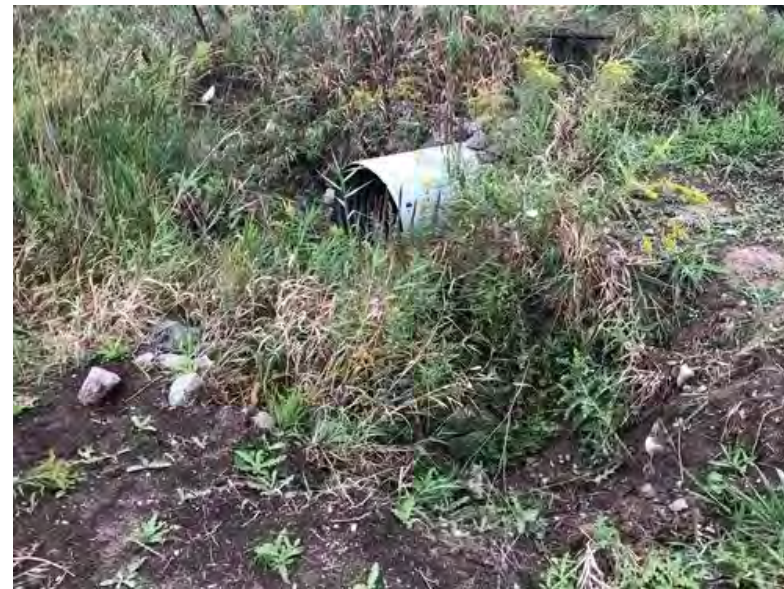
11. Culvert C1a (Inlet)

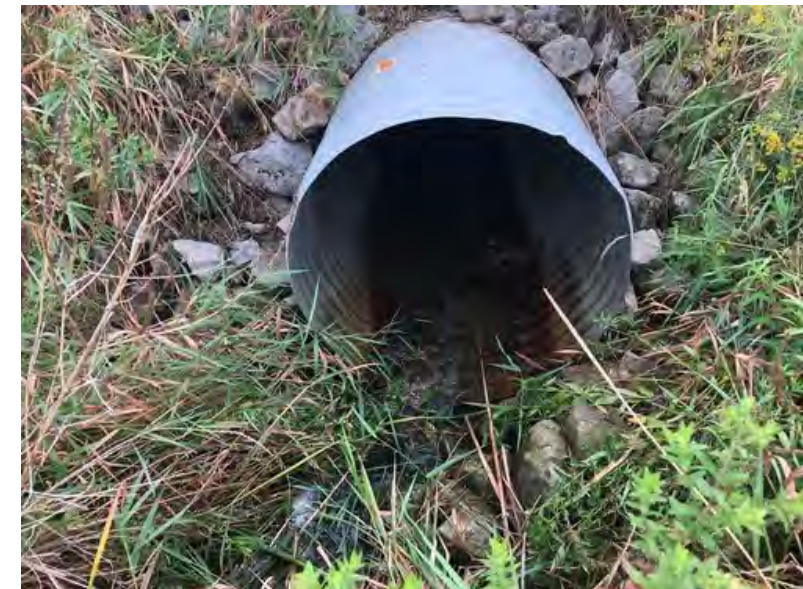
12. Culvert C1a (Inlet)

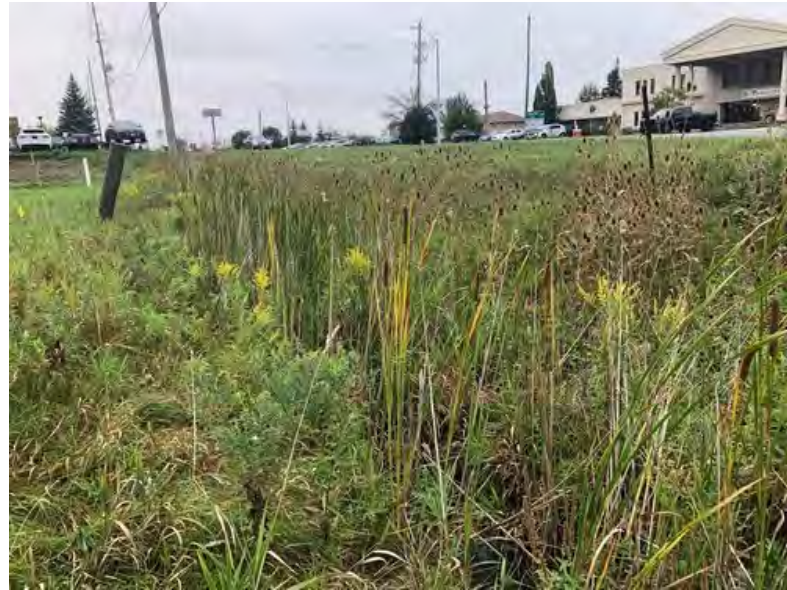
13. Culvert C1a (Inlet)

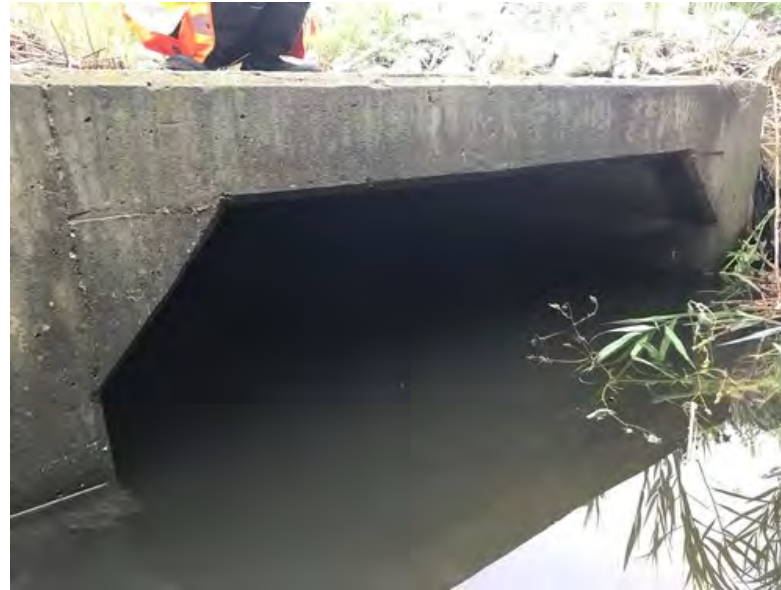
14. Culvert 1 Outlet

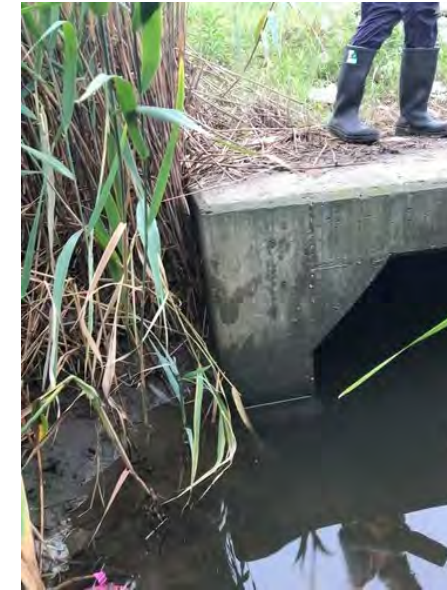
15. Culvert 1 Outlet

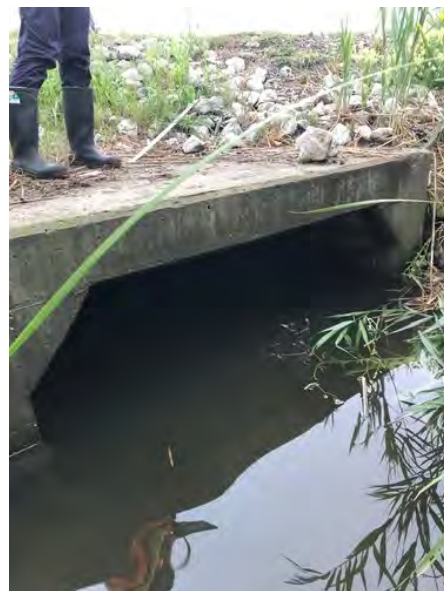
16. Culvert 1 Outlet

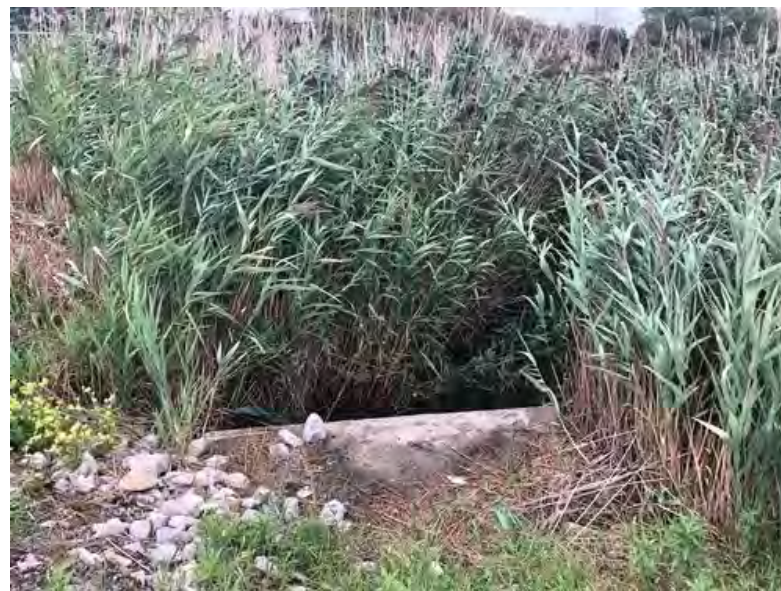
17. Culvert 1 Outlet

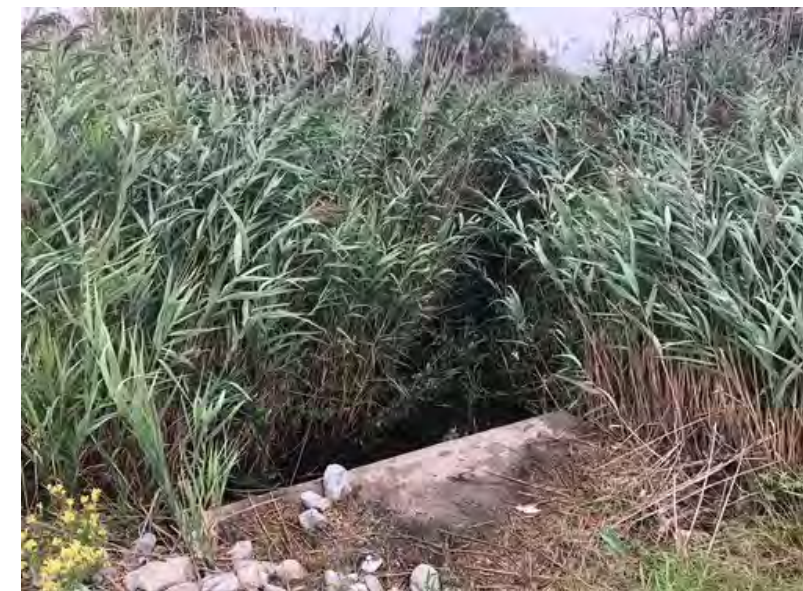
18. Culvert 1 Outlet

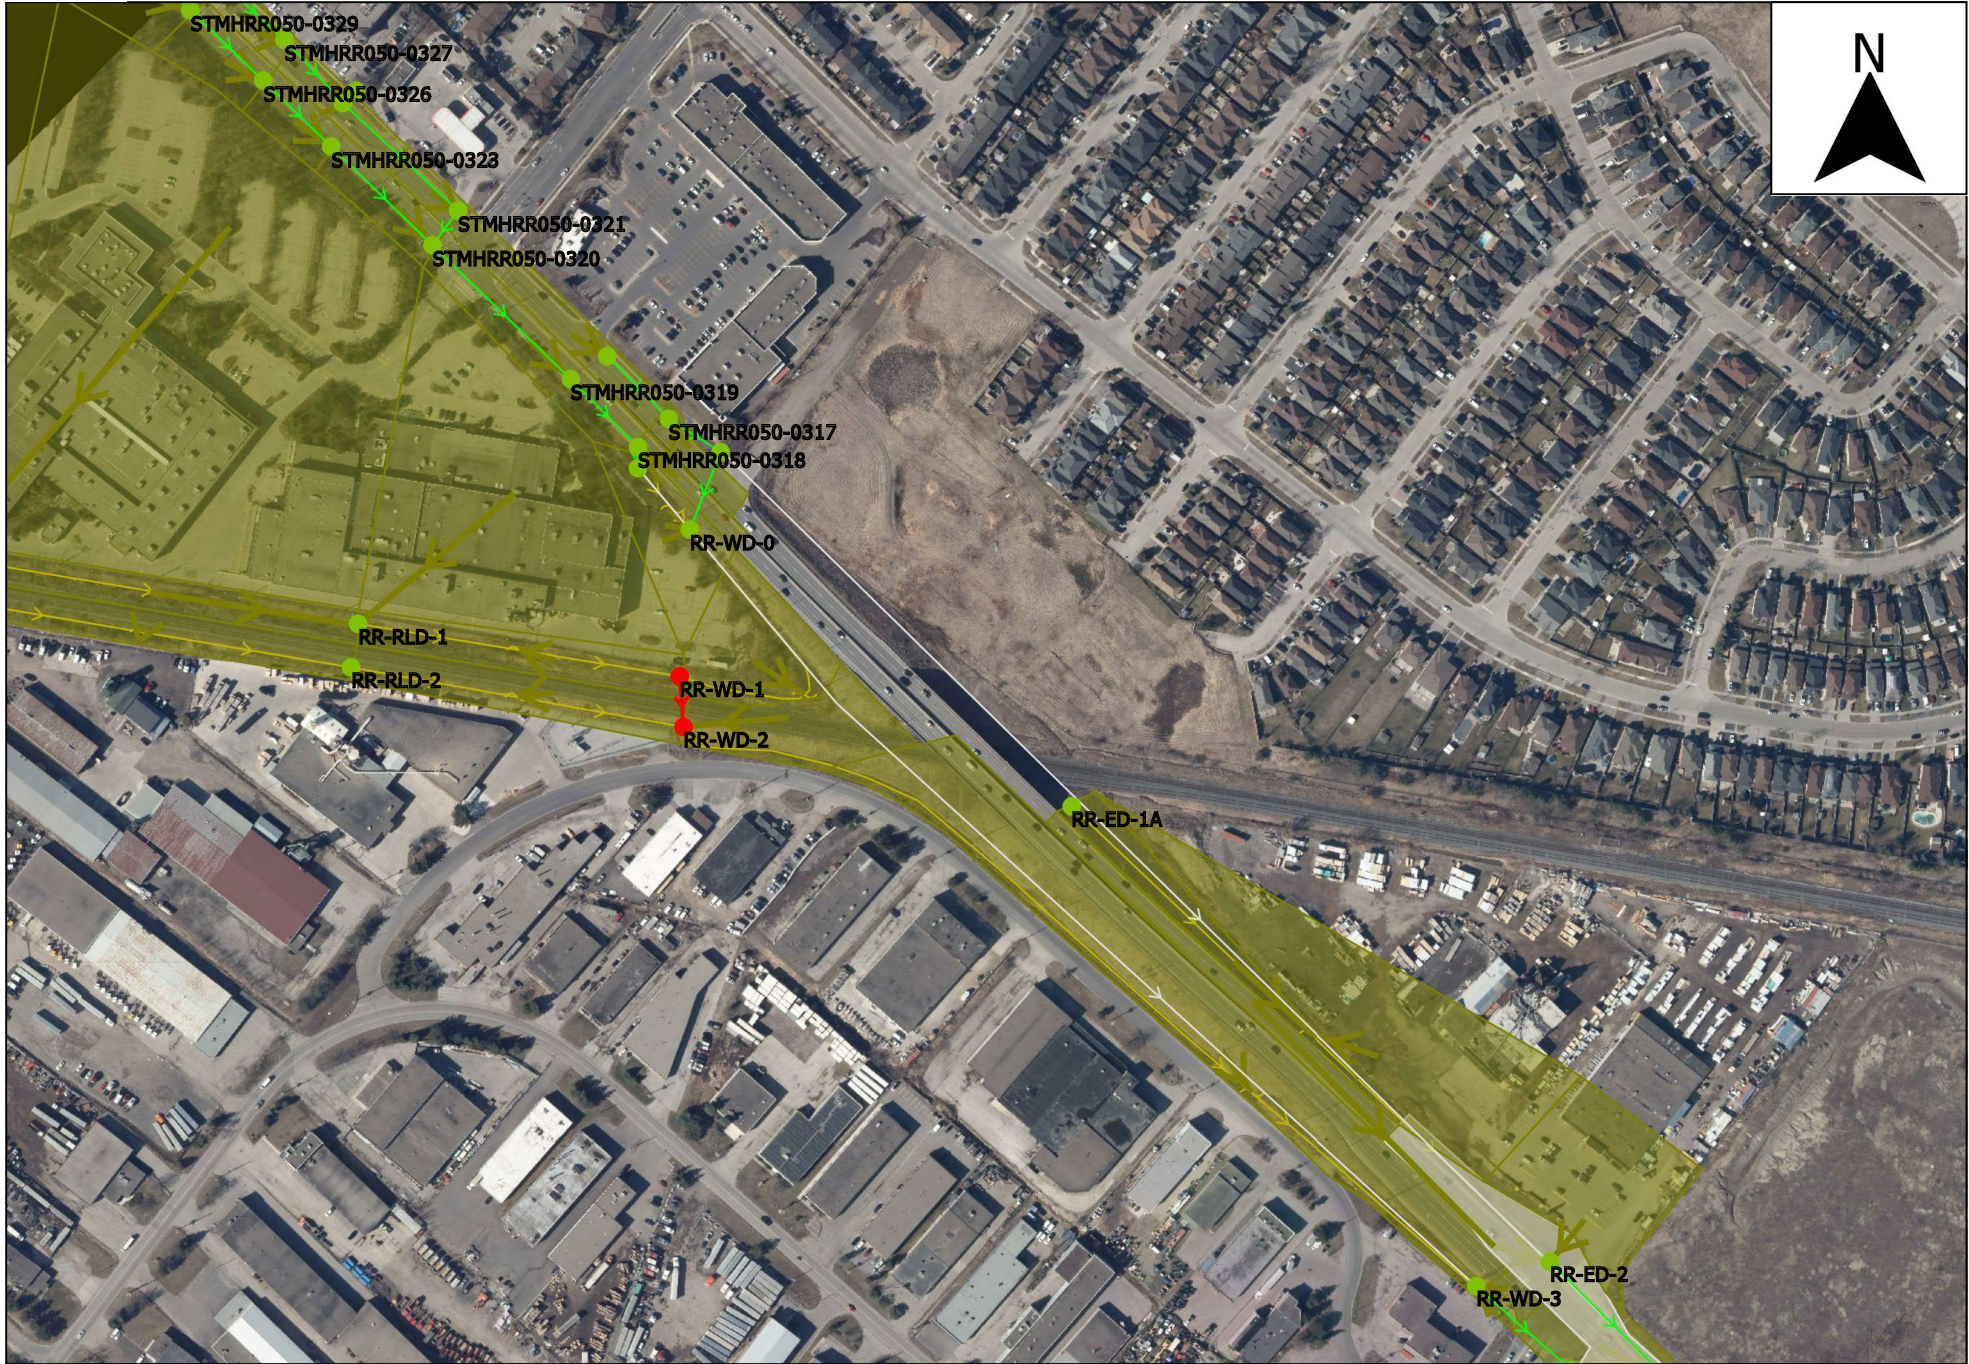
EXISTING CONDITION - 100-YEAR - WEST SIDE PROFILE 1

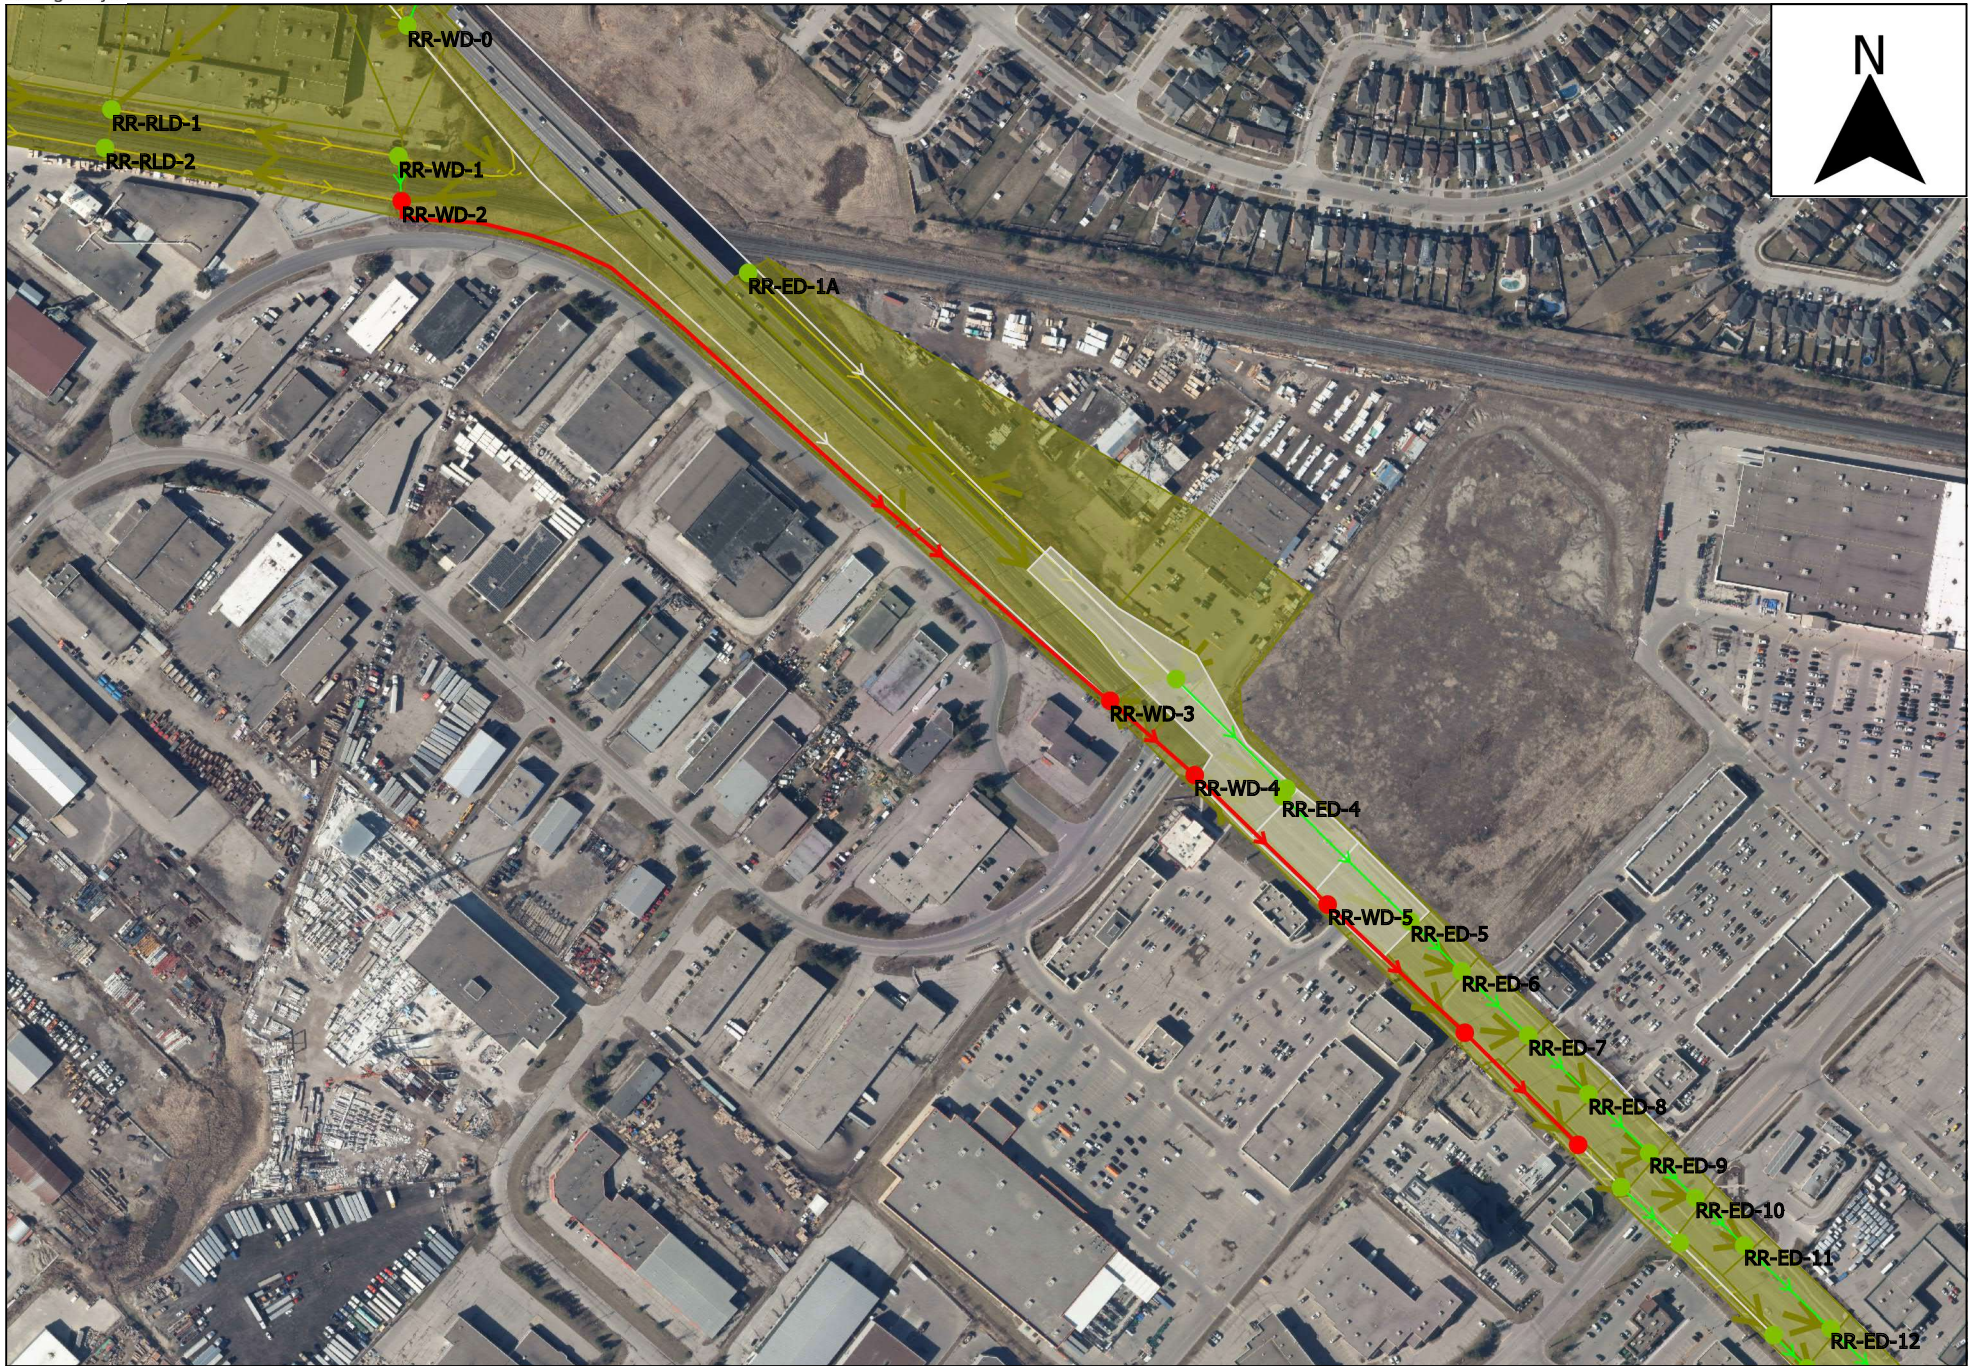
EXISTING CONDITION - 100-YEAR - WEST SIDE PROFILE 1

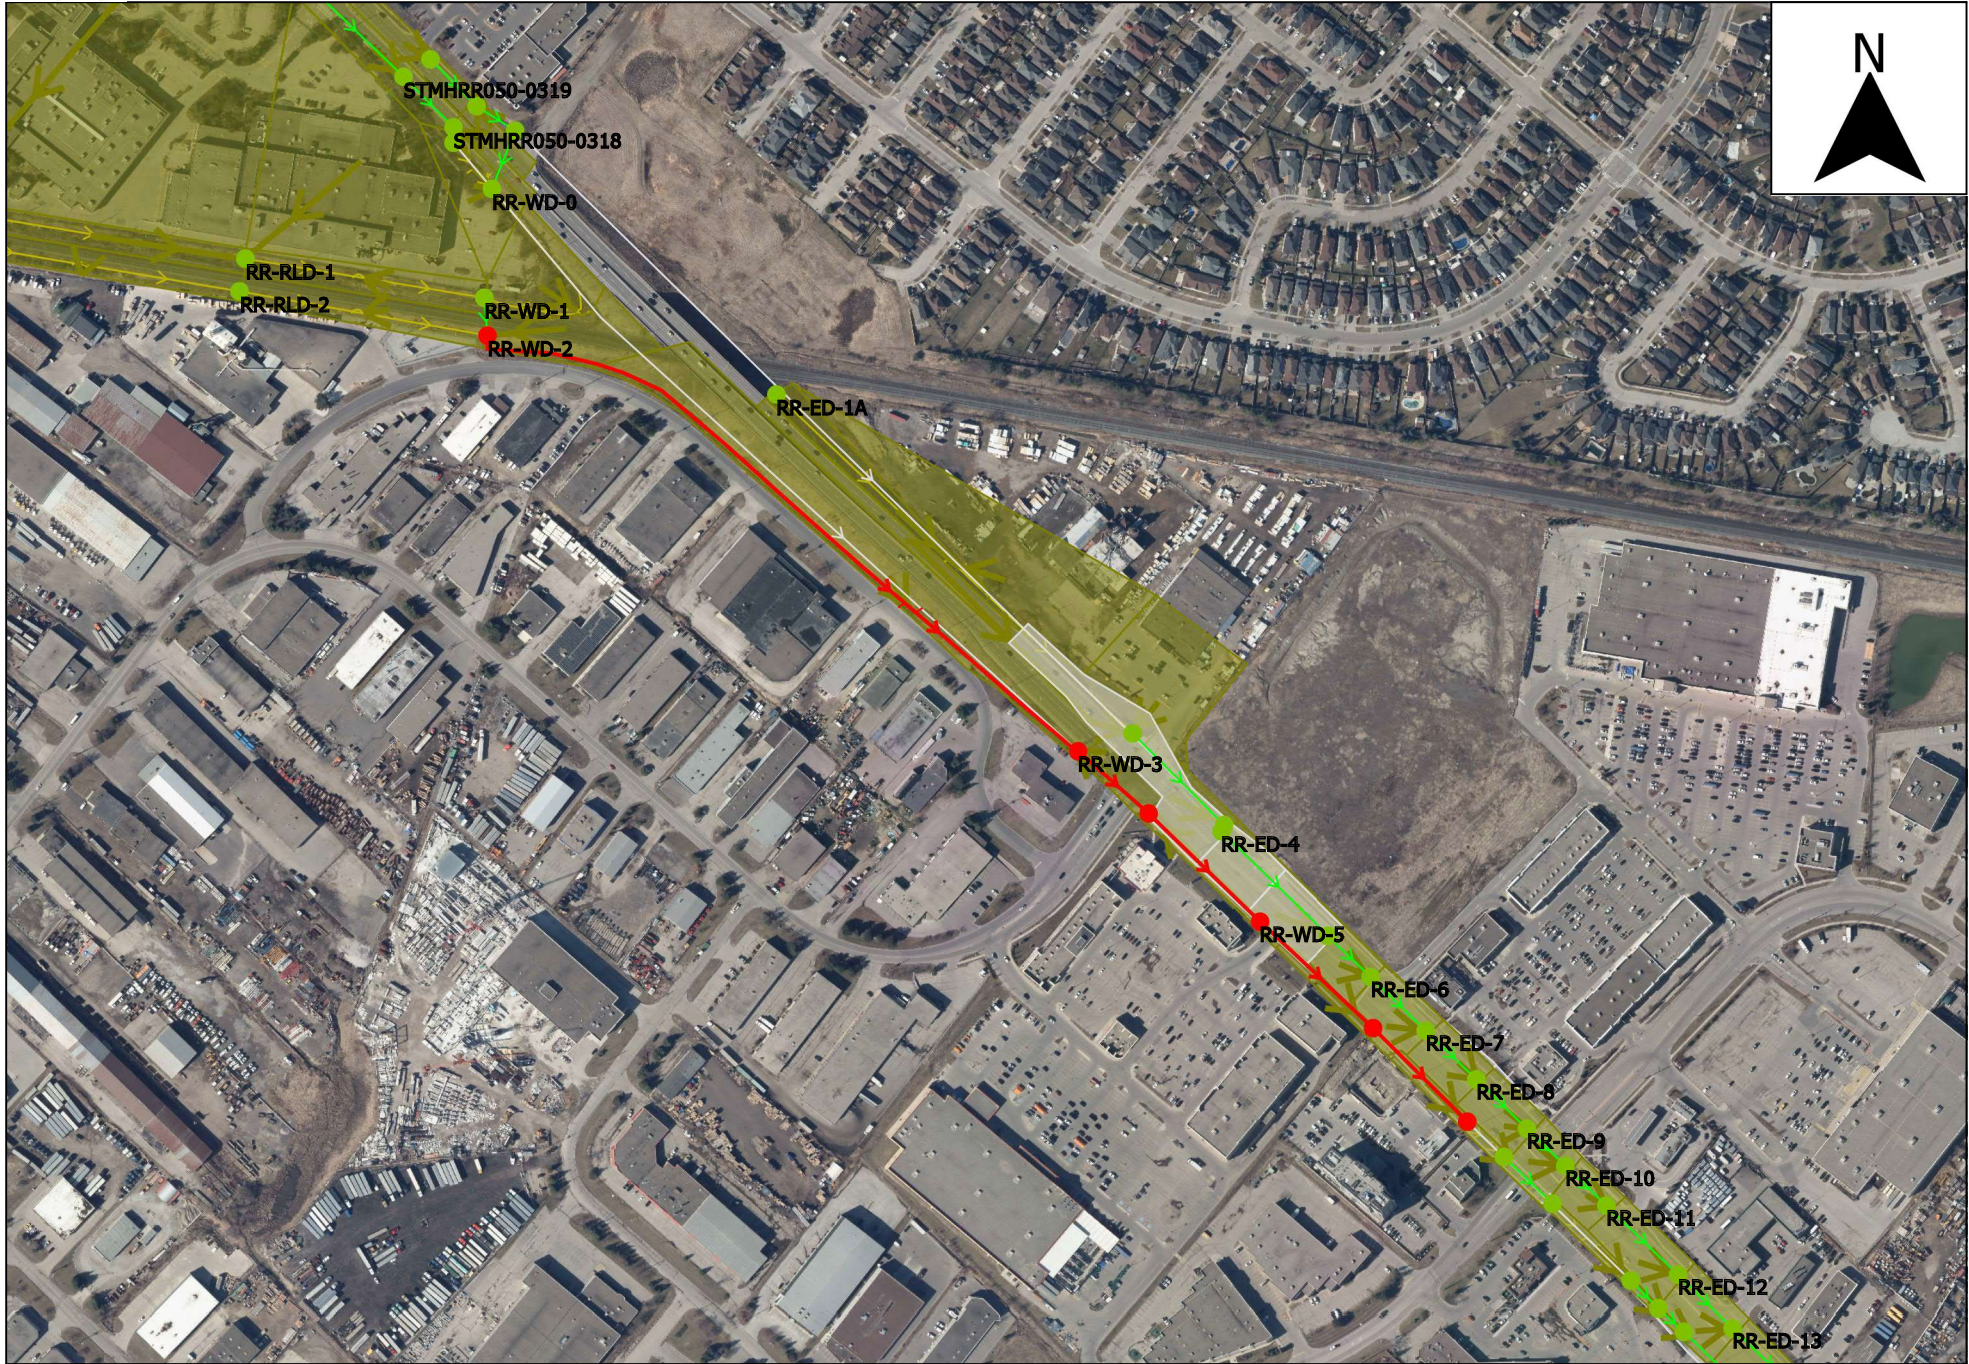
PROPOSED CONDITION - 10-YEAR - WEST SIDE PROFILE 2

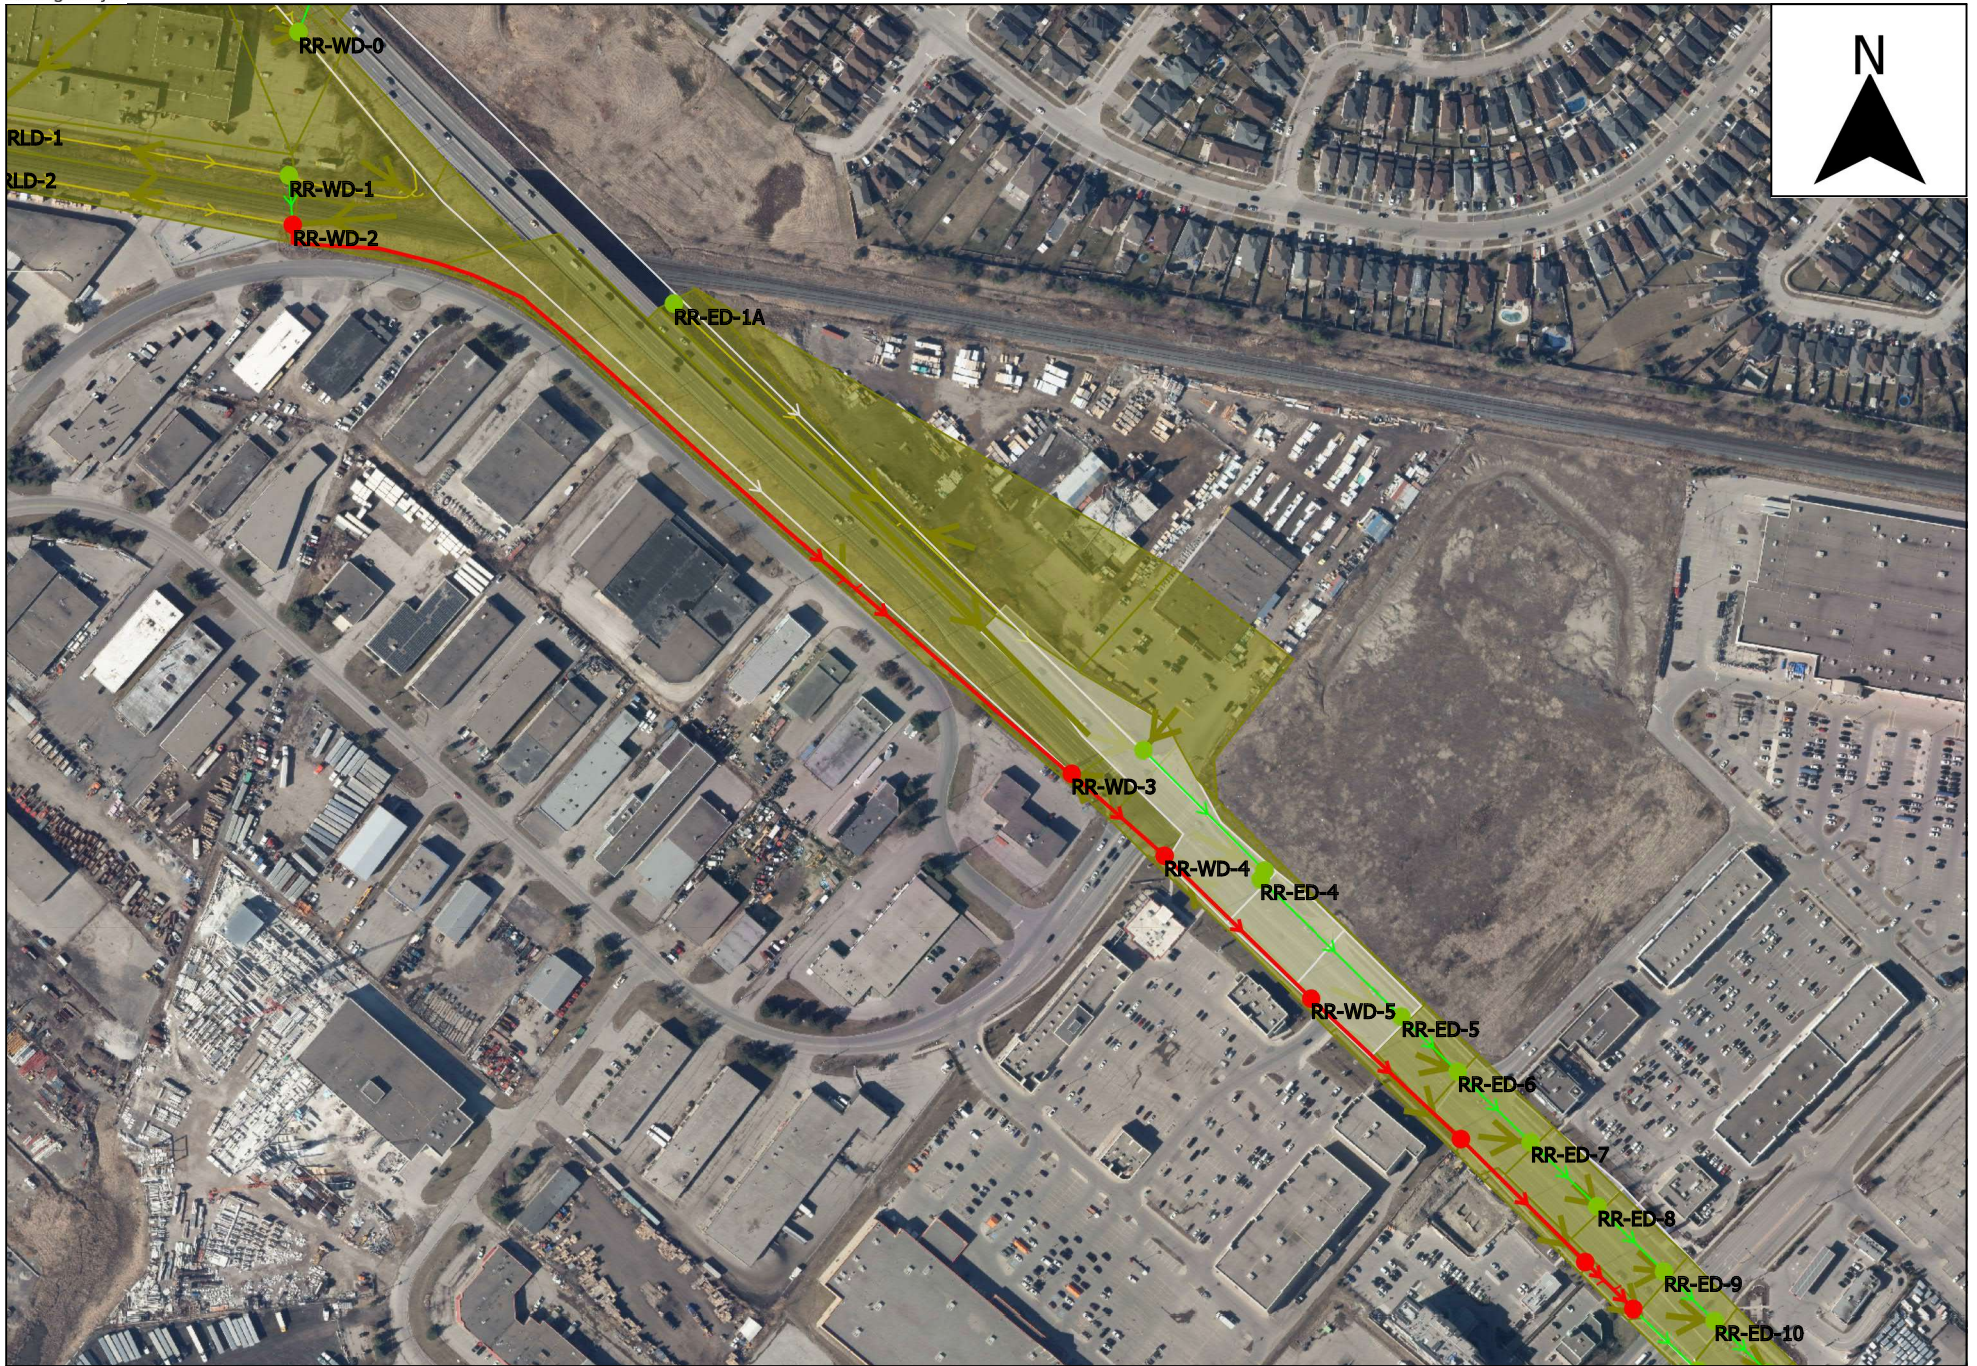
EXISTING CONDITION - 100-YEAR - WEST SIDE PROFILE 2

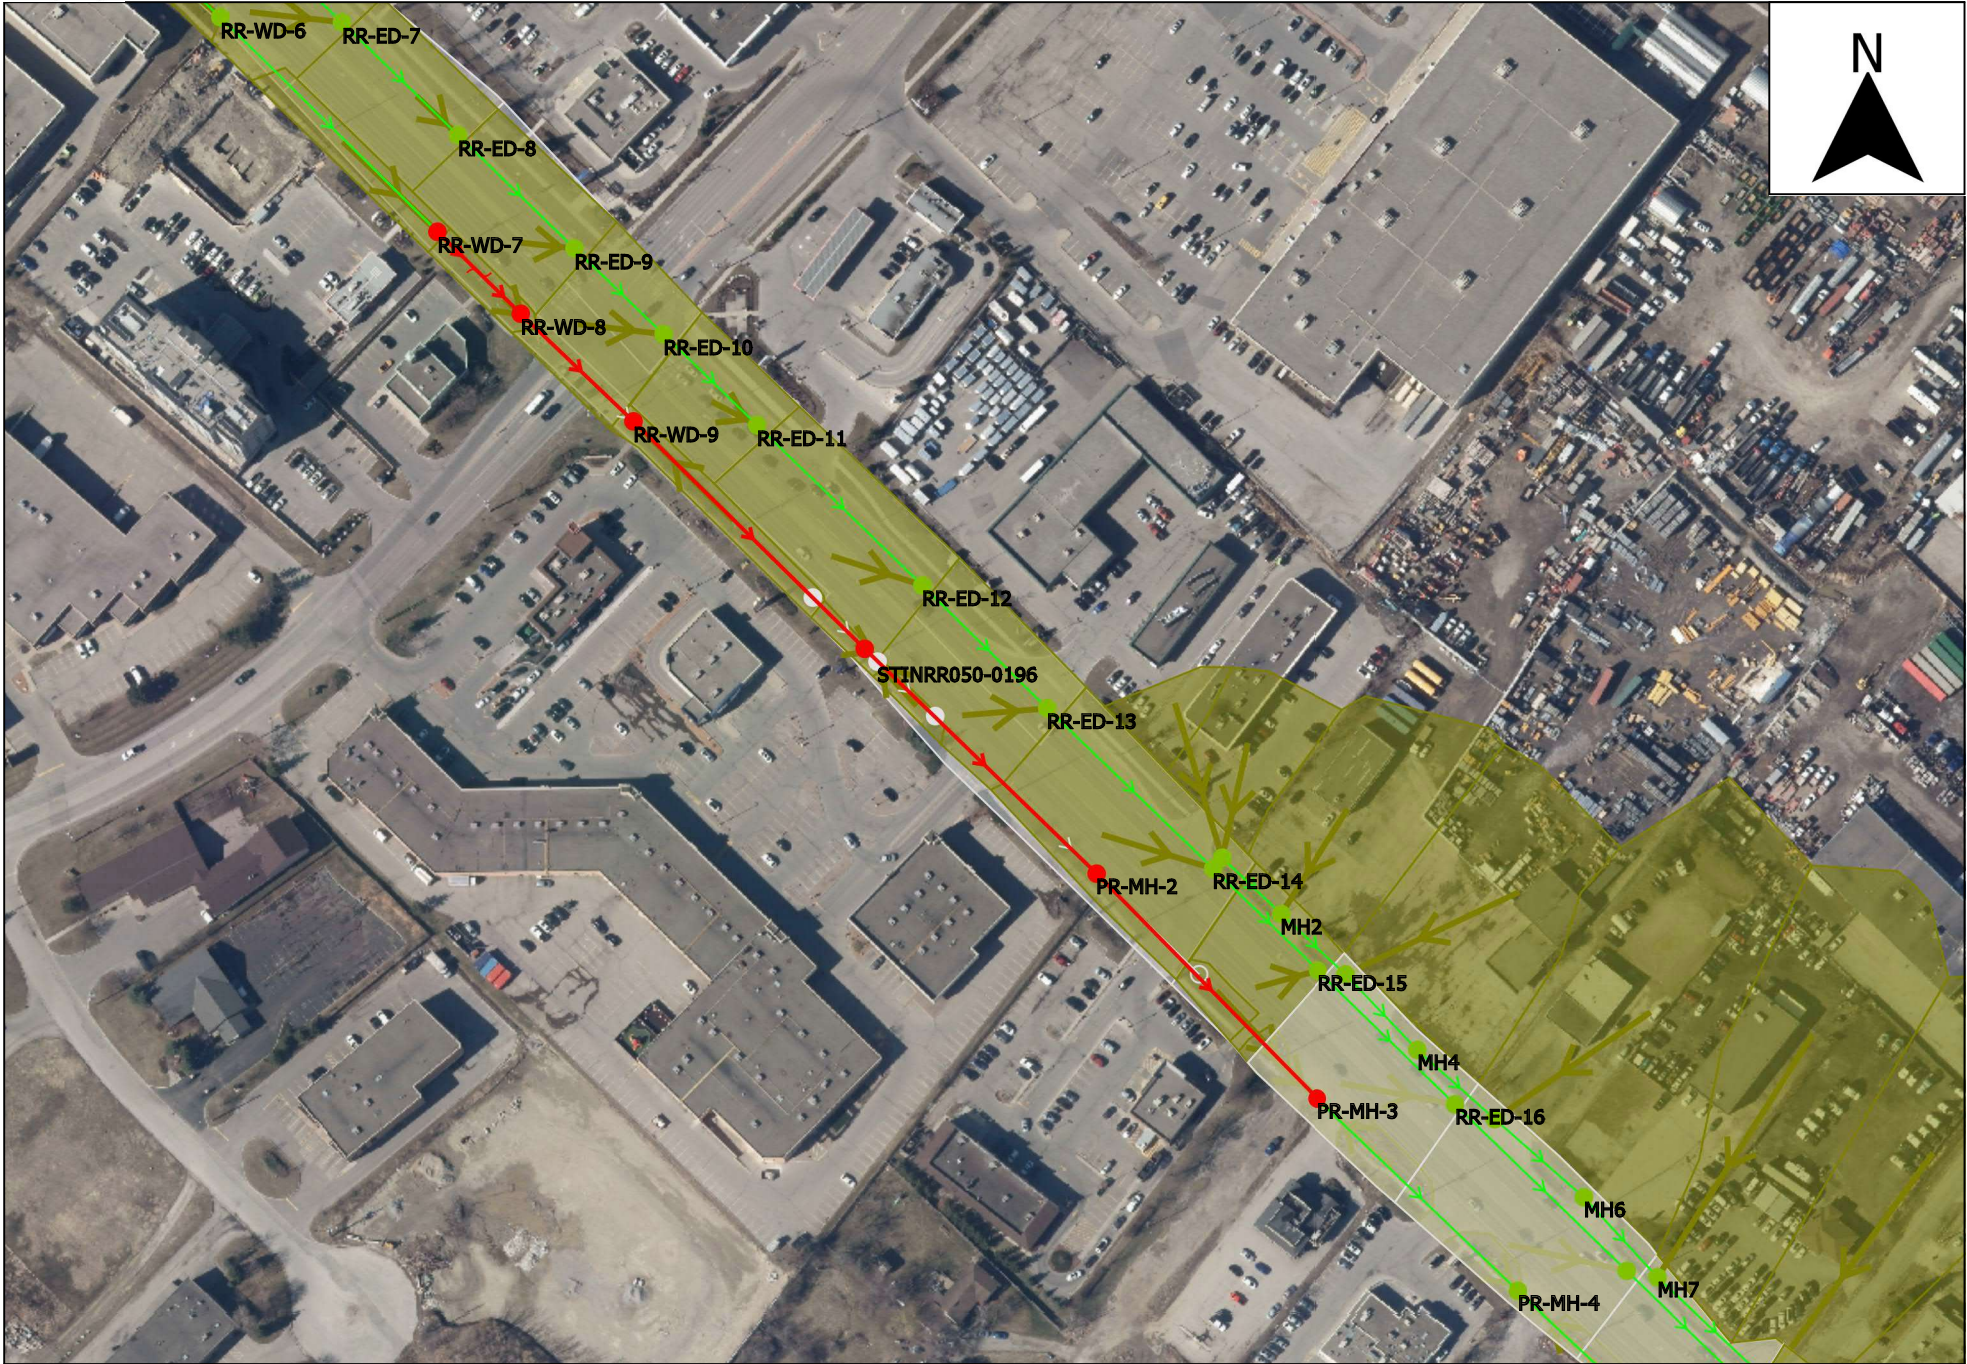
EXISTING CONDITION - 10-YEAR - WEST SIDE PROFILE 3

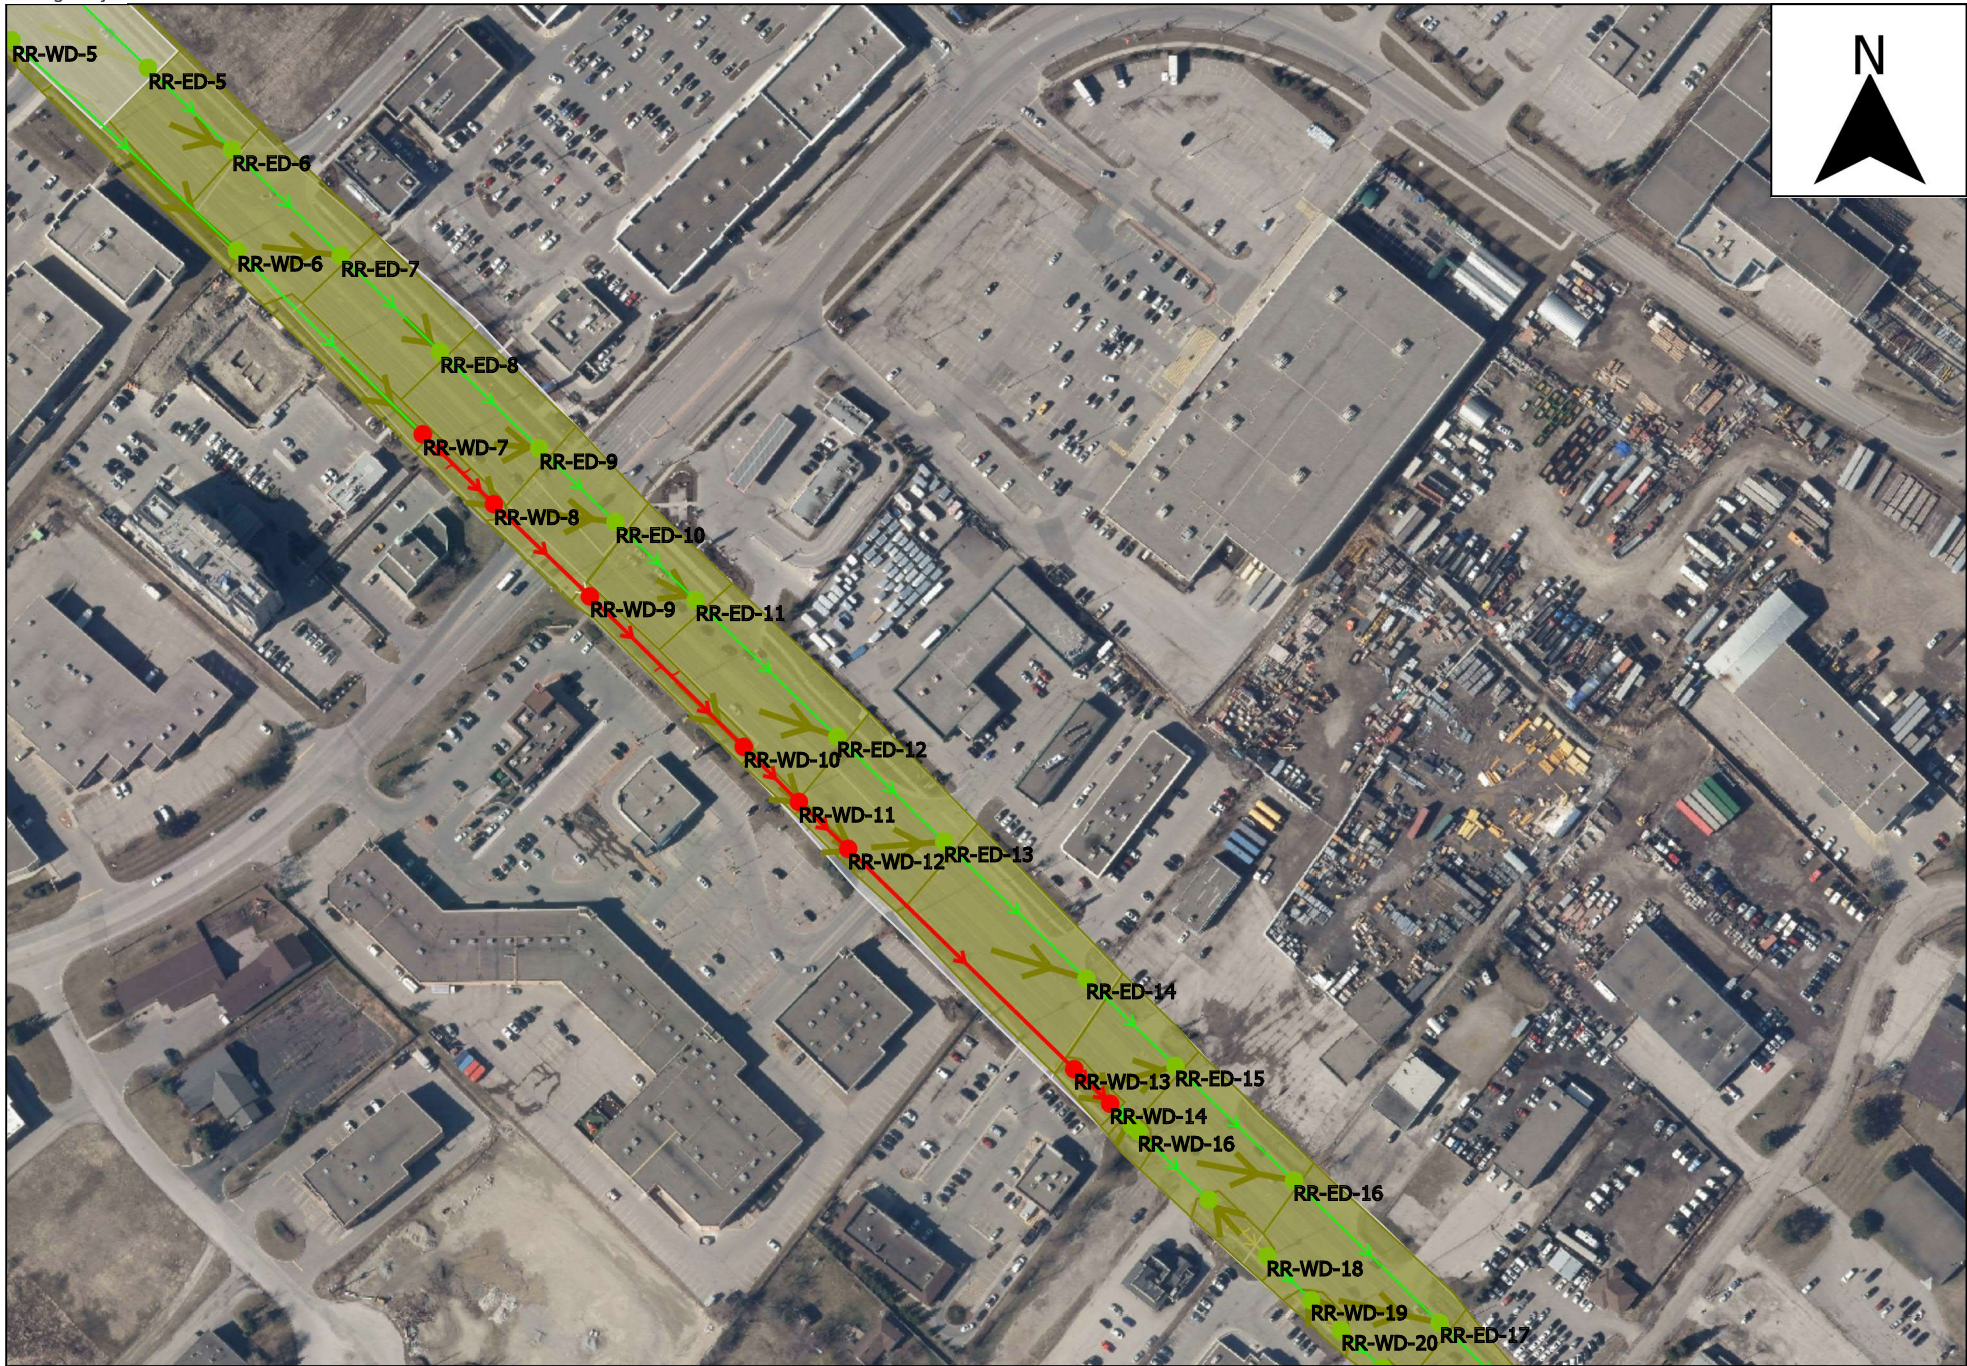
PROPOSED CONDITION - 10-YEAR - WEST SIDE PROFILE 3

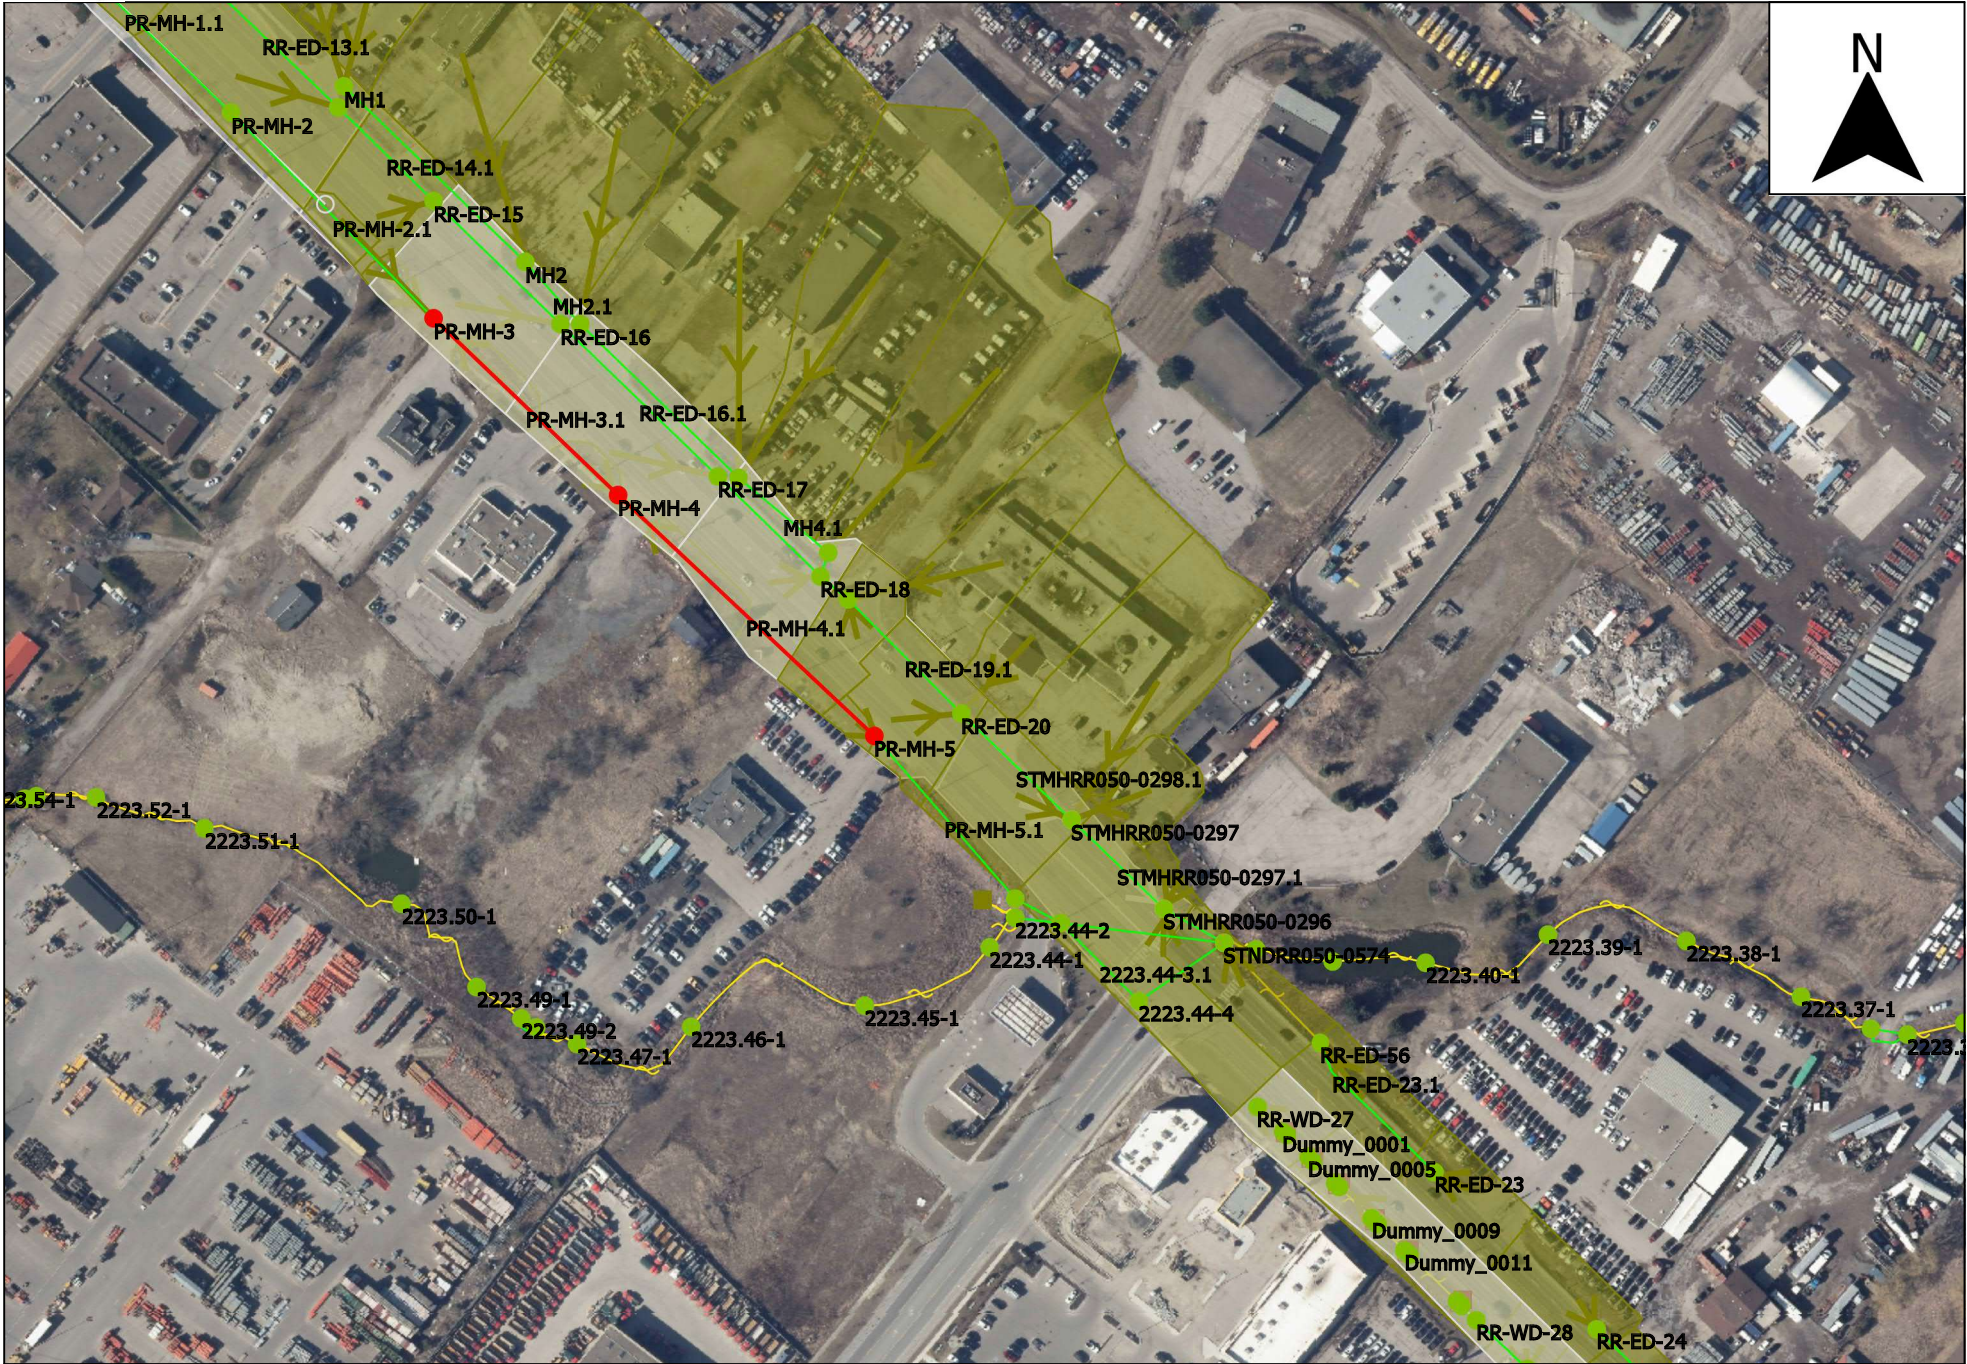
EXISTING CONDITION - 10-YEAR - WEST SIDE PROFILE 4
