STORMWATER MANAGEMENT REPORT

ENVIRONMENTAL ASSESSMENT (EA) AND PRELIMINARY DESIGN FOR DRAINAGE IMPROVEMENTS OF HIGHWAY 50 FROM MAYFIELD ROAD TO HEALEY ROAD

December 1, 2022

Region of Peel

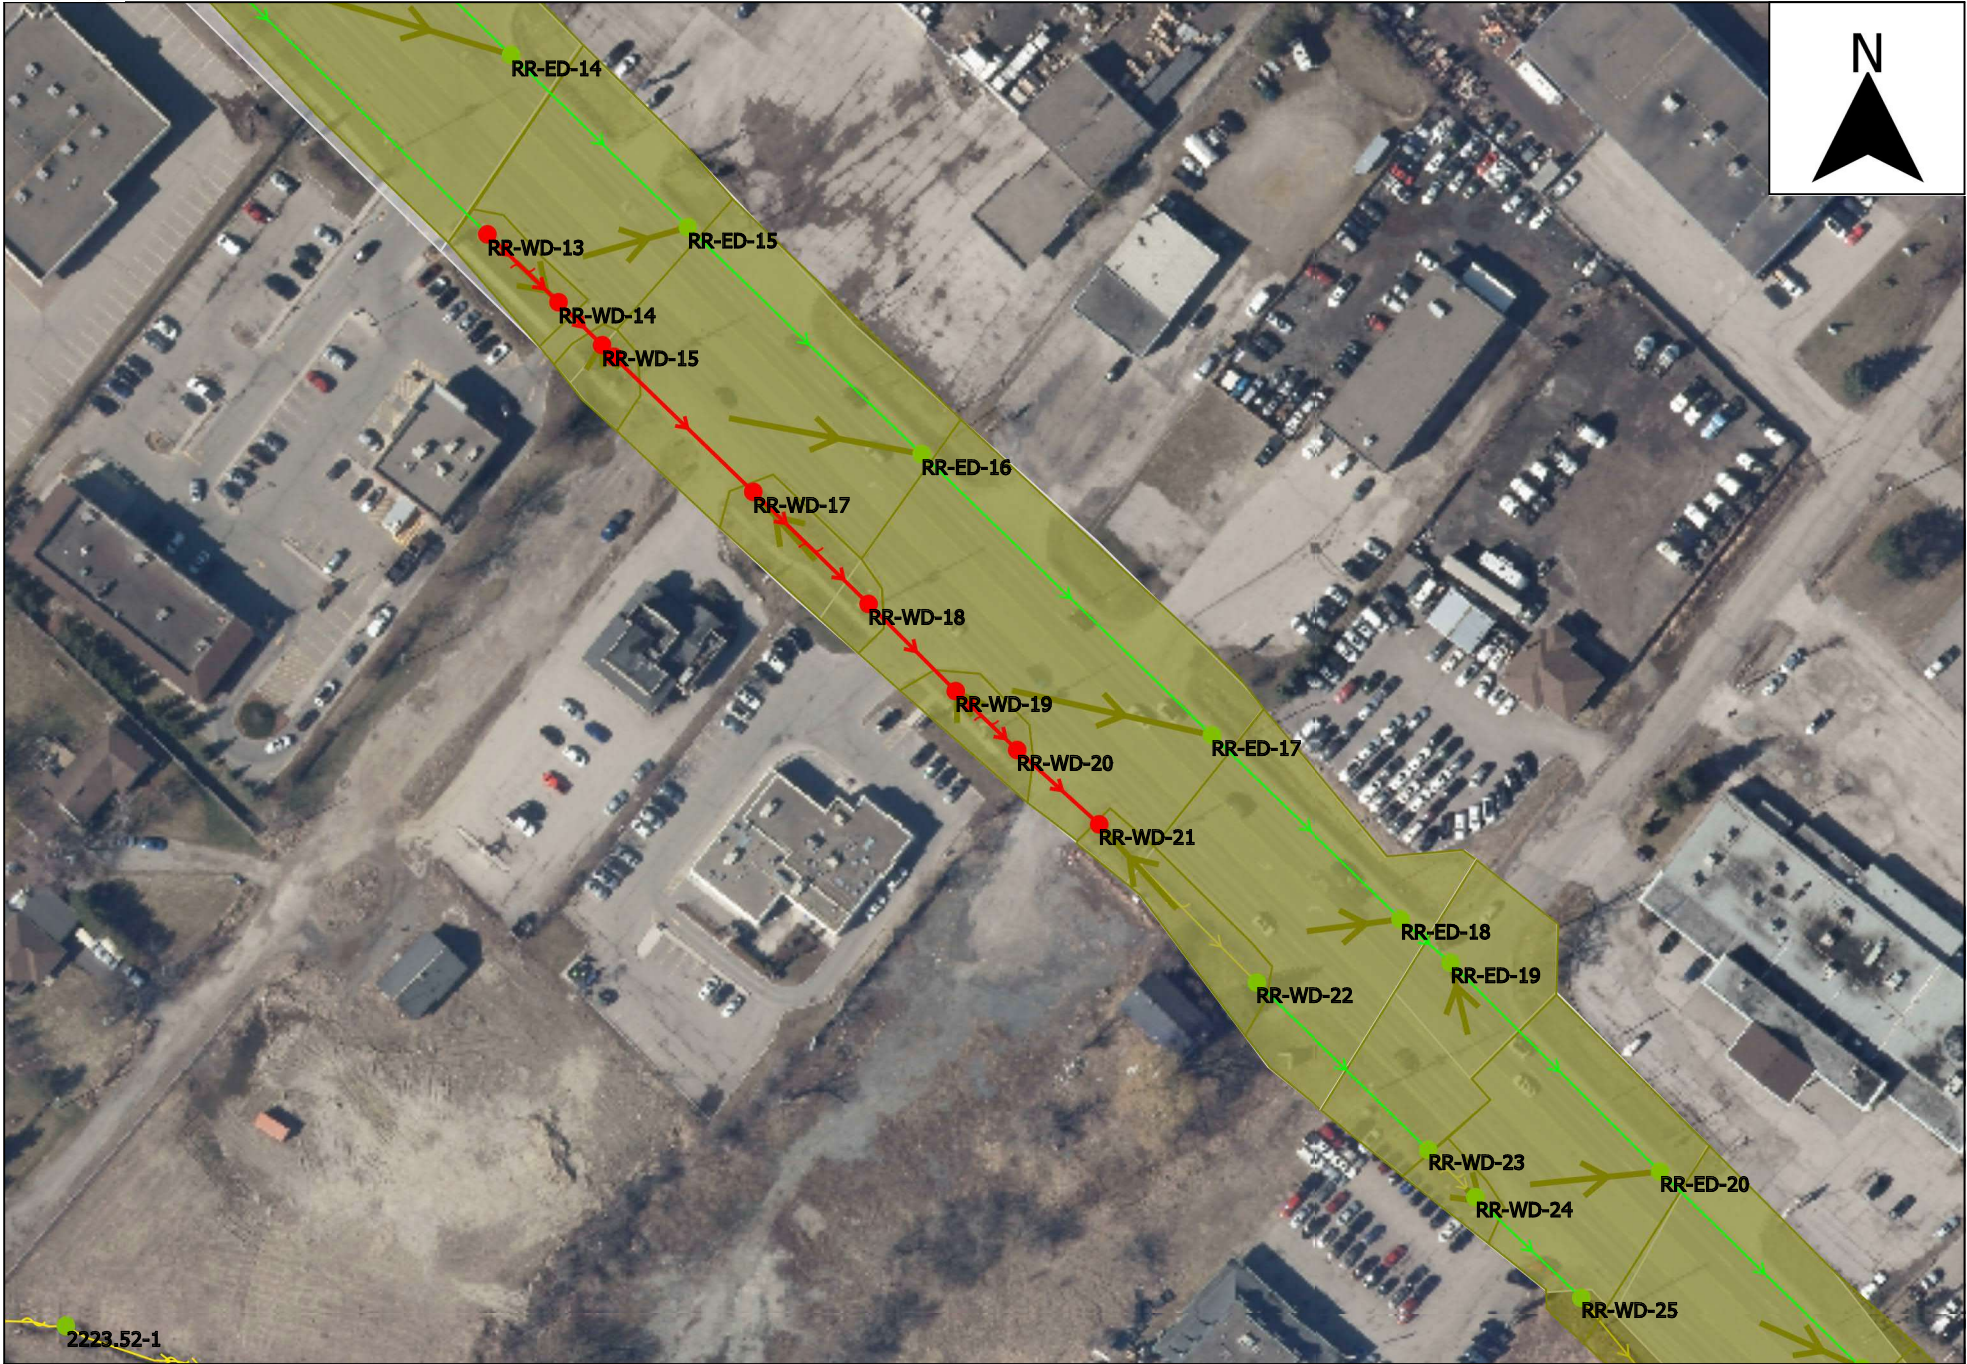
PROPOSED CONDITION - 10-YEAR - WEST SIDE PROFILE 4

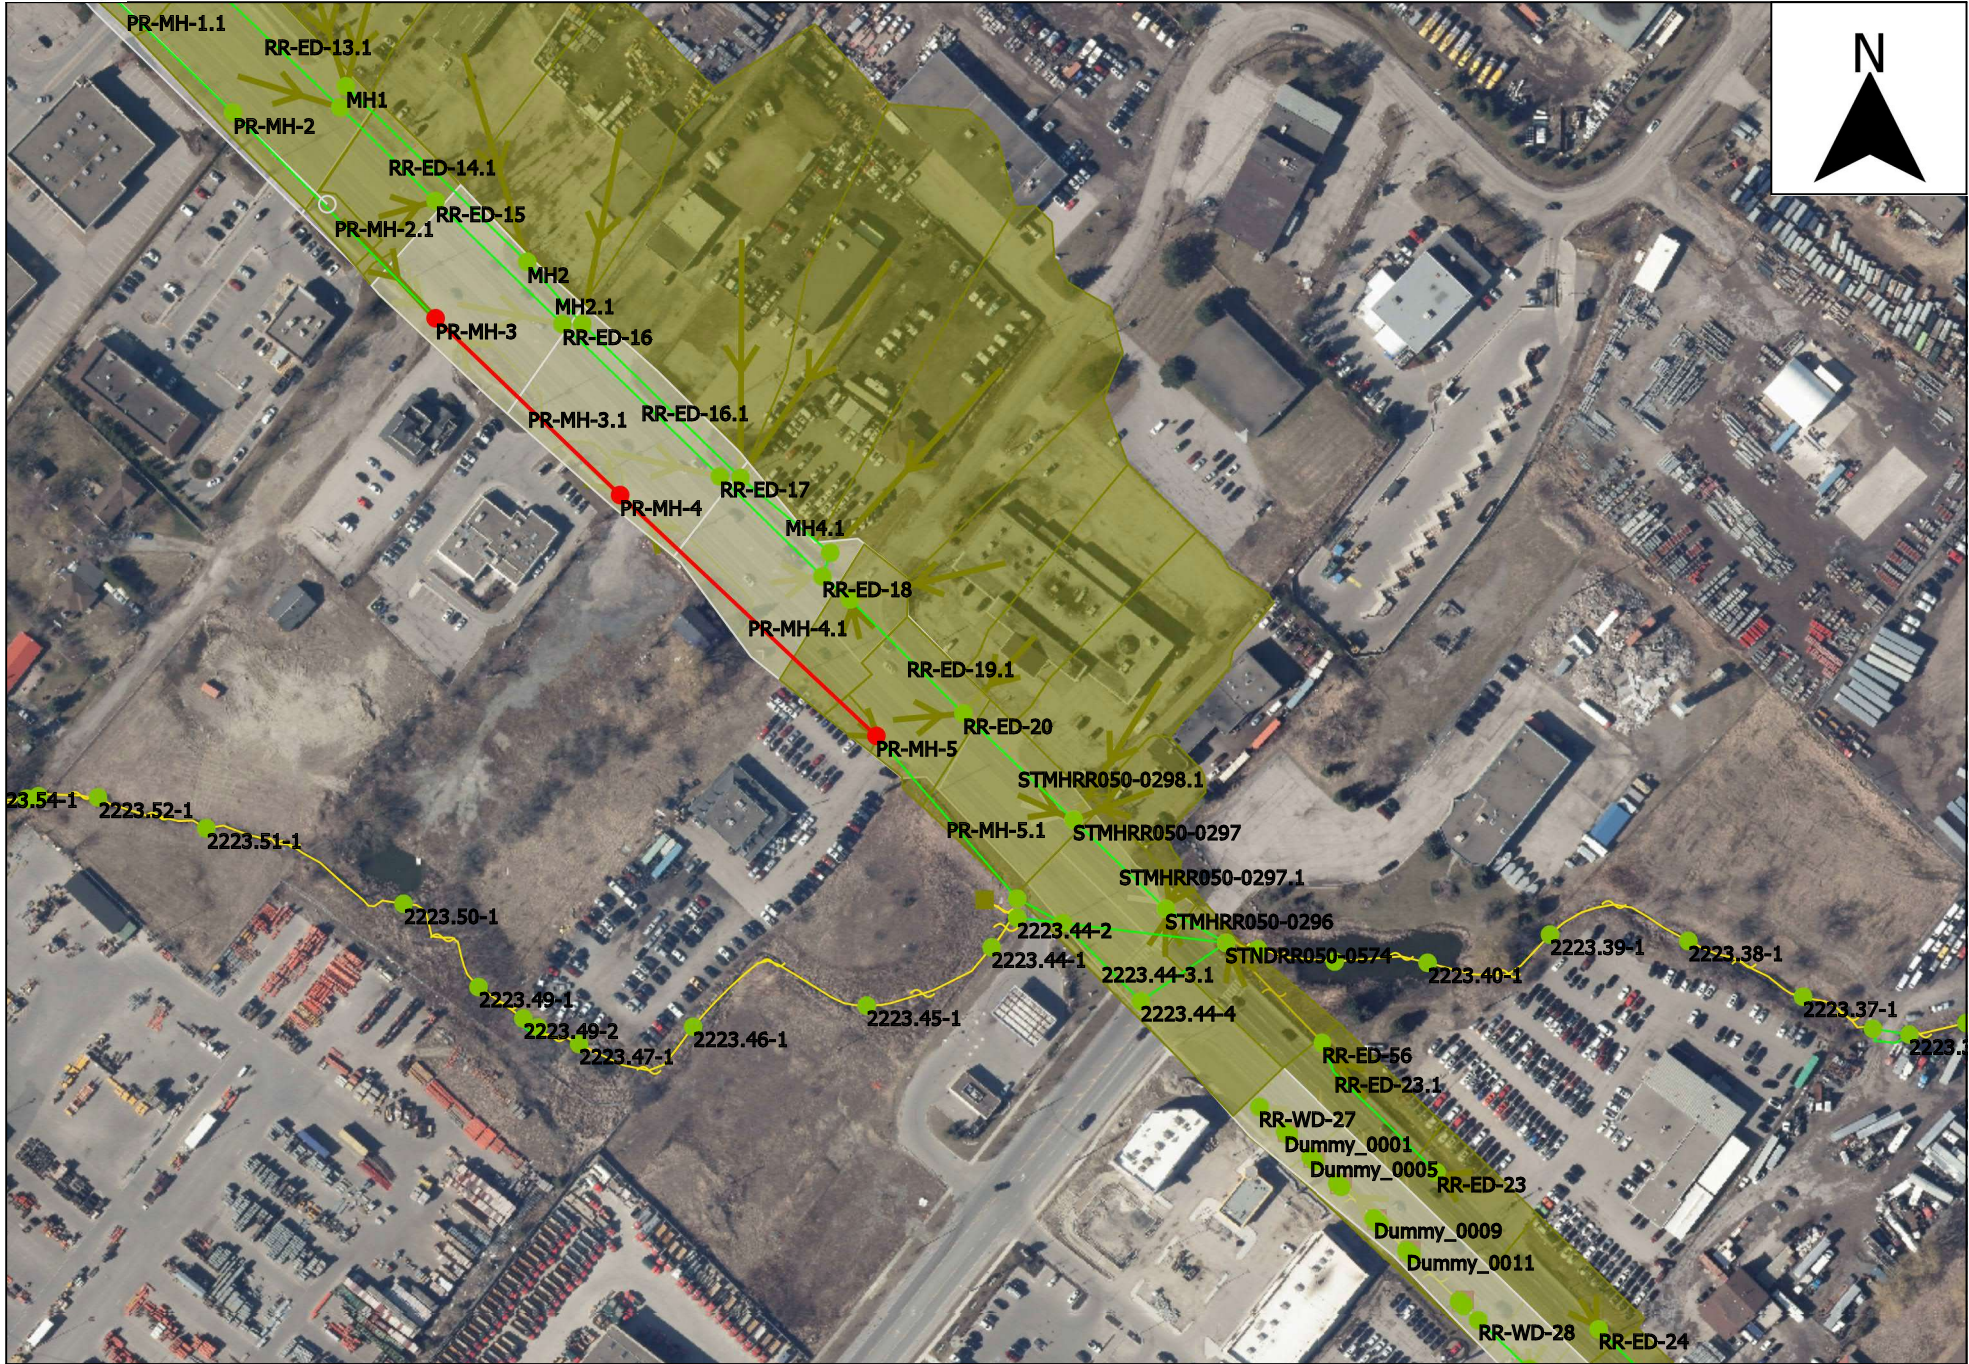
EXISTING CONDITION - 100-YEAR - WEST SIDE PROFILE 4

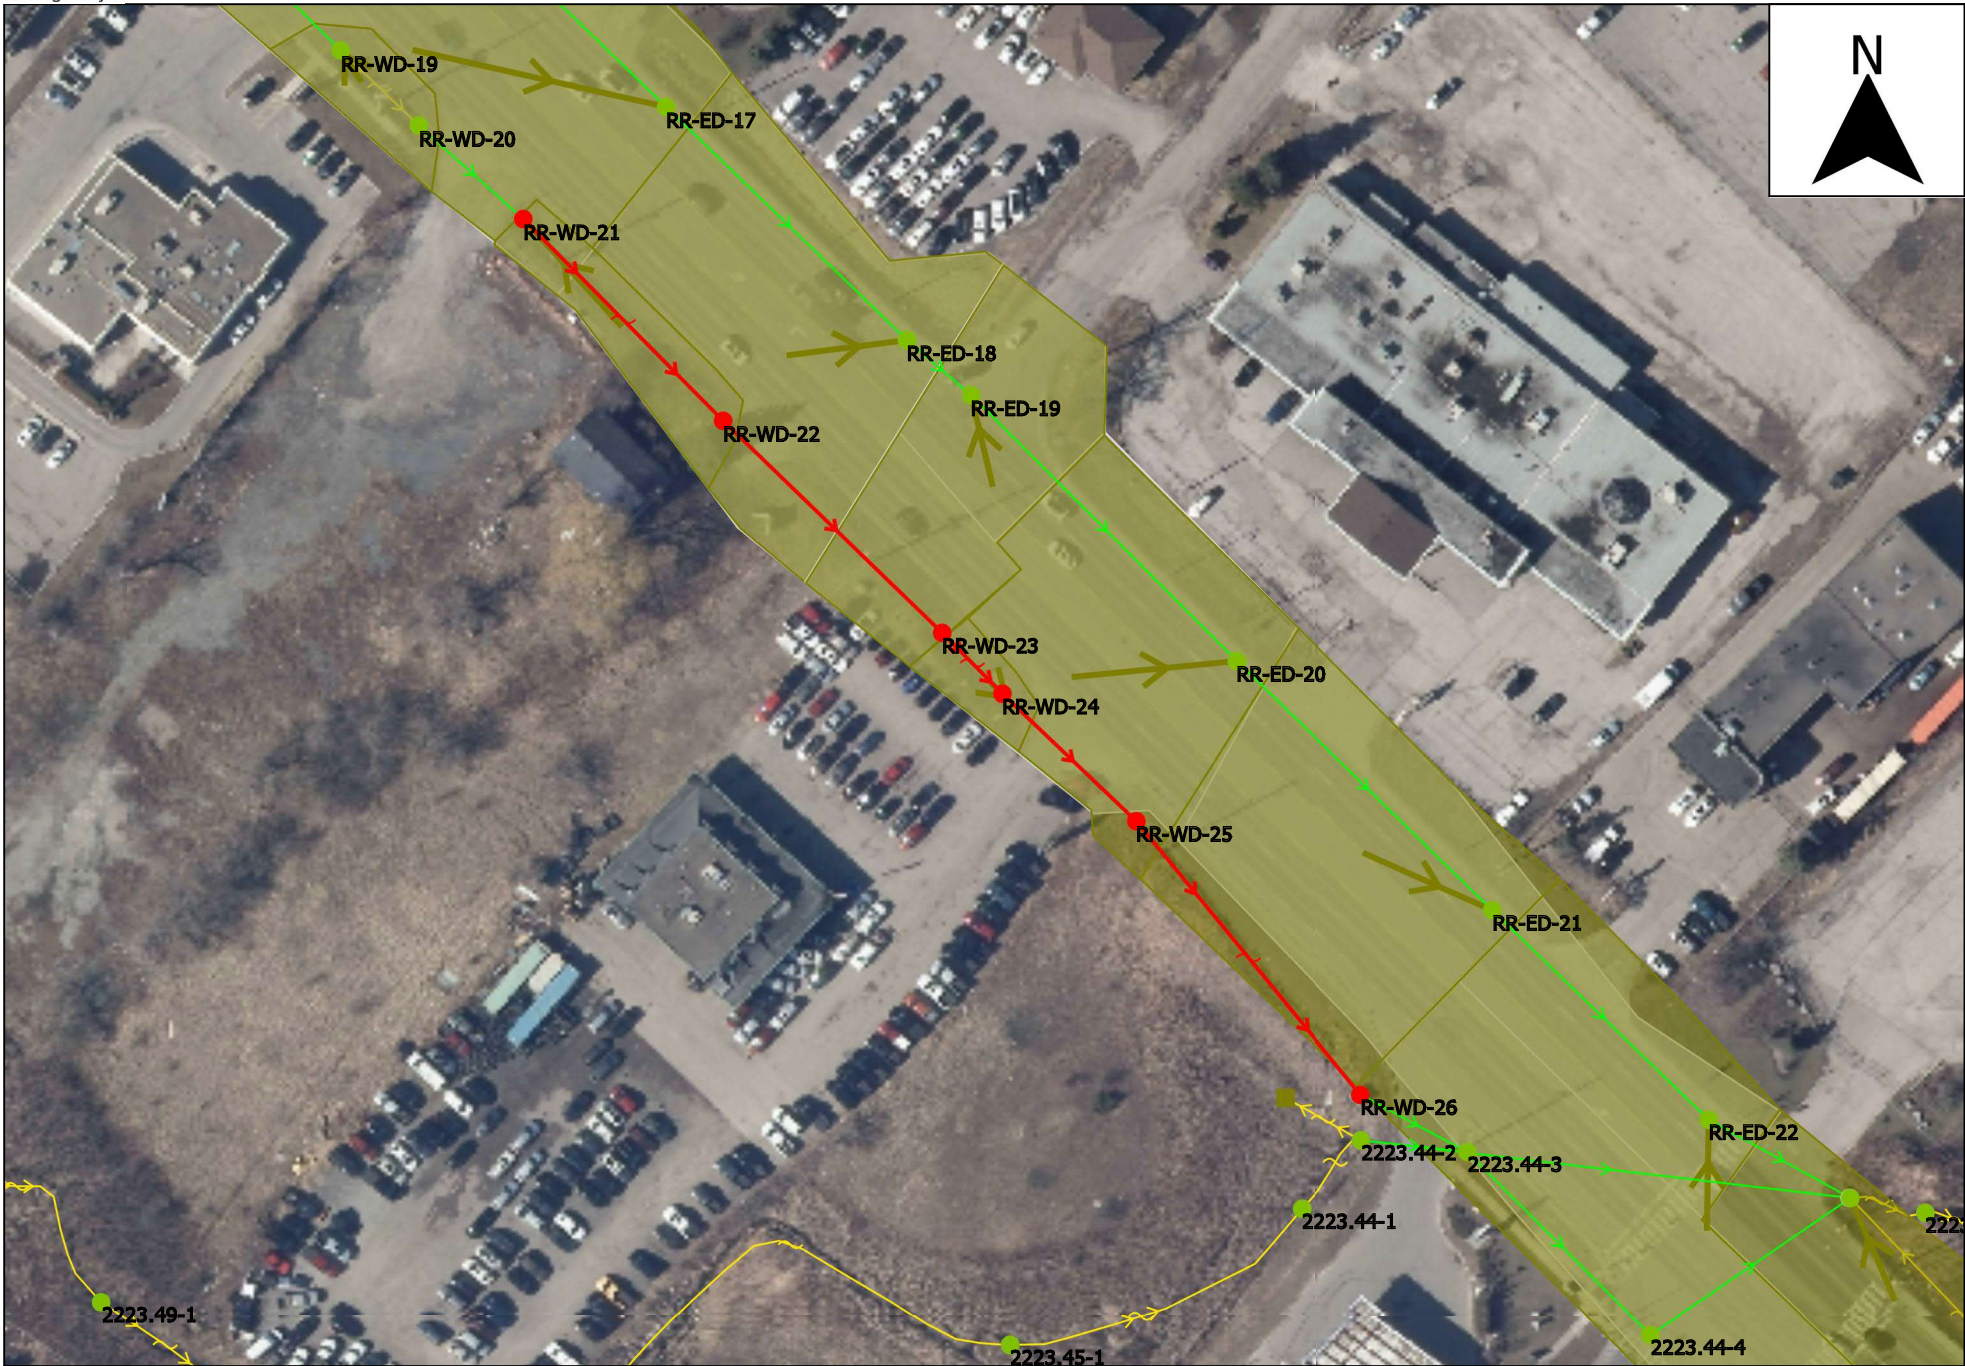
EXISTING CONDITION - 100-YEAR - WEST SIDE PROFILE 4

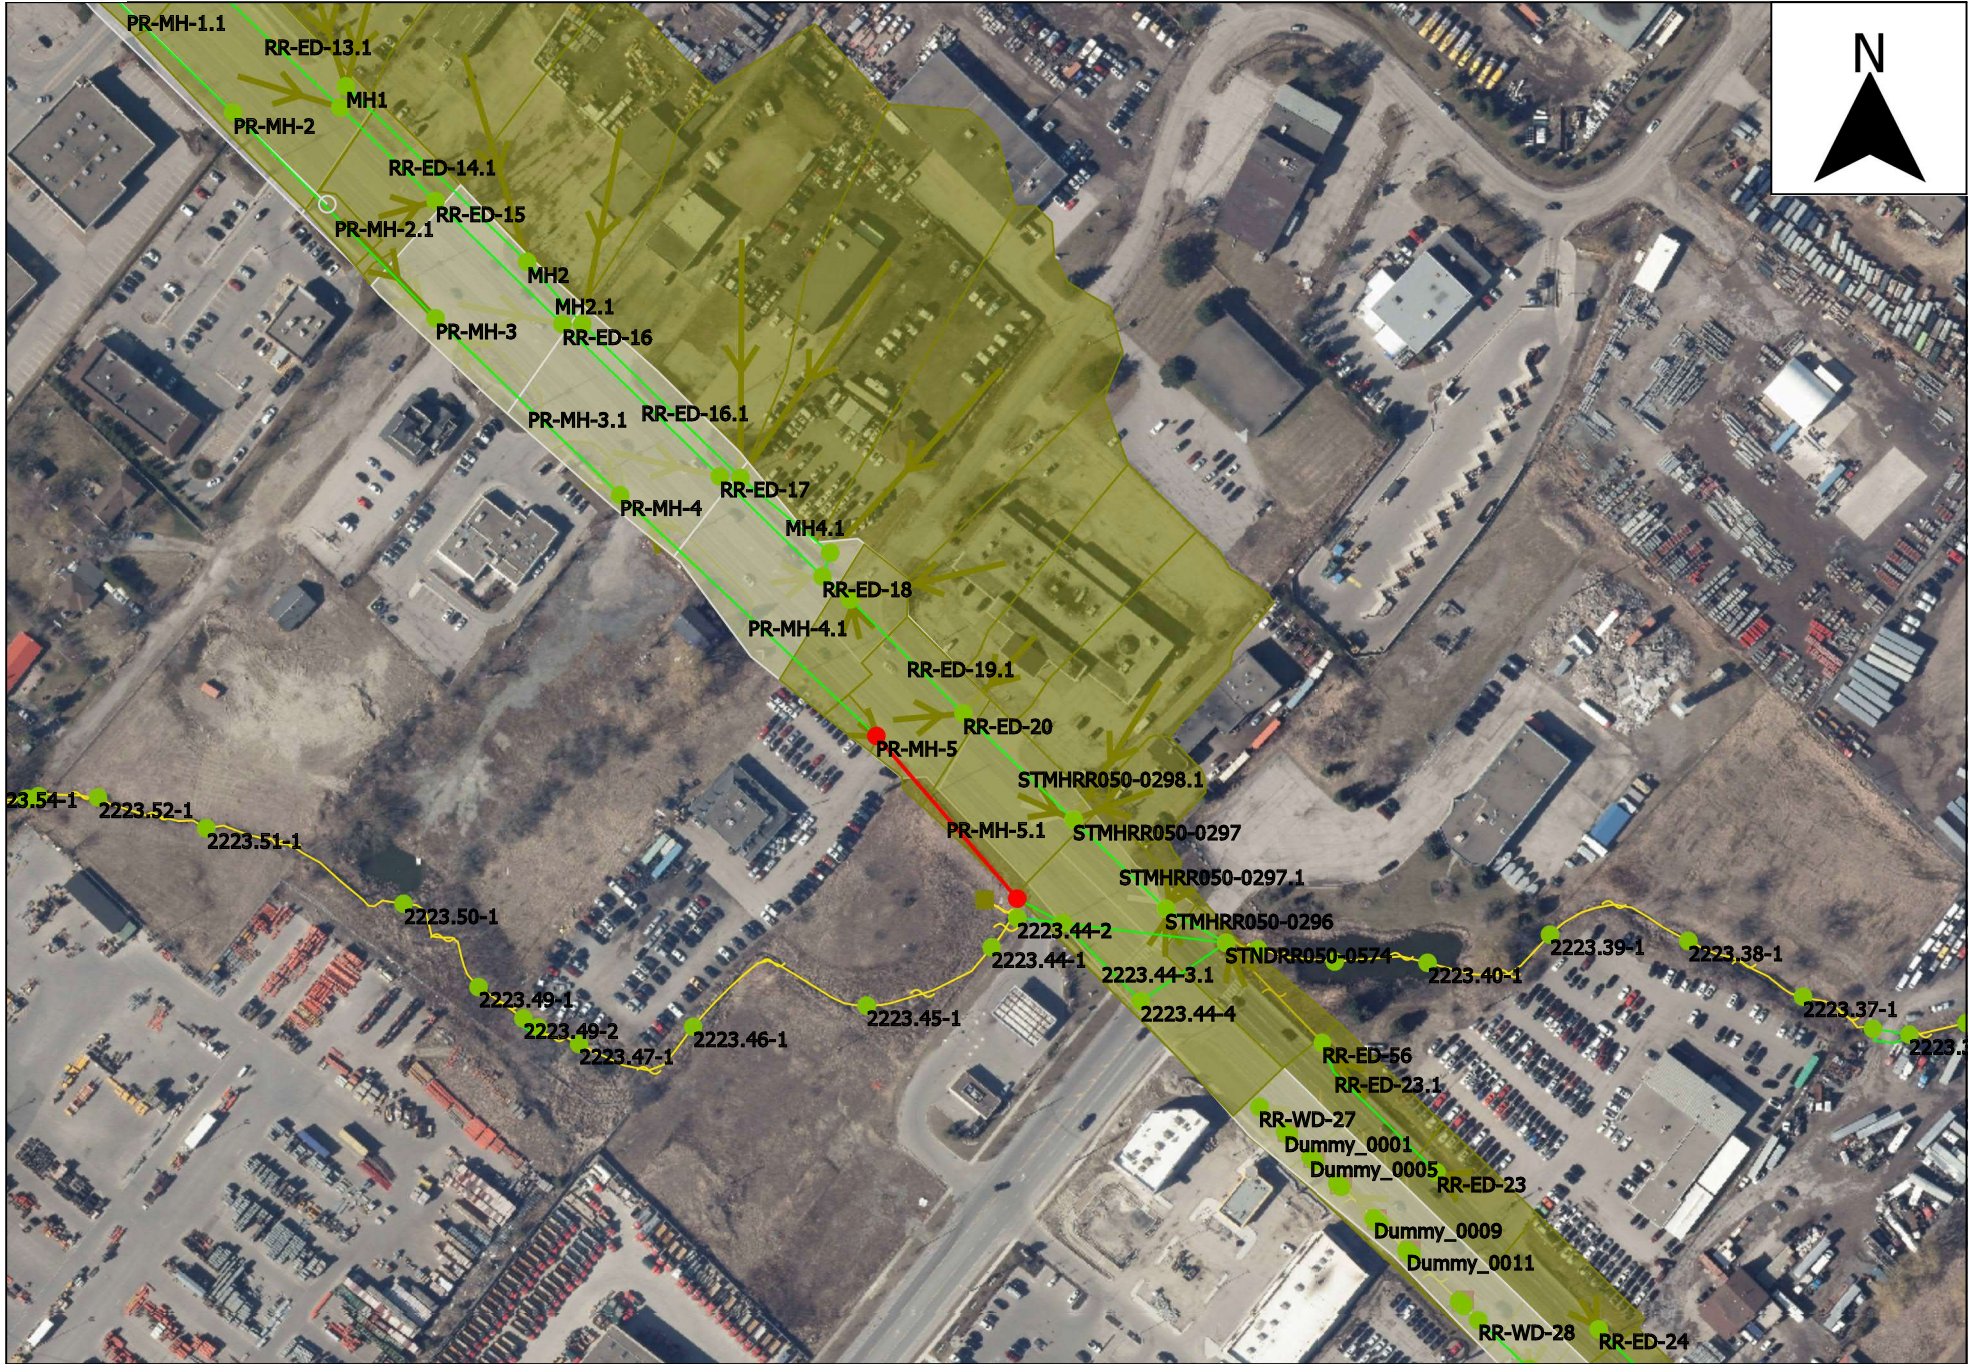
EXISTING CONDITION - 10-YEAR - WEST SIDE PROFILE 5

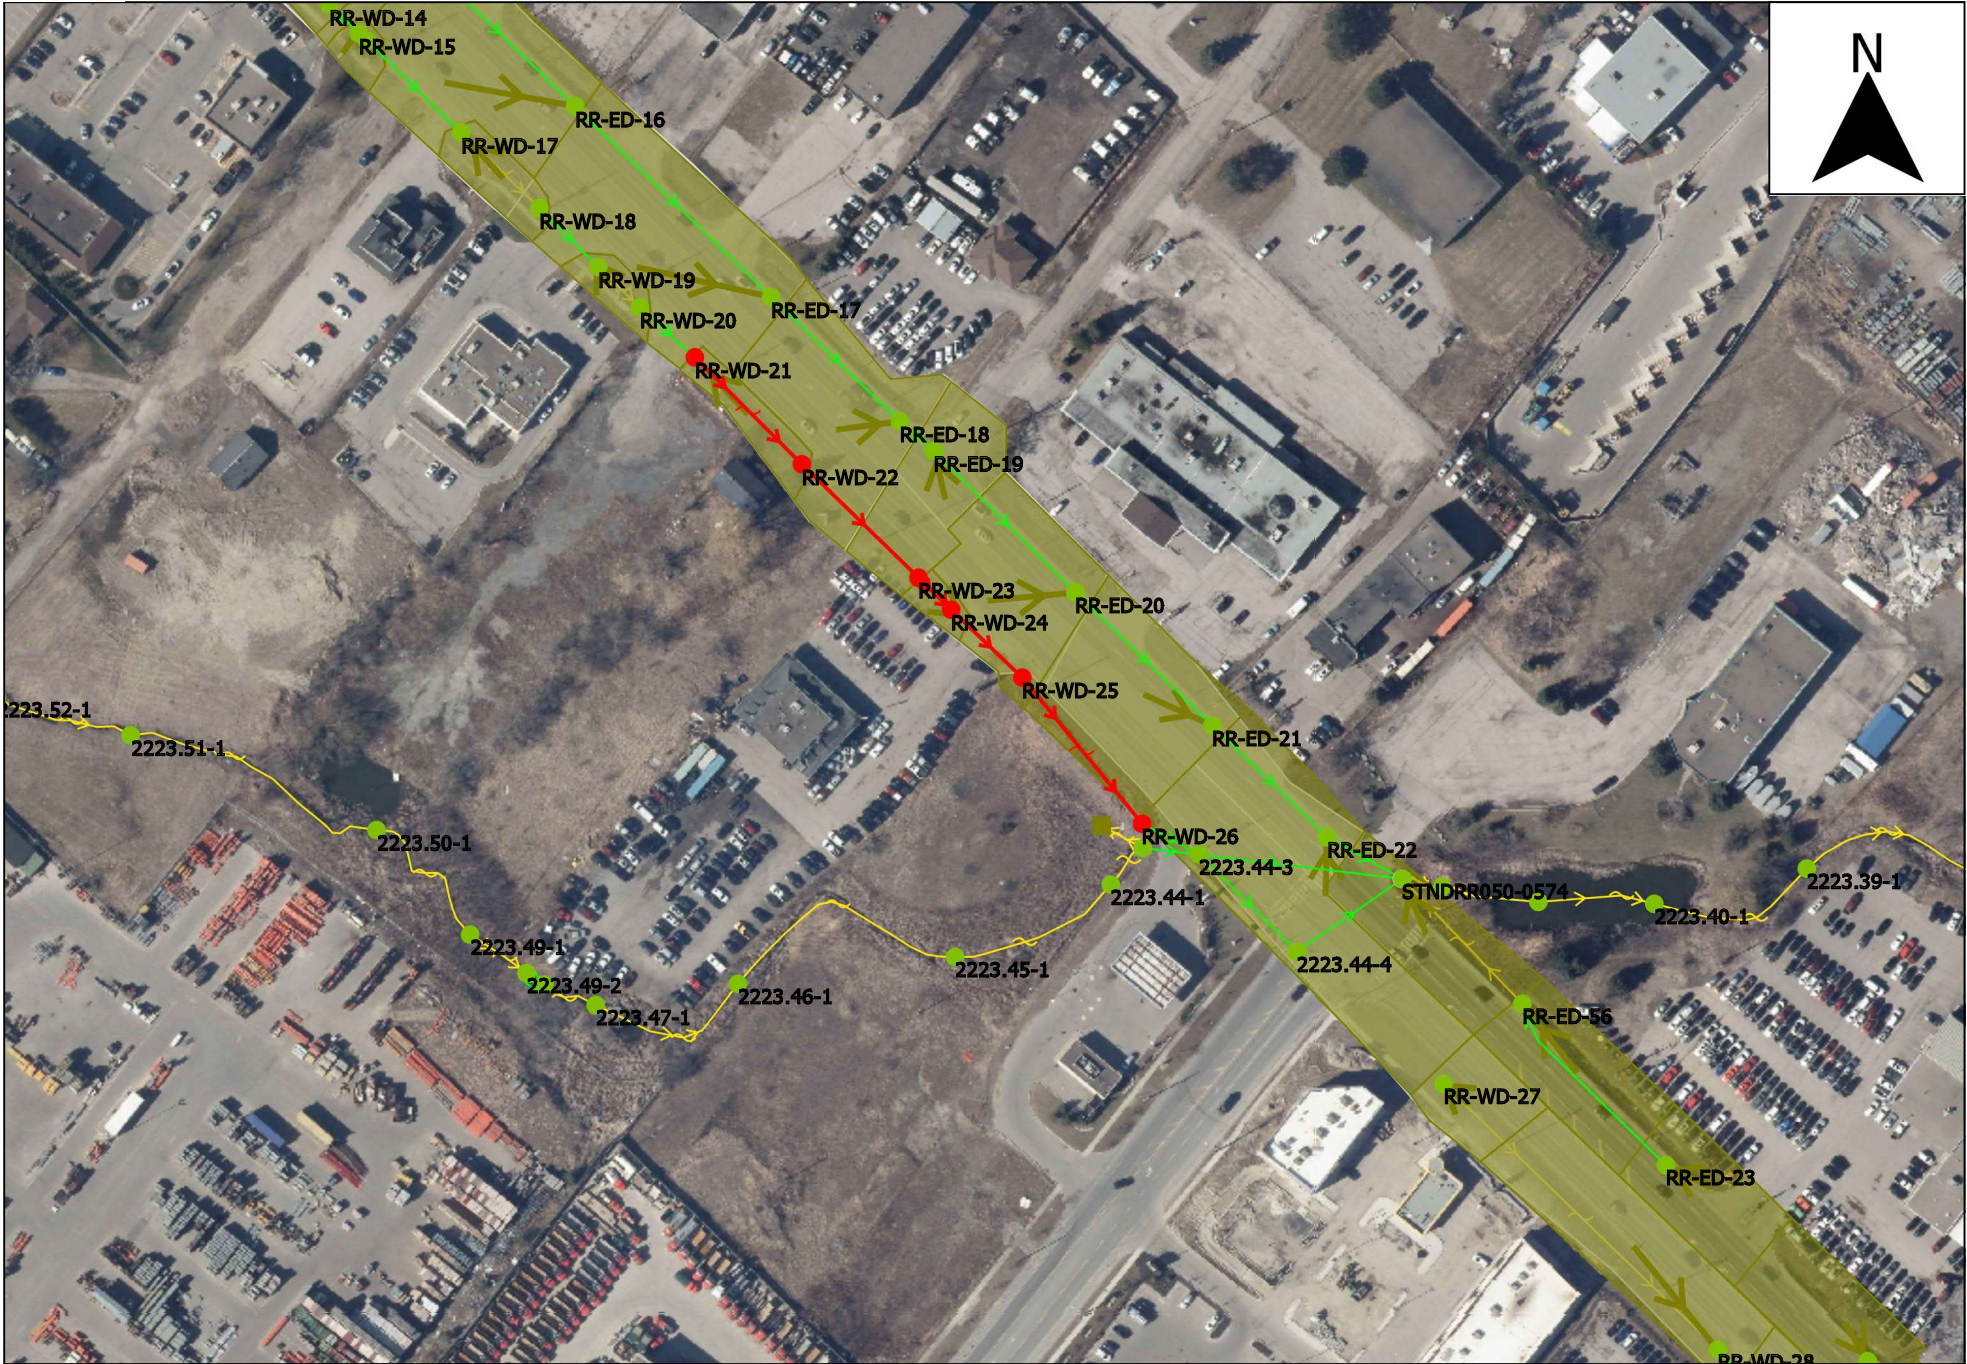
PROPOSED CONDITION - 10-YEAR - WEST SIDE PROFILE 5

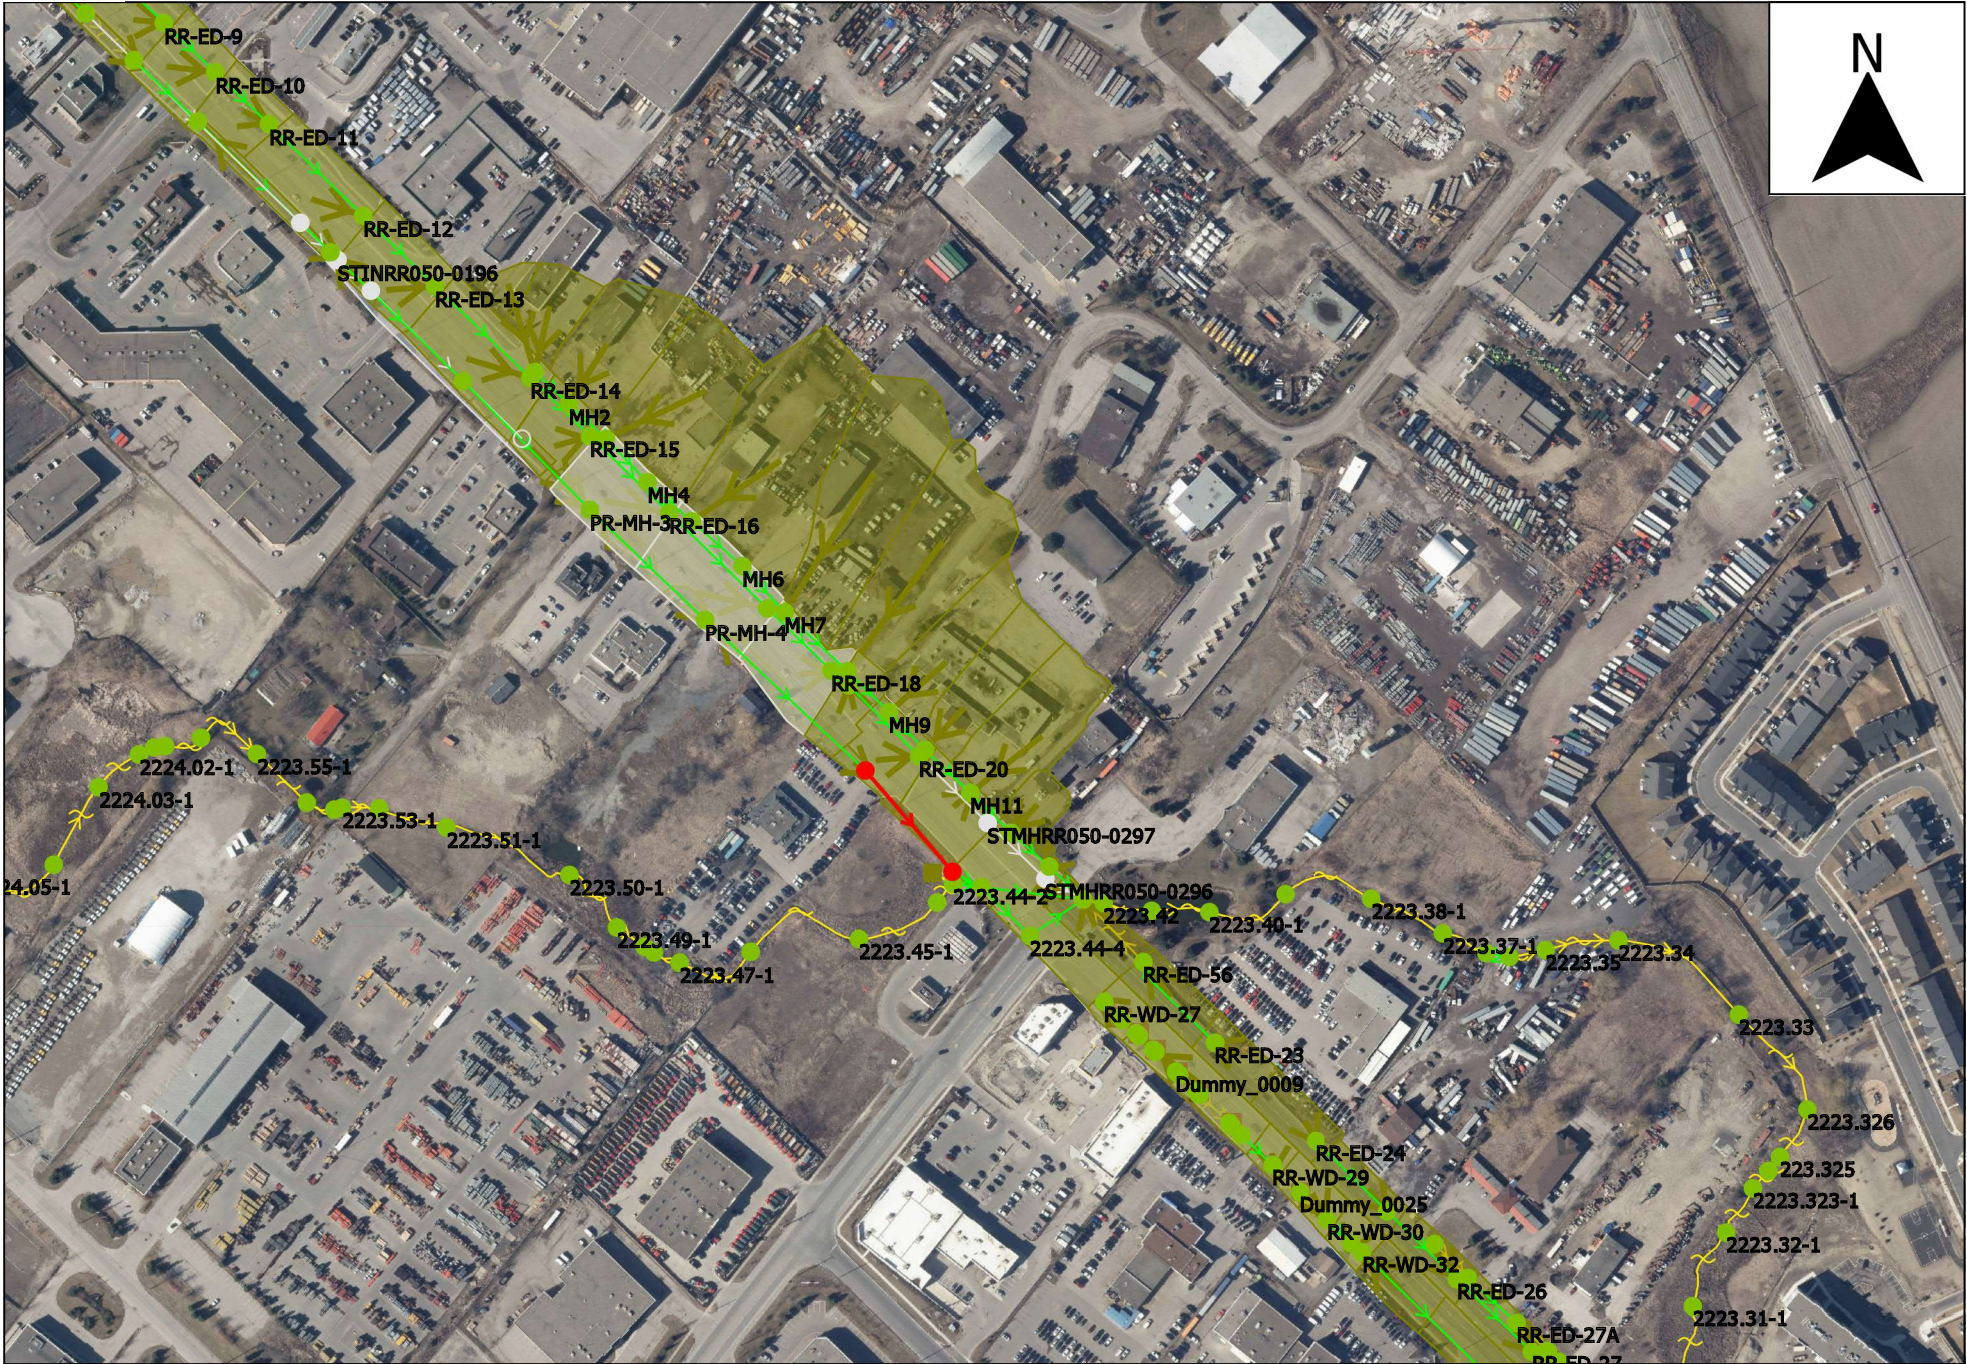
EXISTING CONDITION - 100-YEAR - WEST SIDE PROFILE 5

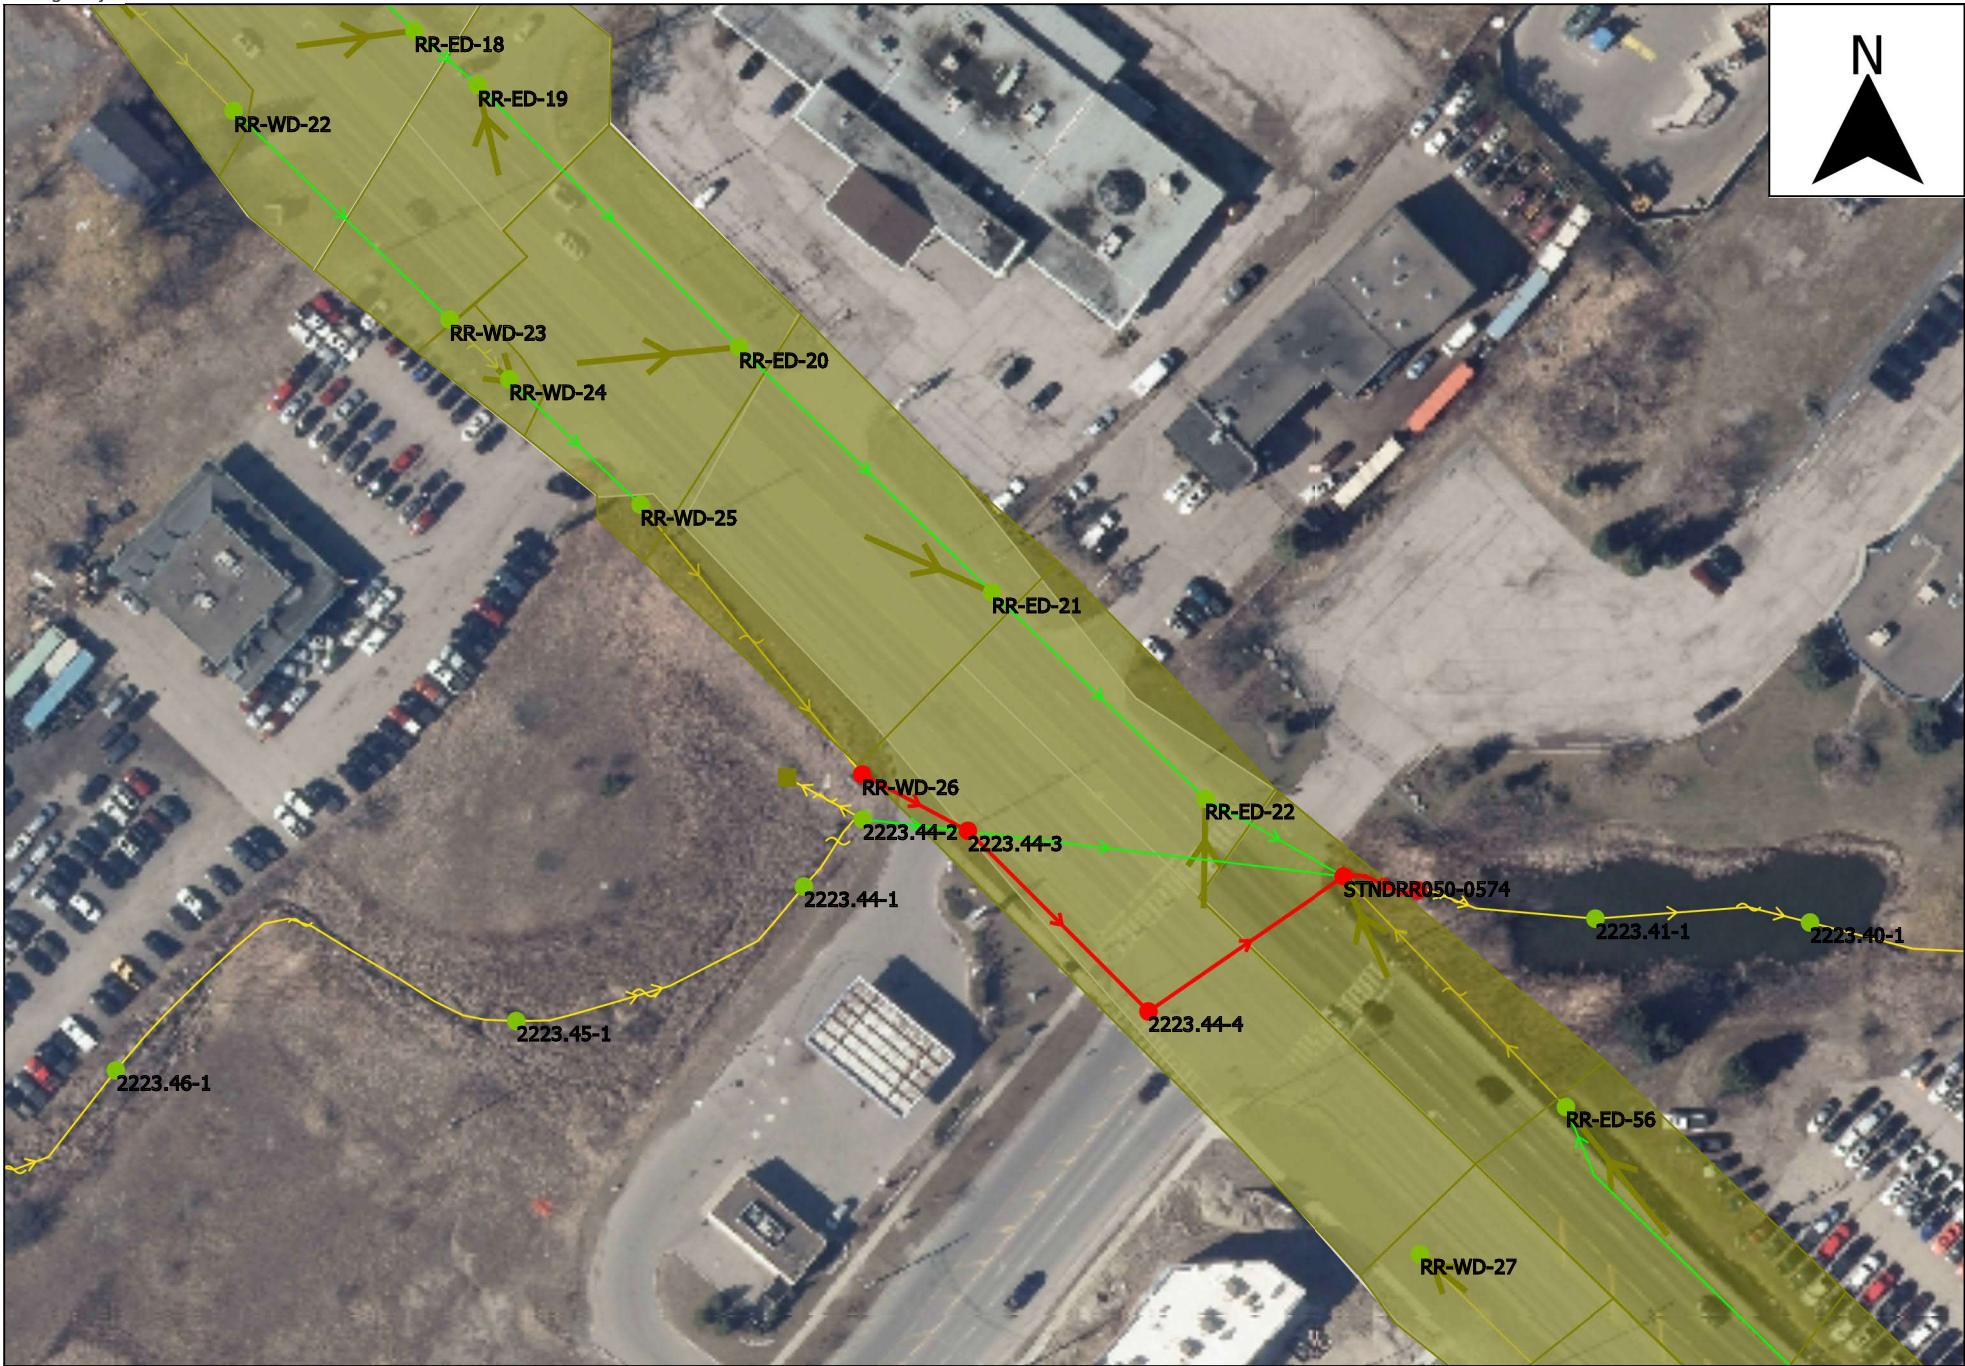
EXISTING CONDITION - 100-YEAR - WEST SIDE PROFILE 5

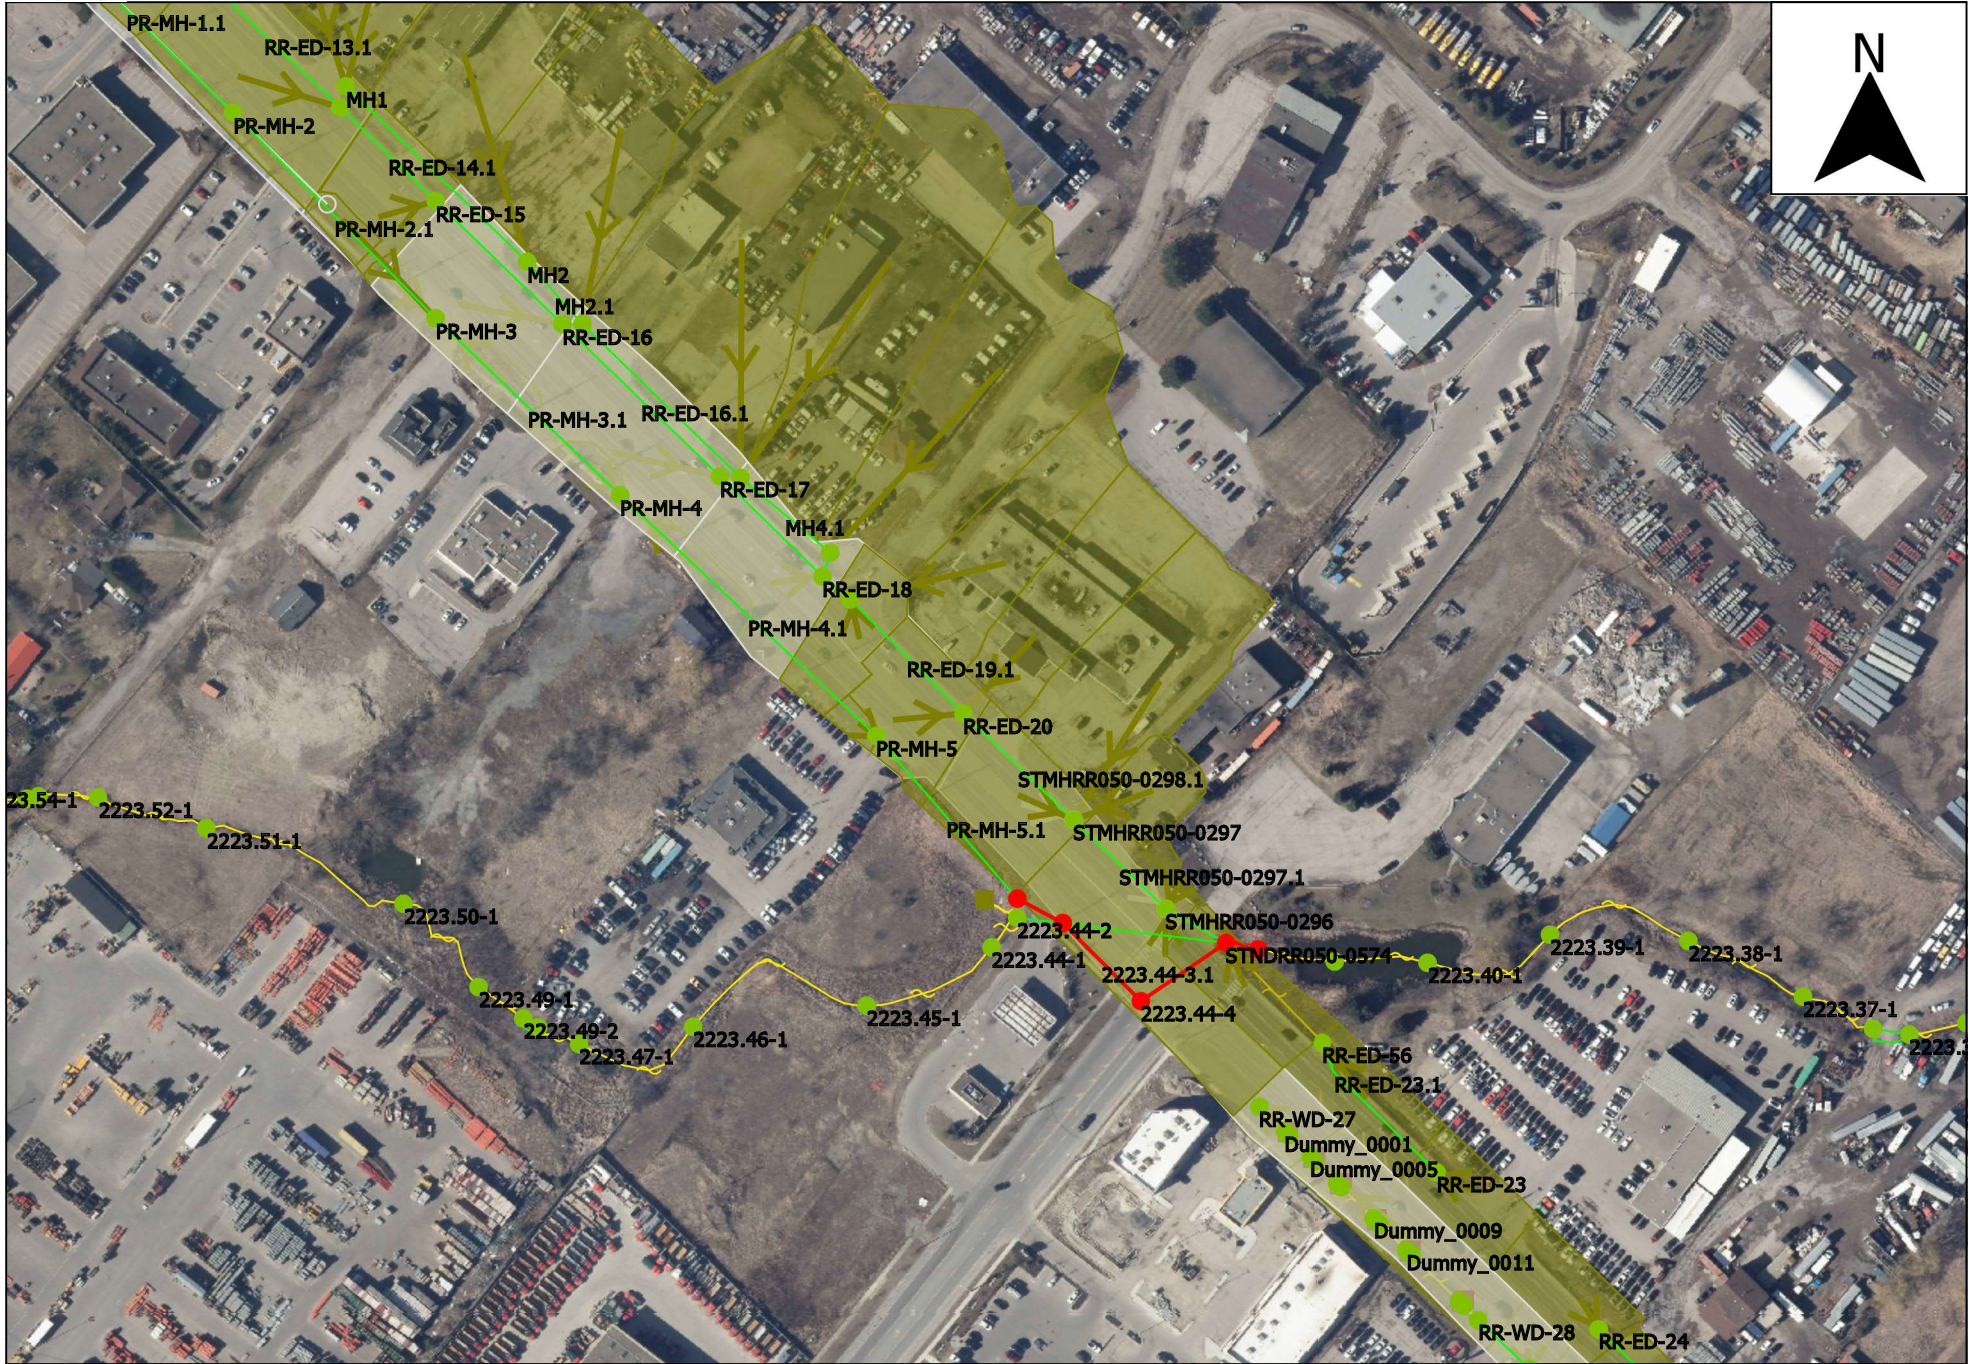
EXISTING CONDITION - 10-YEAR - WEST SIDE PROFILE 6

Node	RR-WD-26	2223.44-3	2223.44-4	2223.43C1-1	2223.42
Node ID	RR-WD-26	2223.44-3	2223.44-4	2223.43C1-1	2223.42
ground (m AD)	239.000	238.599	238.500	238.500	238.500
level (m AD)	237.368	237.368	236.847	236.809	236.801
expr:Freeboard	1.632263	1.231477	1.652847	1.690994	-

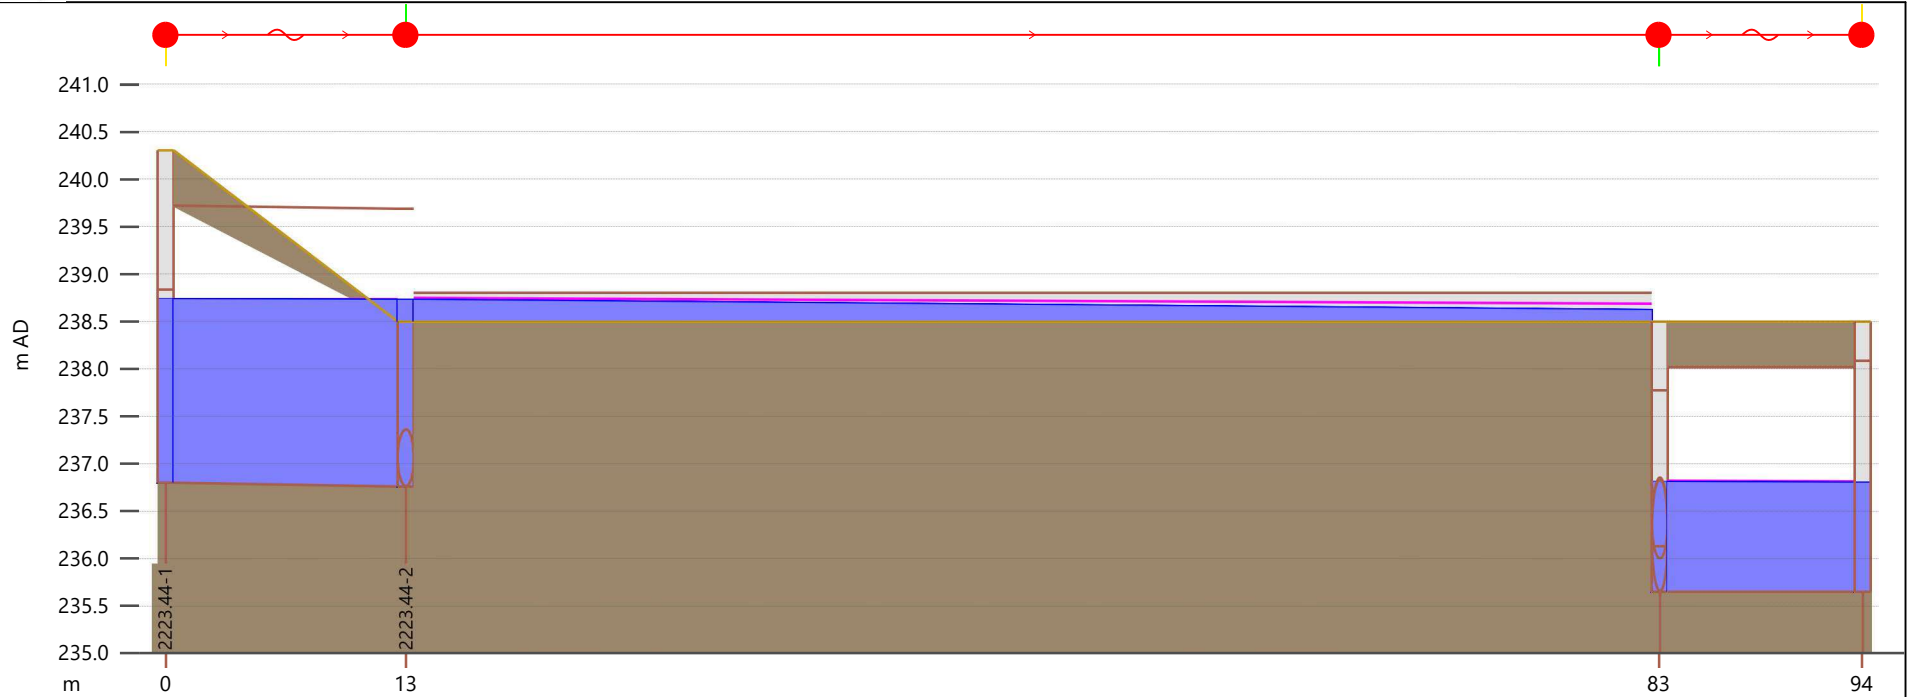
EXISTING CONDITION - 10-YEAR - WEST SIDE PLAN 8

Link	2223.44-1.1		2223.44-2.2		2223.43C1-1.1
US node ID	2223.44-1		2223.44-2		2223.43C1-1
ds node	2223.44-2		2223.43C1-1		2223.42
numbarrels	1		1		1
length (m)			69.5		
Shape ID	Matrix-2223.44		OREC		Matrix-2223.43
width (mm)			25000		
height (mm)			300		
Rough type			N		
us inv (m AD)	236.800		238.500		235.653
ds inv (m AD)	236.763		238.500		235.652
grad (m/m)			0.00000		
r.pfc (m3/s)	106.361		0.000		20.564
US depth (m)	1.932		0.230		1.156
US flow (m3/s)	5.11000		3.38957		5.10639
US velocity (m/s)	0.551		0.590		0.530
Node	2223.44-1	2223.44-2			2223.43C1-1
Node ID	2223.44-1	2223.44-2			2223.43C1-1
ground (m AD)	240.300	238.500			238.500
level (m AD)	238.732	238.730			236.809
expr:Freeboard	1.568127	-0.229935			1.690994
					2223.42
					2223.42
					238.500
					238.500
