STORMWATER MANAGEMENT REPORT

ENVIRONMENTAL ASSESSMENT (EA) AND PRELIMINARY DESIGN FOR DRAINAGE IMPROVEMENTS OF HIGHWAY 50 FROM MAYFIELD ROAD TO HEALEY ROAD

December 1, 2022

Region of Peel

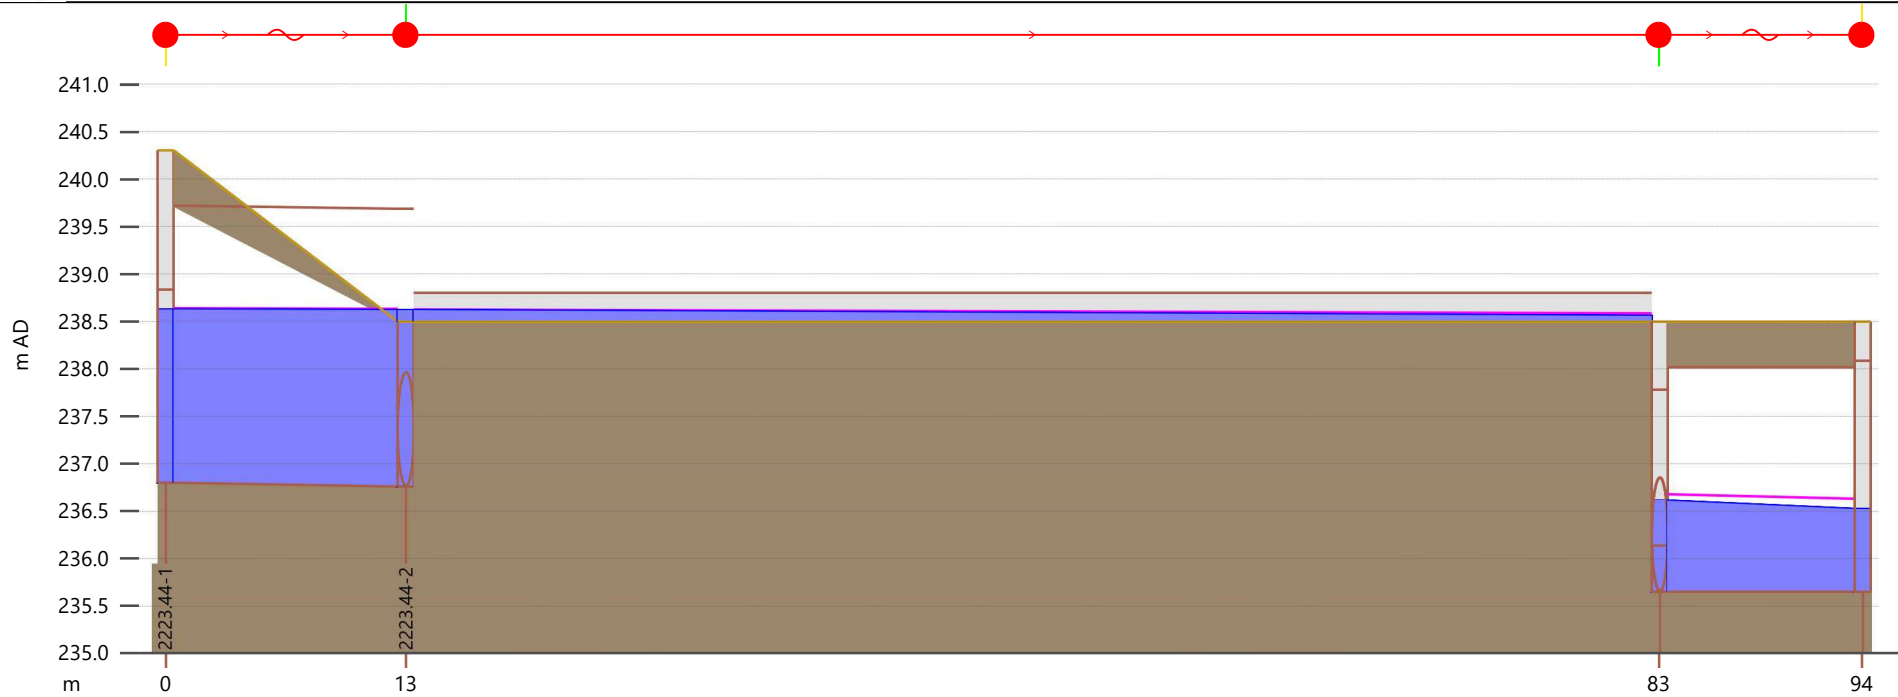
PROPOSED CONDITION - 100-YEAR - WEST SIDE PLAN 8

Link	2223.44-1.1		2223.44-2.2		2223.43C1-1.1
US node ID	2223.44-1		2223.44-2		2223.43C1-1
ds node	2223.44-2		2223.43C1-1		2223.42
numbarrels	1		1		1
length (m)			69.5		
Shape ID	Matrix-2223.44		OREC		Matrix-2223.43
width (mm)			25000		
height (mm)			300		
Rough type			N		
us inv (m AD)	236.800		238.500		235.653
ds inv (m AD)	236.763		238.500		235.652
grad (m/m)			0.00000		
r.pfc (m3/s)	106.361		0.000		20.564
US depth (m)	1.830		0.123		0.957
US flow (m3/s)	7.90000		1.11810		7.89915
US velocity (m/s)	1.588		0.364		1.195

Node	2223.44-1	2223.44-2		2223.43C1-1	2223.42
Node ID	2223.44-1	2223.44-2		2223.43C1-1	2223.42
ground (m AD)	240.300	238.500		238.500	238.500
level (m AD)	238.630	238.623		236.610	236.526
expr:Freeboard	1.670392	-0.122910		1.889725	-

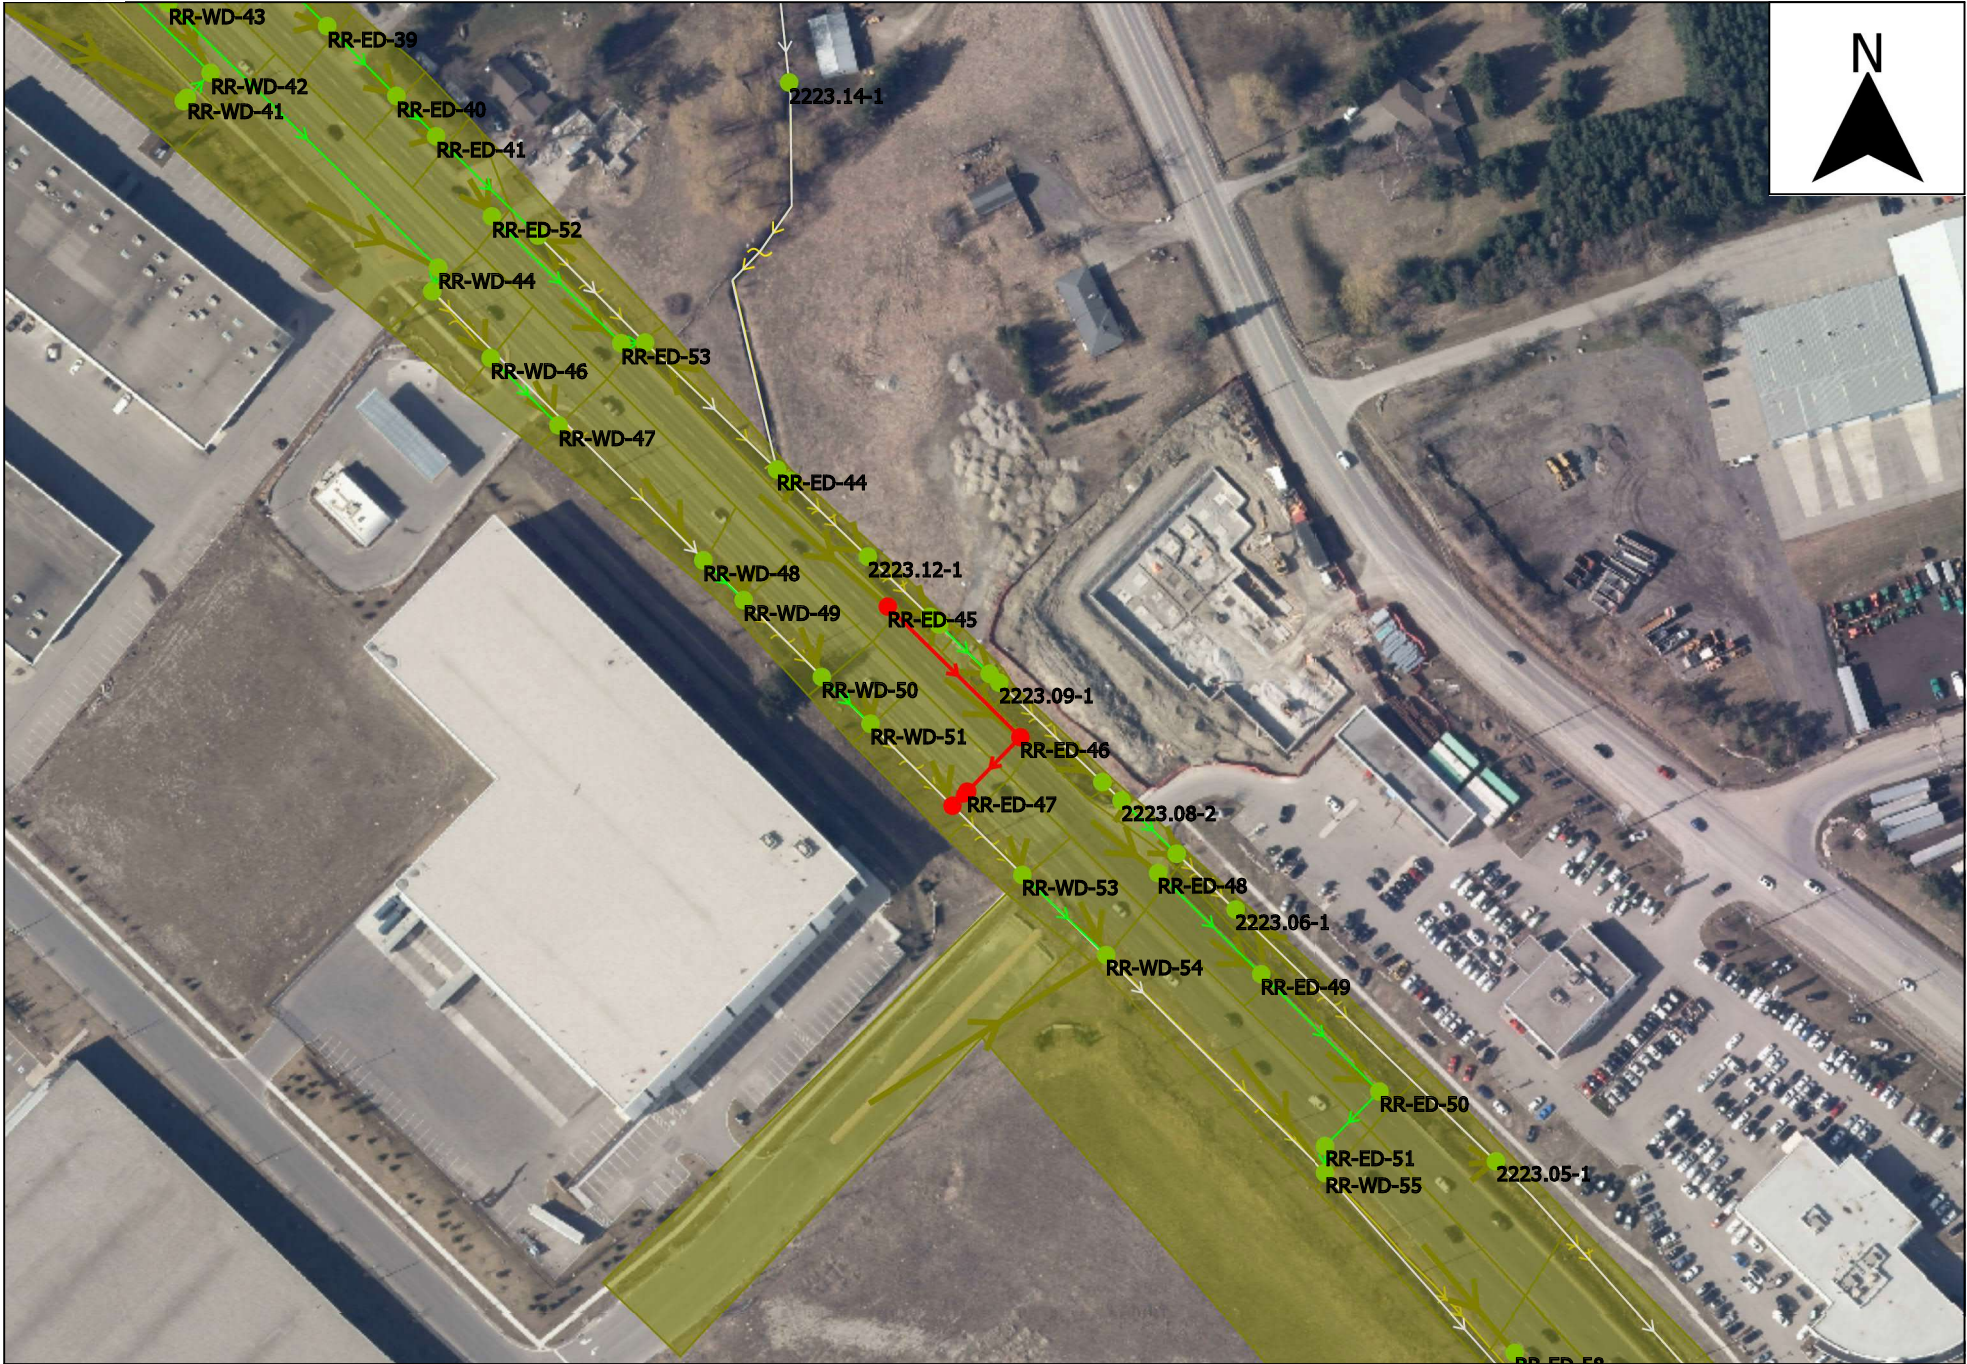
PROPOSED CONDITION - 10-YEAR - WEST SIDE PROFILE 15

Node	DCBMH-210	DCBMH-211
Node ID	DCBMH-210	DCBMH-211
ground (m AD)	228.728	228.328
level (m AD)	227.239	226.841
expr:Freeboard	1.488880	1.487271

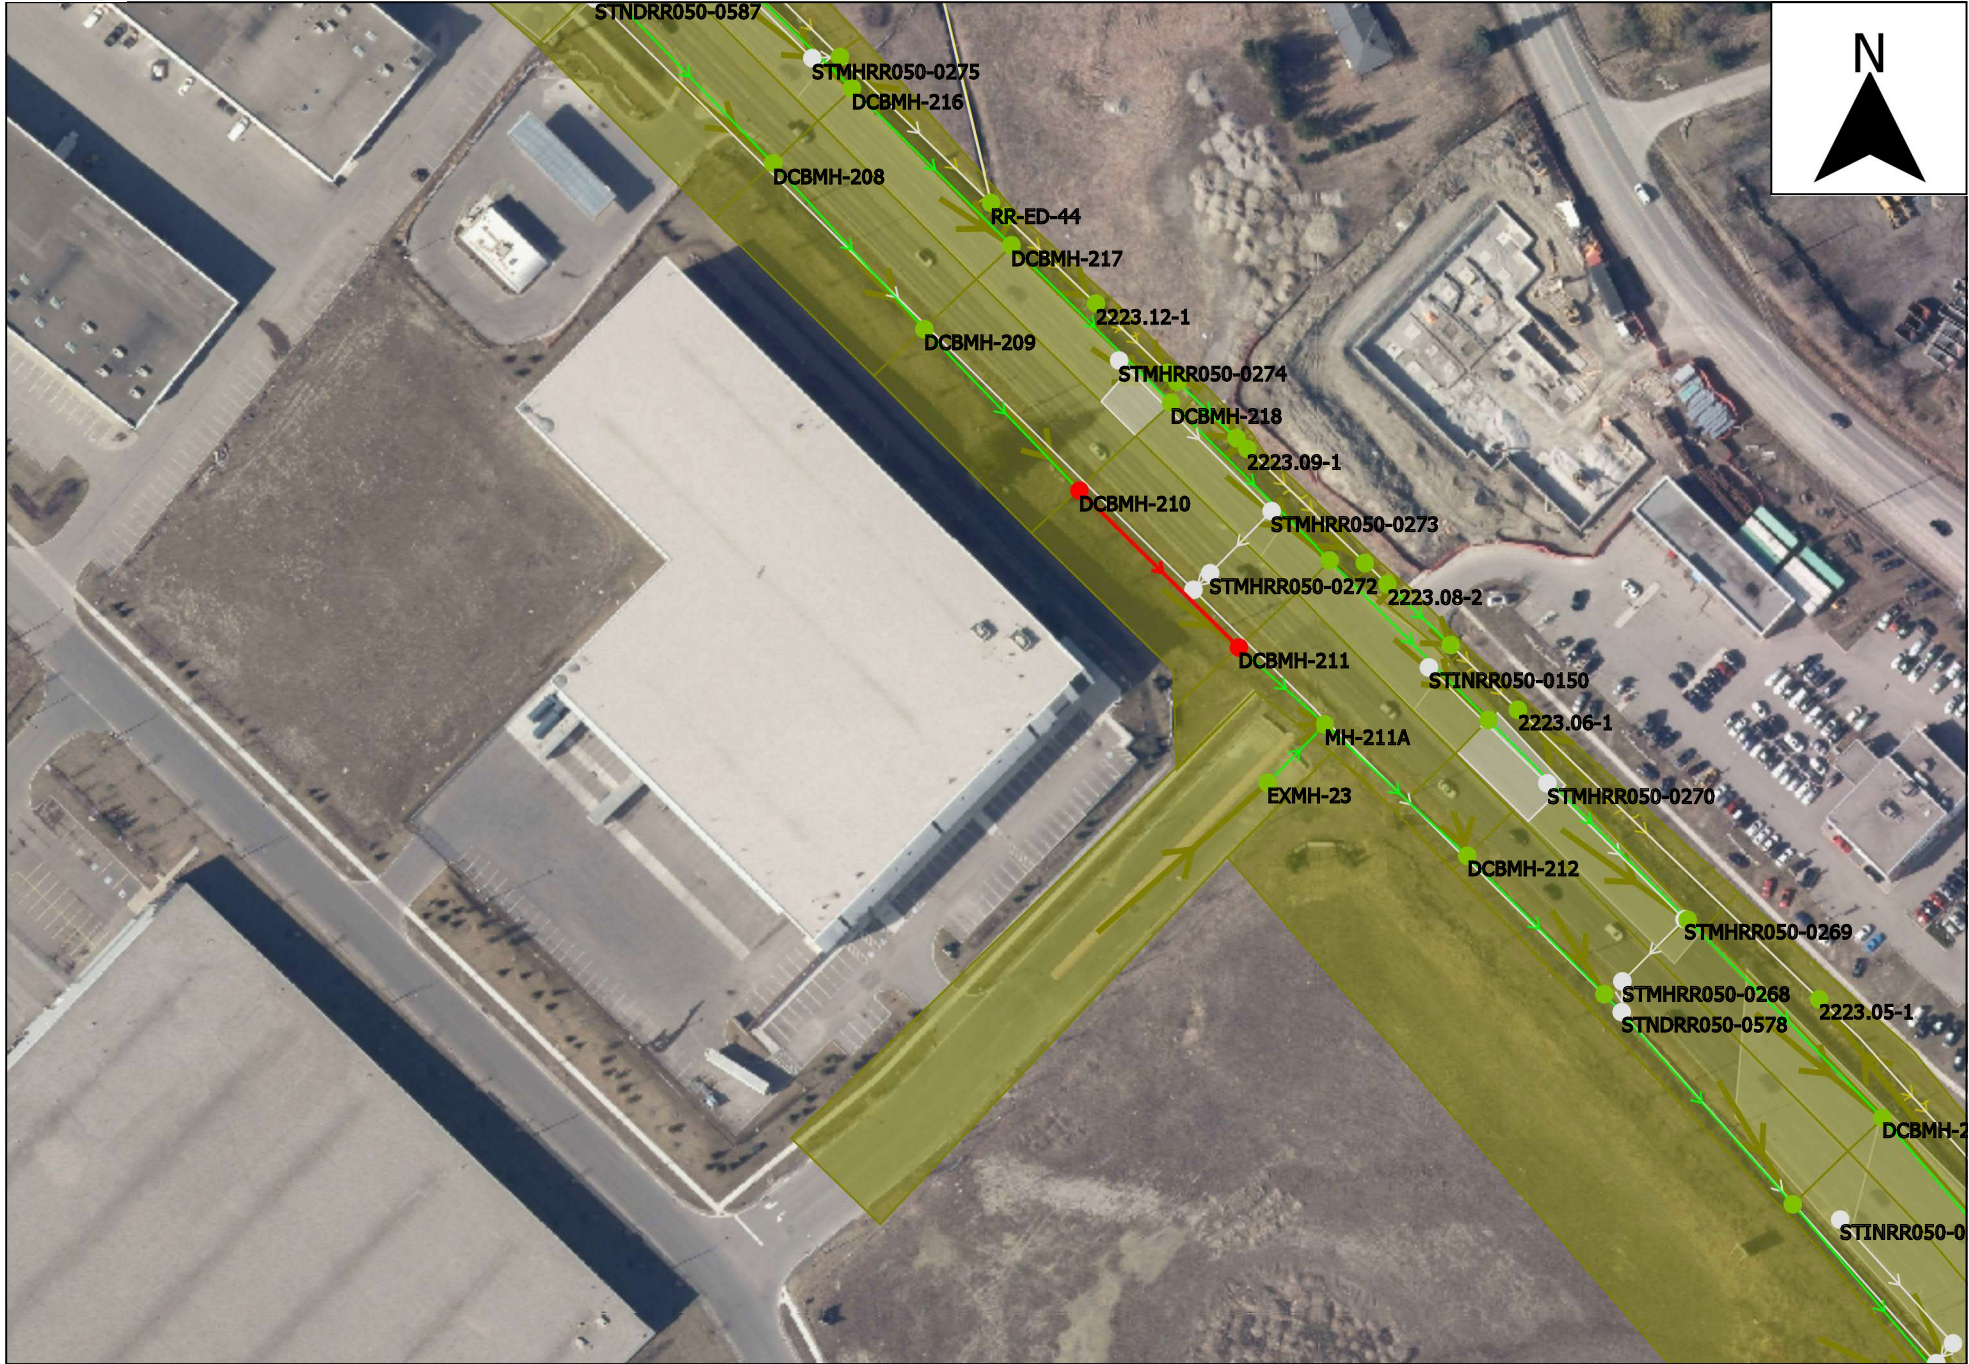
EXISTING CONDITION - 100-YEAR - WEST SIDE PROFILE 15

Link		RR-ED-45.1		RR-ED-46.1		RR-ED-47.1
US node ID		RR-ED-45		RR-ED-46		RR-ED-47
ds node		RR-ED-46		RR-ED-47		RR-WD-52
numbarrels		1		1		1
length (m)		49.8		20.3		5.5
Shape ID		CIRC		CIRC		CIRC
width (mm)		300		300		300
height (mm)		300		300		300
Rough type		N		N		N
us inv (m AD)		227.327		227.116		227.011
ds inv (m AD)		227.116		227.011		226.910
grad (m/m)		0.00424		0.00518		0.01844
r.pfc (m3/s)		0.063		0.070		0.131
US depth (m)		0.813		0.886		0.950
US flow (m3/s)		0.06115		0.09108		0.08938
US velocity (m/s)		0.996		1.212		1.198
Node	RR-ED-45		RR-ED-46		RR-ED-47	-
Node ID	RR-ED-45		RR-ED-46		RR-ED-47	-
ground (m AD)	228.764		228.462		228.394	-
level (m AD)	228.143		228.030		227.963	-
expr:Freeboard	0.620392		0.432220		0.431183	-

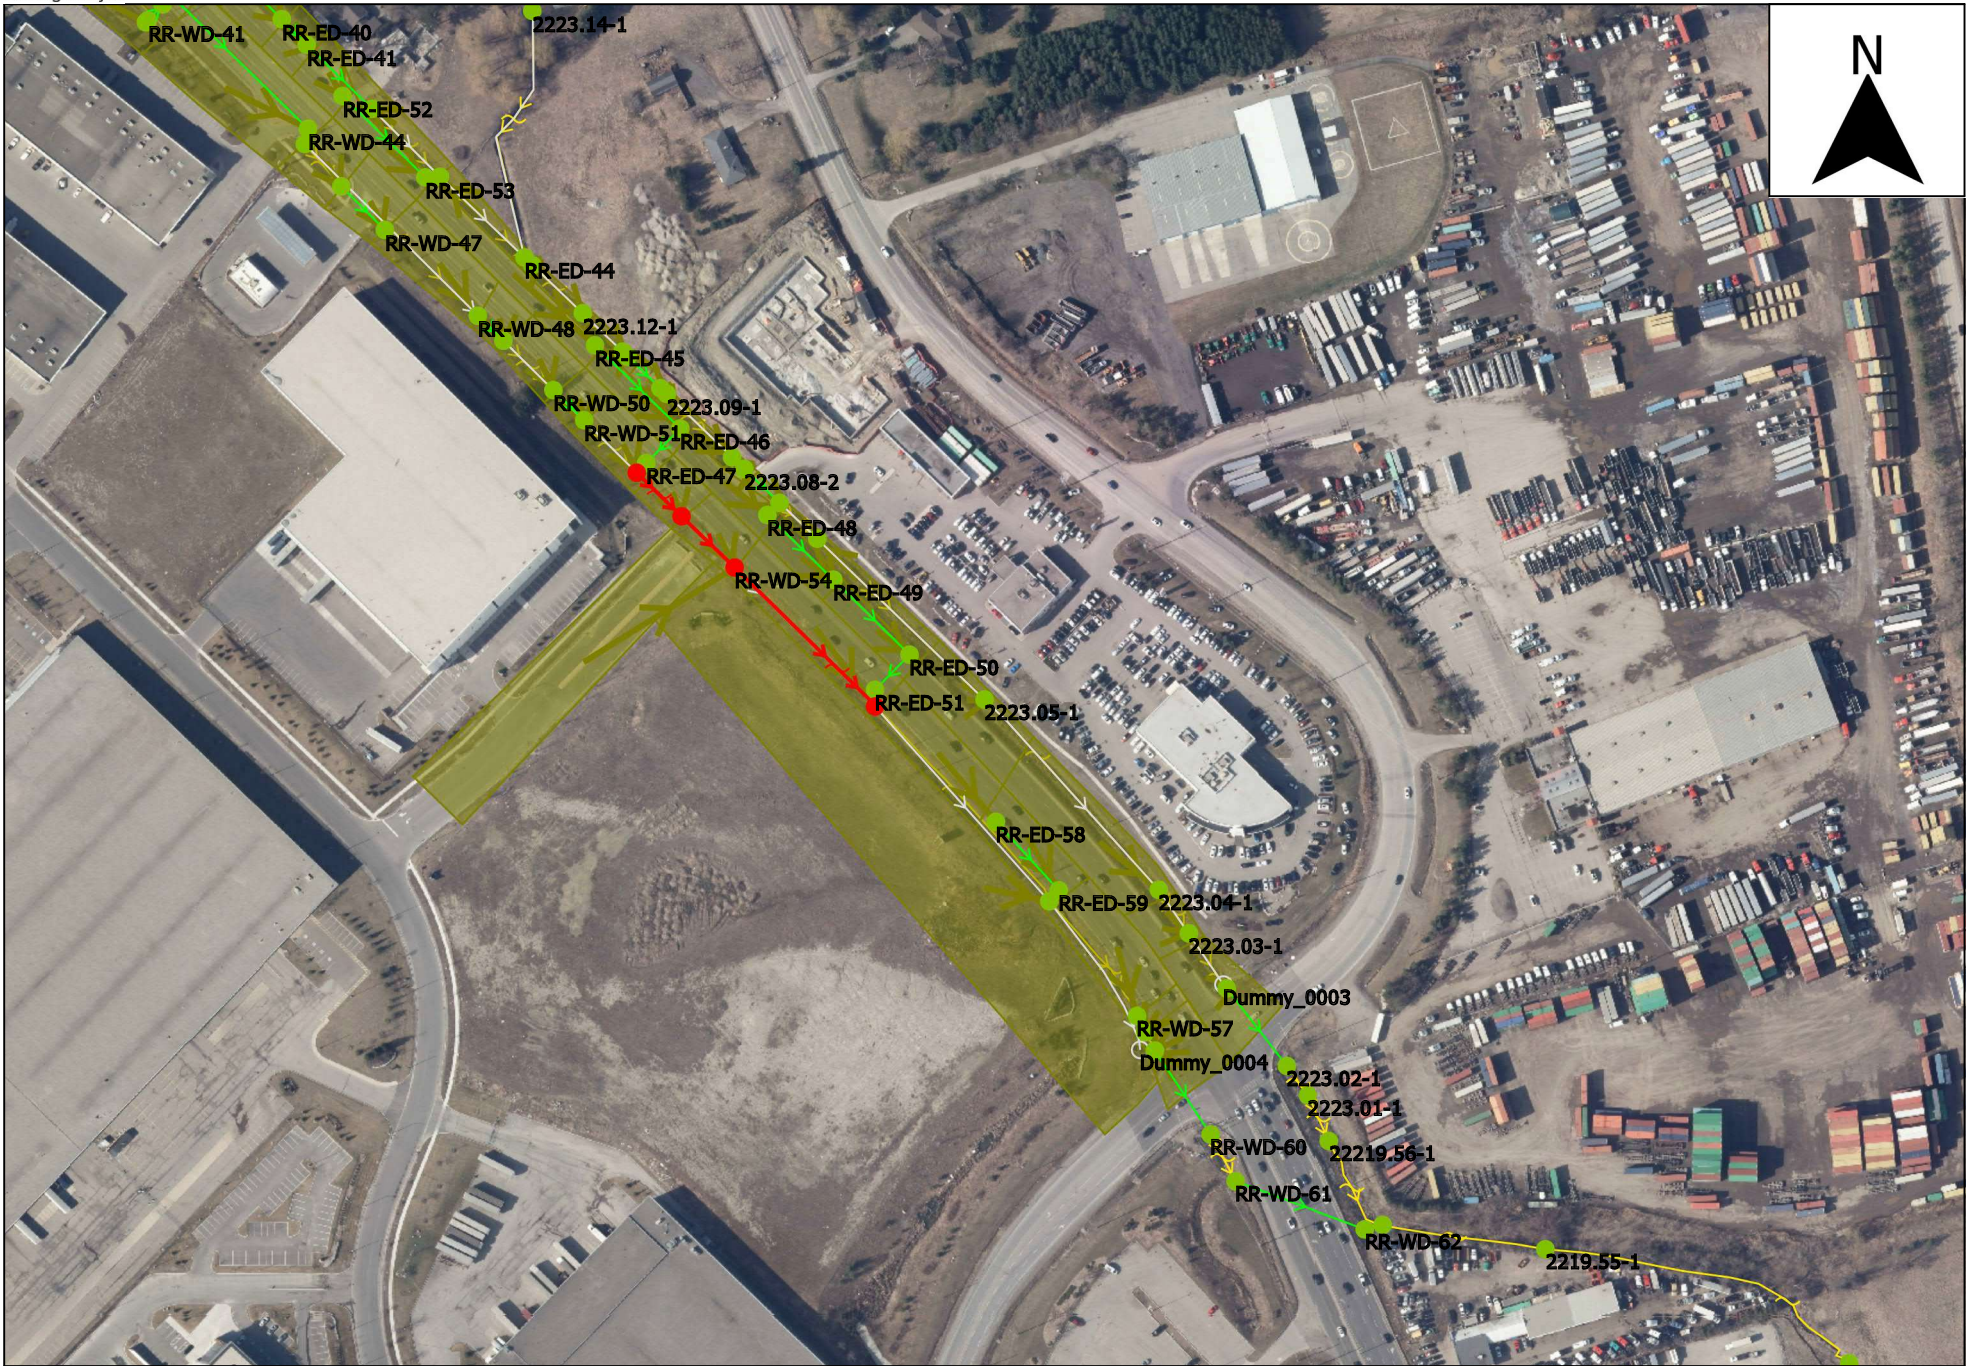
EXISTING CONDITION - 100-YEAR - WEST SIDE PROFILE 15

Link	DCBMH-210.1	
US node ID	DCBMH-210	
ds node	DCBMH-211	
numbarrels	1	
length (m)	52.0	
Shape ID	CIRC	
width (mm)	450	
height (mm)	450	
Rough type	N	
us inv (m AD)	226.899	
ds inv (m AD)	226.639	
grad (m/m)	0.00500	
r.pfc (m3/s)	0.202	
US depth (m)	1.990	
US flow (m3/s)	0.25036	
US velocity (m/s)	1.526

Node	DCBMH-210	DCBMH-211
Node ID	DCBMH-210	DCBMH-211
ground (m AD)	228.728	228.328
level (m AD)	228.904	228.487
expr:Freeboard	-0.176312	-0.158694

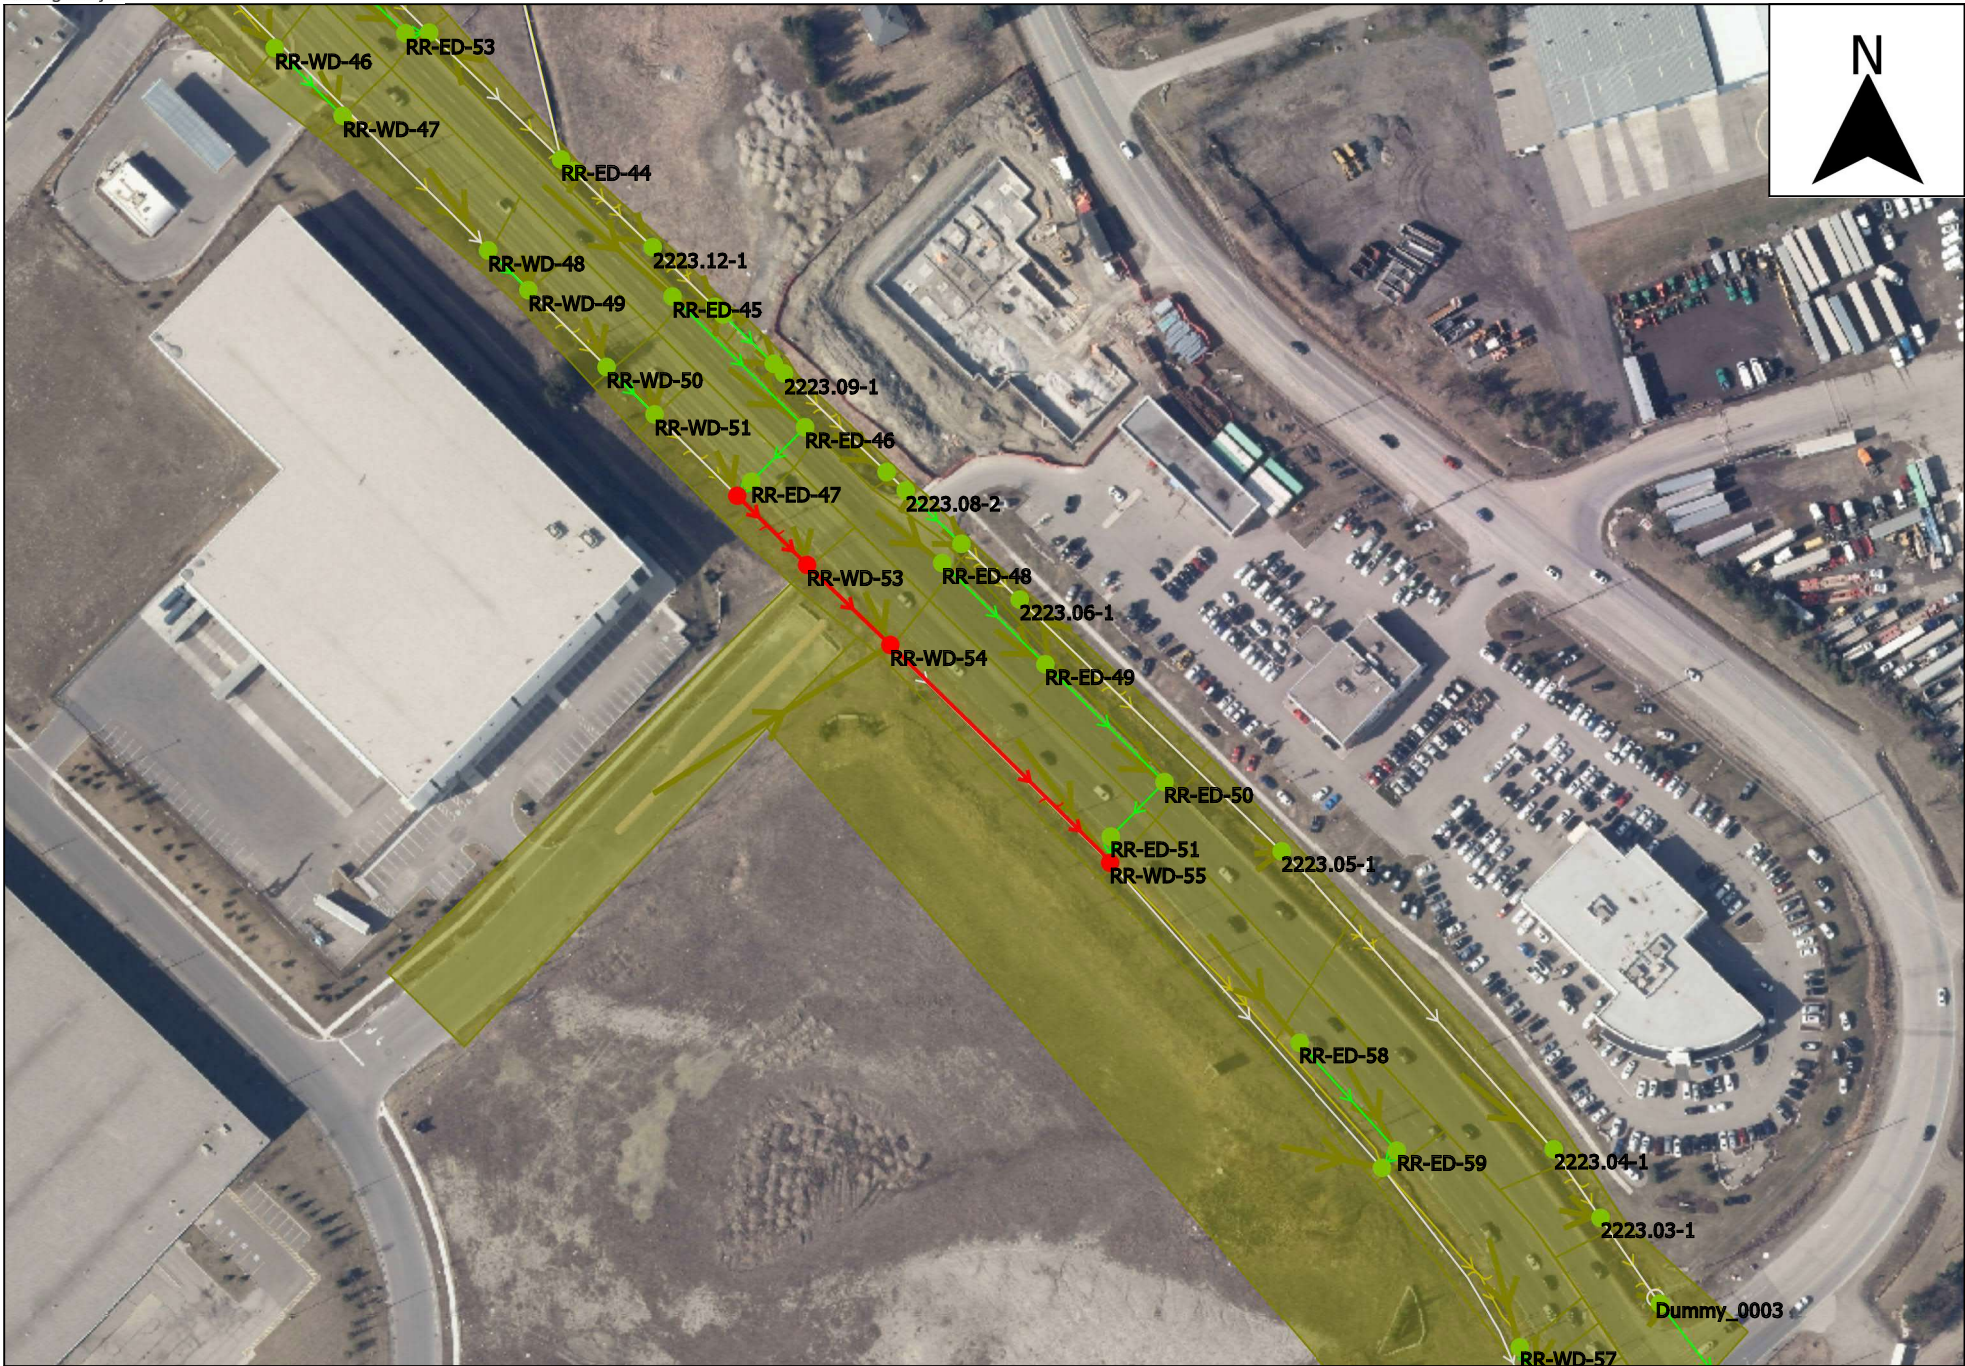
PROPOSED CONDITION - 10-YEAR - WEST SIDE PROFILE 16

Link	DCBMH-211.1	
US node ID	DCBMH-211	
ds node	MH-211A	
numbarrels	1	
length (m)	26.9	
Shape ID	CIRC	
width (mm)	450	
height (mm)	450	
Rough type	N	
us inv (m AD)	226.474	
ds inv (m AD)	226.209	
grad (m/m)	0.00986	
r.pfc (m3/s)	0.283	
US depth (m)	0.358	
US flow (m3/s)	0.22690	
US velocity (m/s)	1.896

Node	DCBMH-211	MH-211A
Node ID	DCBMH-211	MH-211A
ground (m AD)	228.328	229.000
level (m AD)	226.841	226.656
expr:Freeboard	1.487271	2.343567

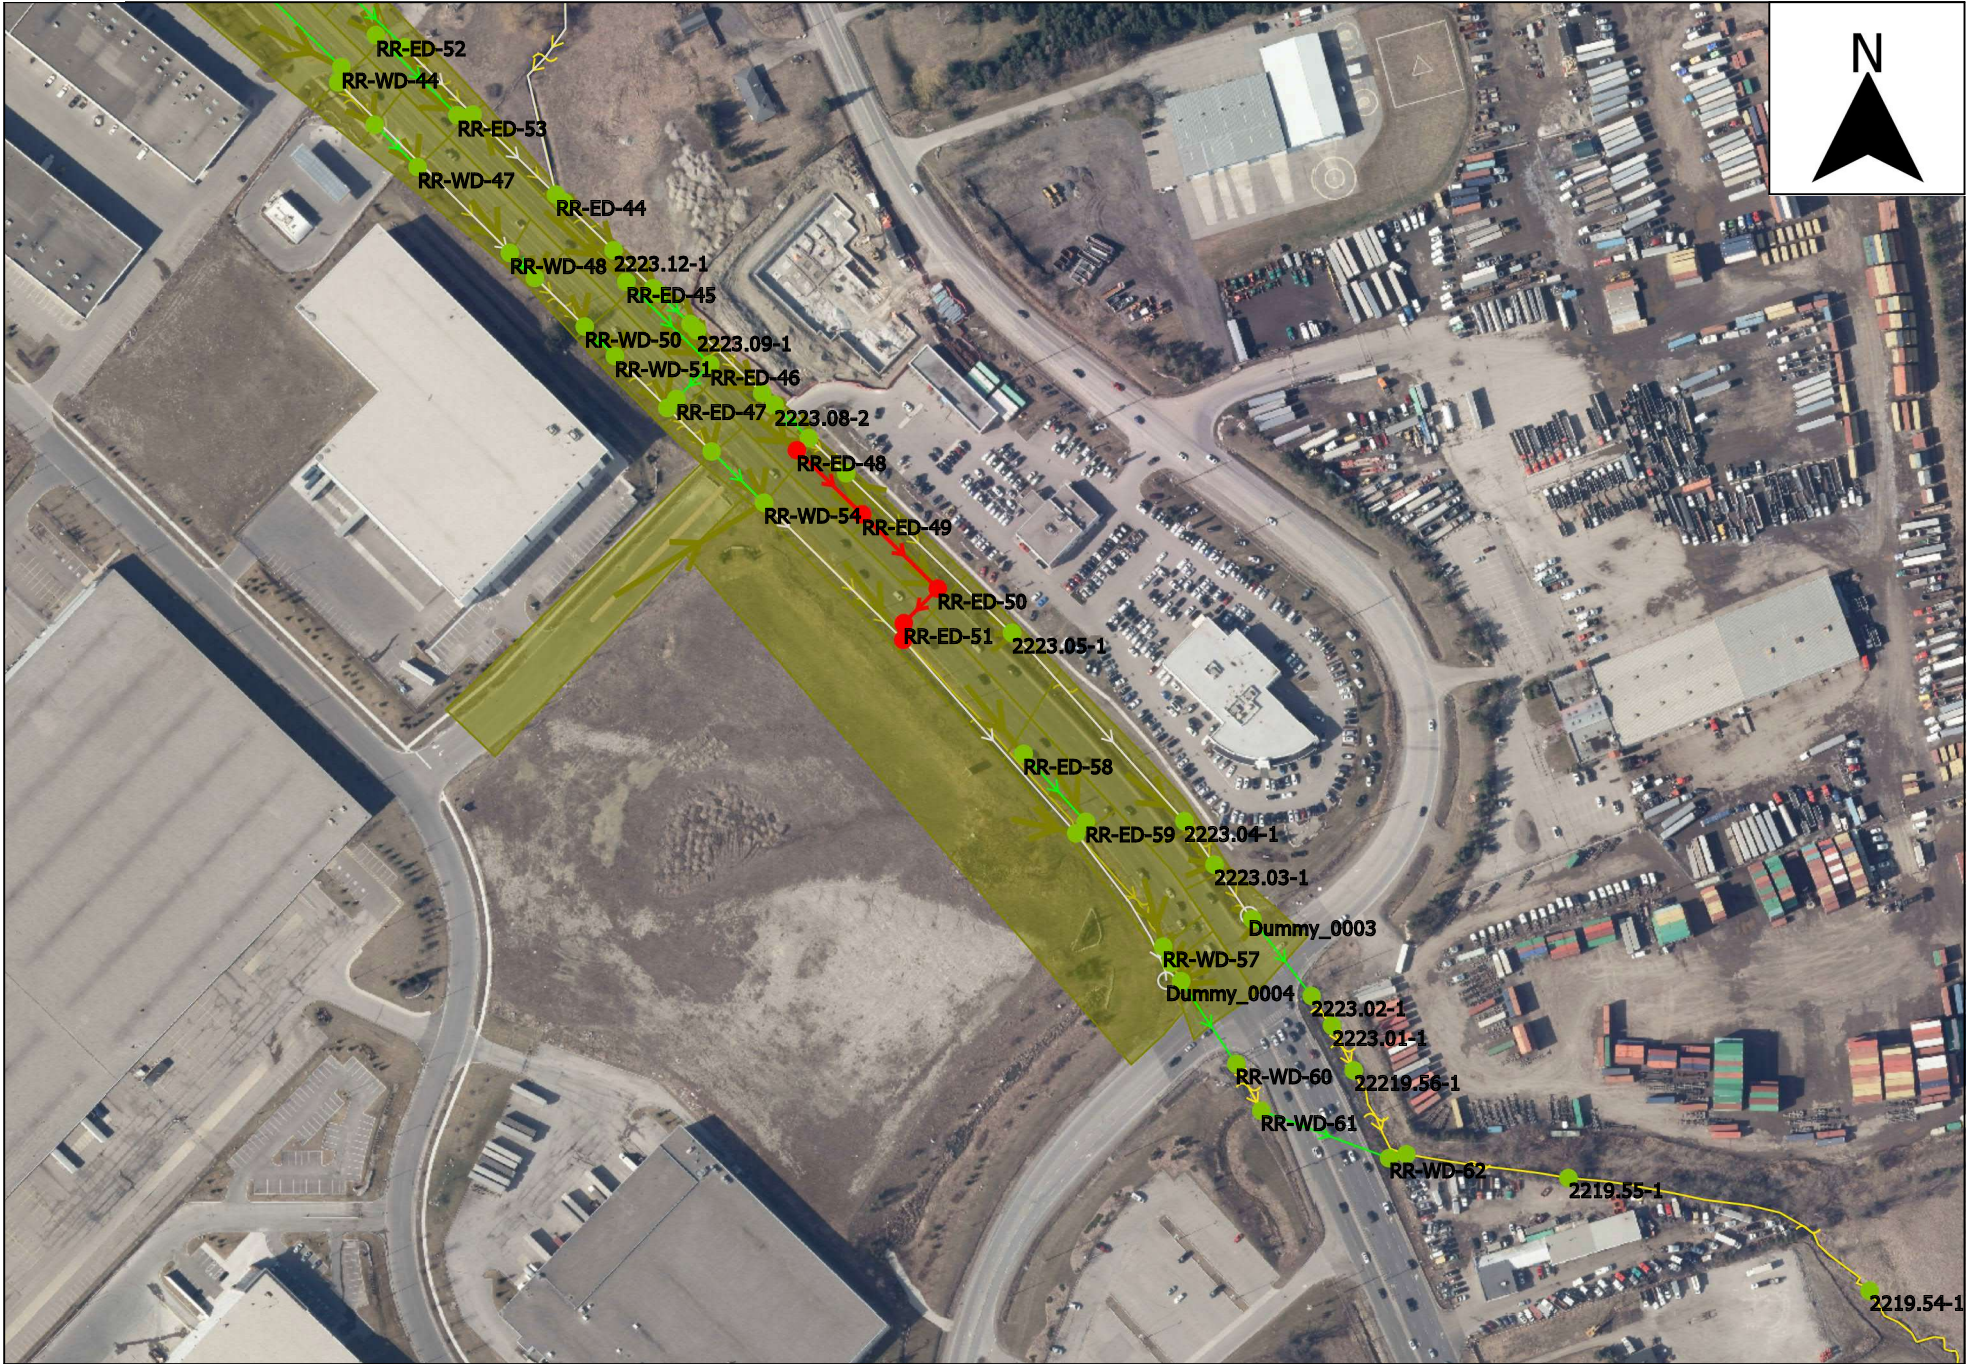
EXISTING CONDITION - 100-YEAR - WEST SIDE PROFILE 16

Link	DCBMH-211.1	
US node ID	DCBMH-211	
ds node	MH-211A	
numbarrels	1	
length (m)	26.9	
Shape ID	CIRC	
width (mm)	450	
height (mm)	450	
Rough type	N	
us inv (m AD)	226.474	
ds inv (m AD)	226.209	
grad (m/m)	0.00986	
r.pfc (m3/s)	0.283	
US depth (m)	1.990	
US flow (m3/s)	0.30681	
US velocity (m/s)	1.920

Node	DCBMH-211	MH-211A
Node ID	DCBMH-211	MH-211A
ground (m AD)	228.328	229.000
level (m AD)	228.487	228.150
expr:Freeboard	-0.158694	0.850433

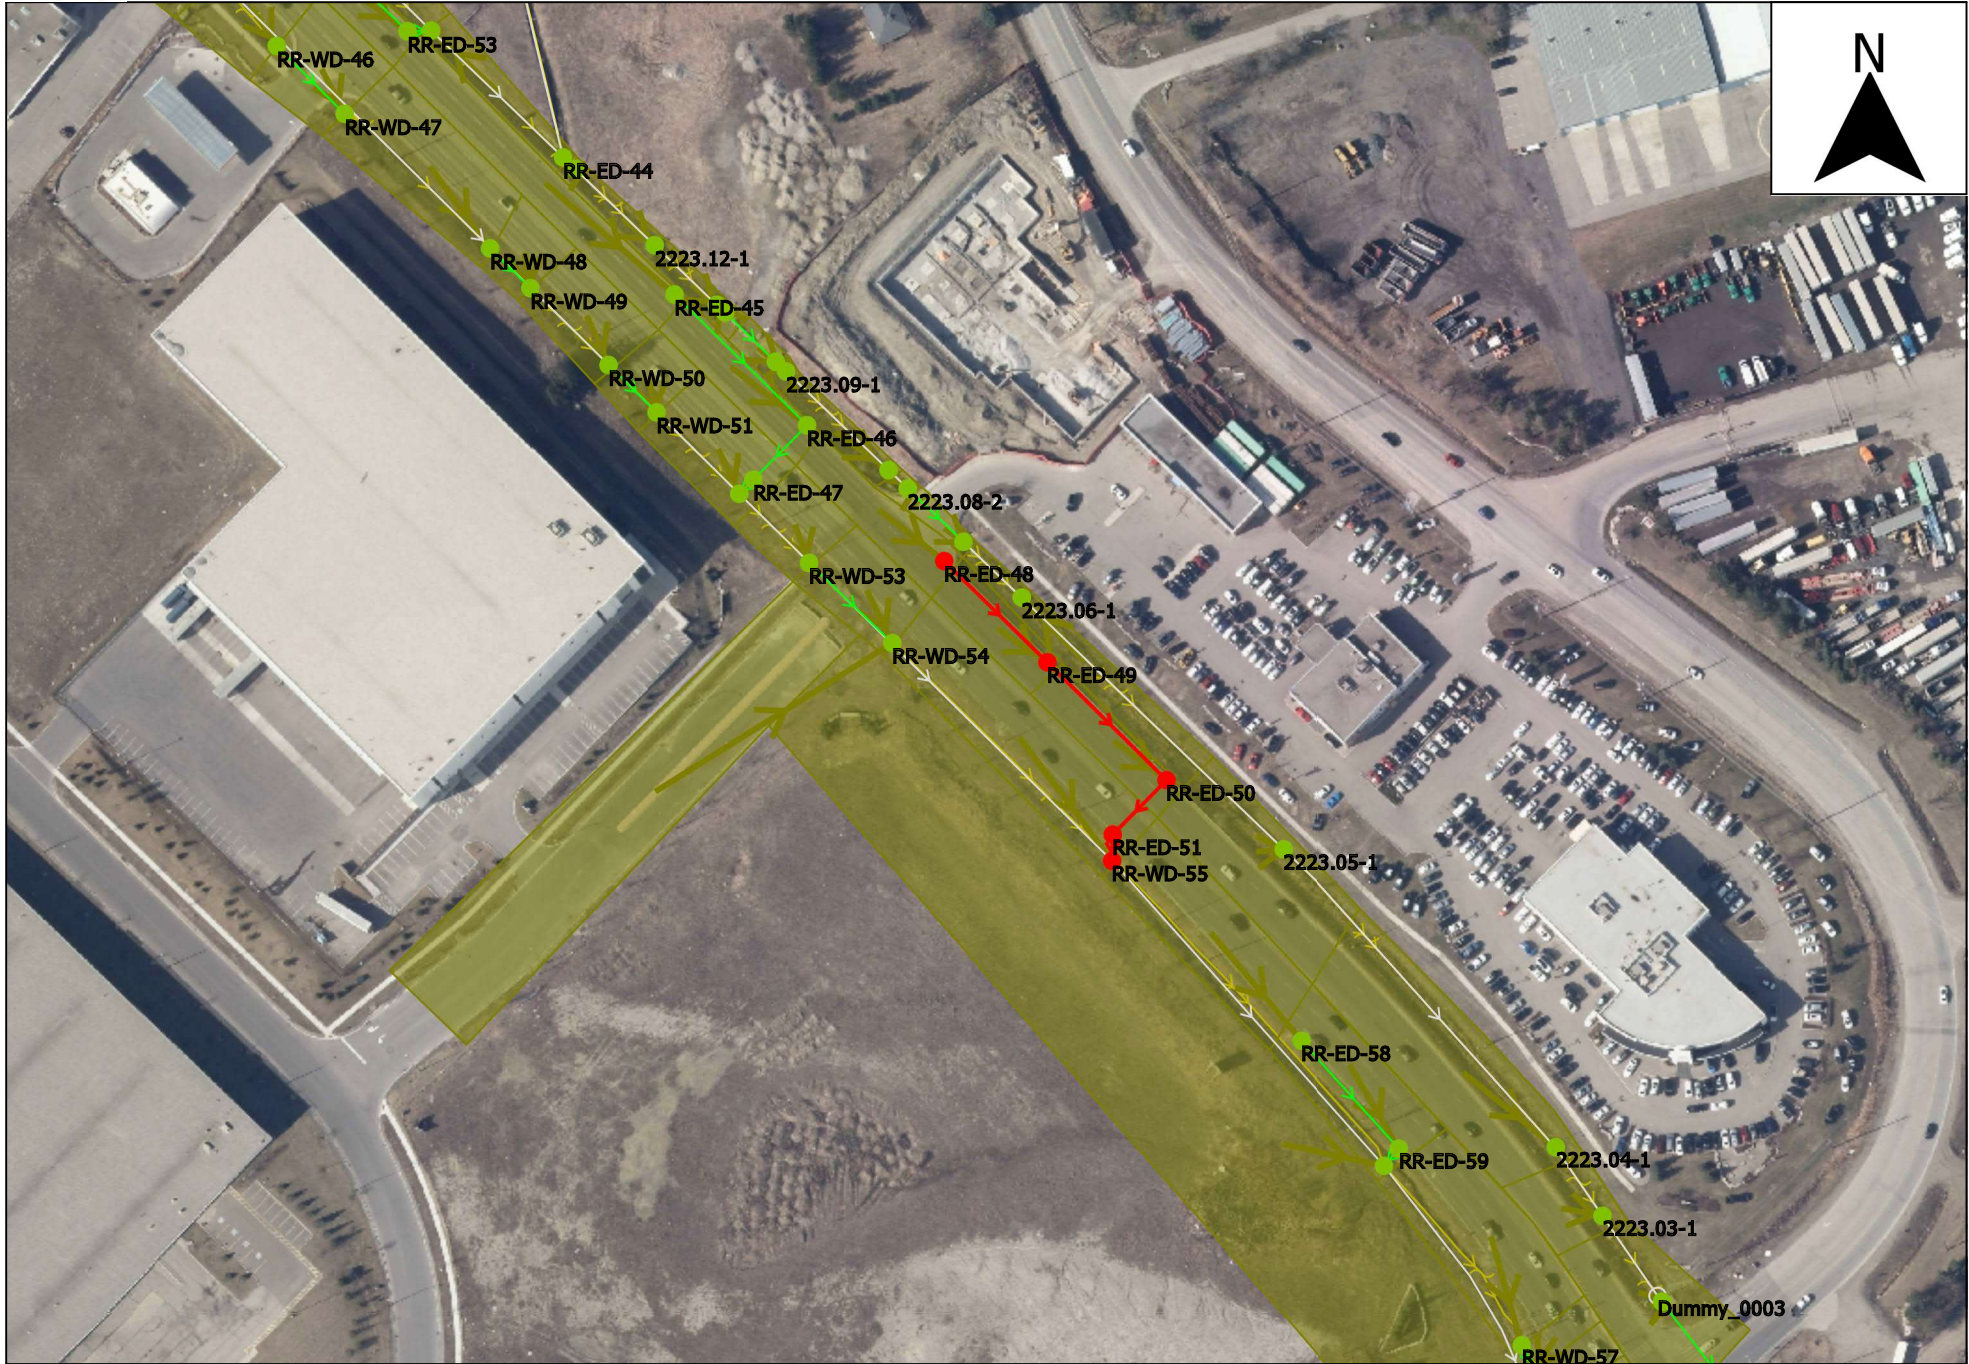
PROPOSED CONDITION - 10-YEAR - WEST SIDE PROFILE 17

Link	EXMH-23.1	MH-211A.1
US node ID	EXMH-23	MH-211A
ds node	MH-211A	DCBMH-212
numbarrels	1	1
length (m)	19.2	45.1
Shape ID	CIRC	CIRC
width (mm)	450	525
height (mm)	450	525
Rough type	N	N
us inv (m AD)	226.294	226.123
ds inv (m AD)	226.198	225.898
grad (m/m)	0.00500	0.00499
r.pfc (m3/s)	0.202	0.304
US depth (m)	0.380	0.521
US flow (m3/s)	0.09502	0.33715
US velocity (m/s)	1.036	1.680

Node	EXMH-23	MH-211A	DCBMH-212
Node ID	EXMH-23	MH-211A	DCBMH-212
ground (m AD)	227.898	229.000	227.843
level (m AD)	226.676	226.656	226.365
expr:Freeboard	1.222265	2.343567	1.478162

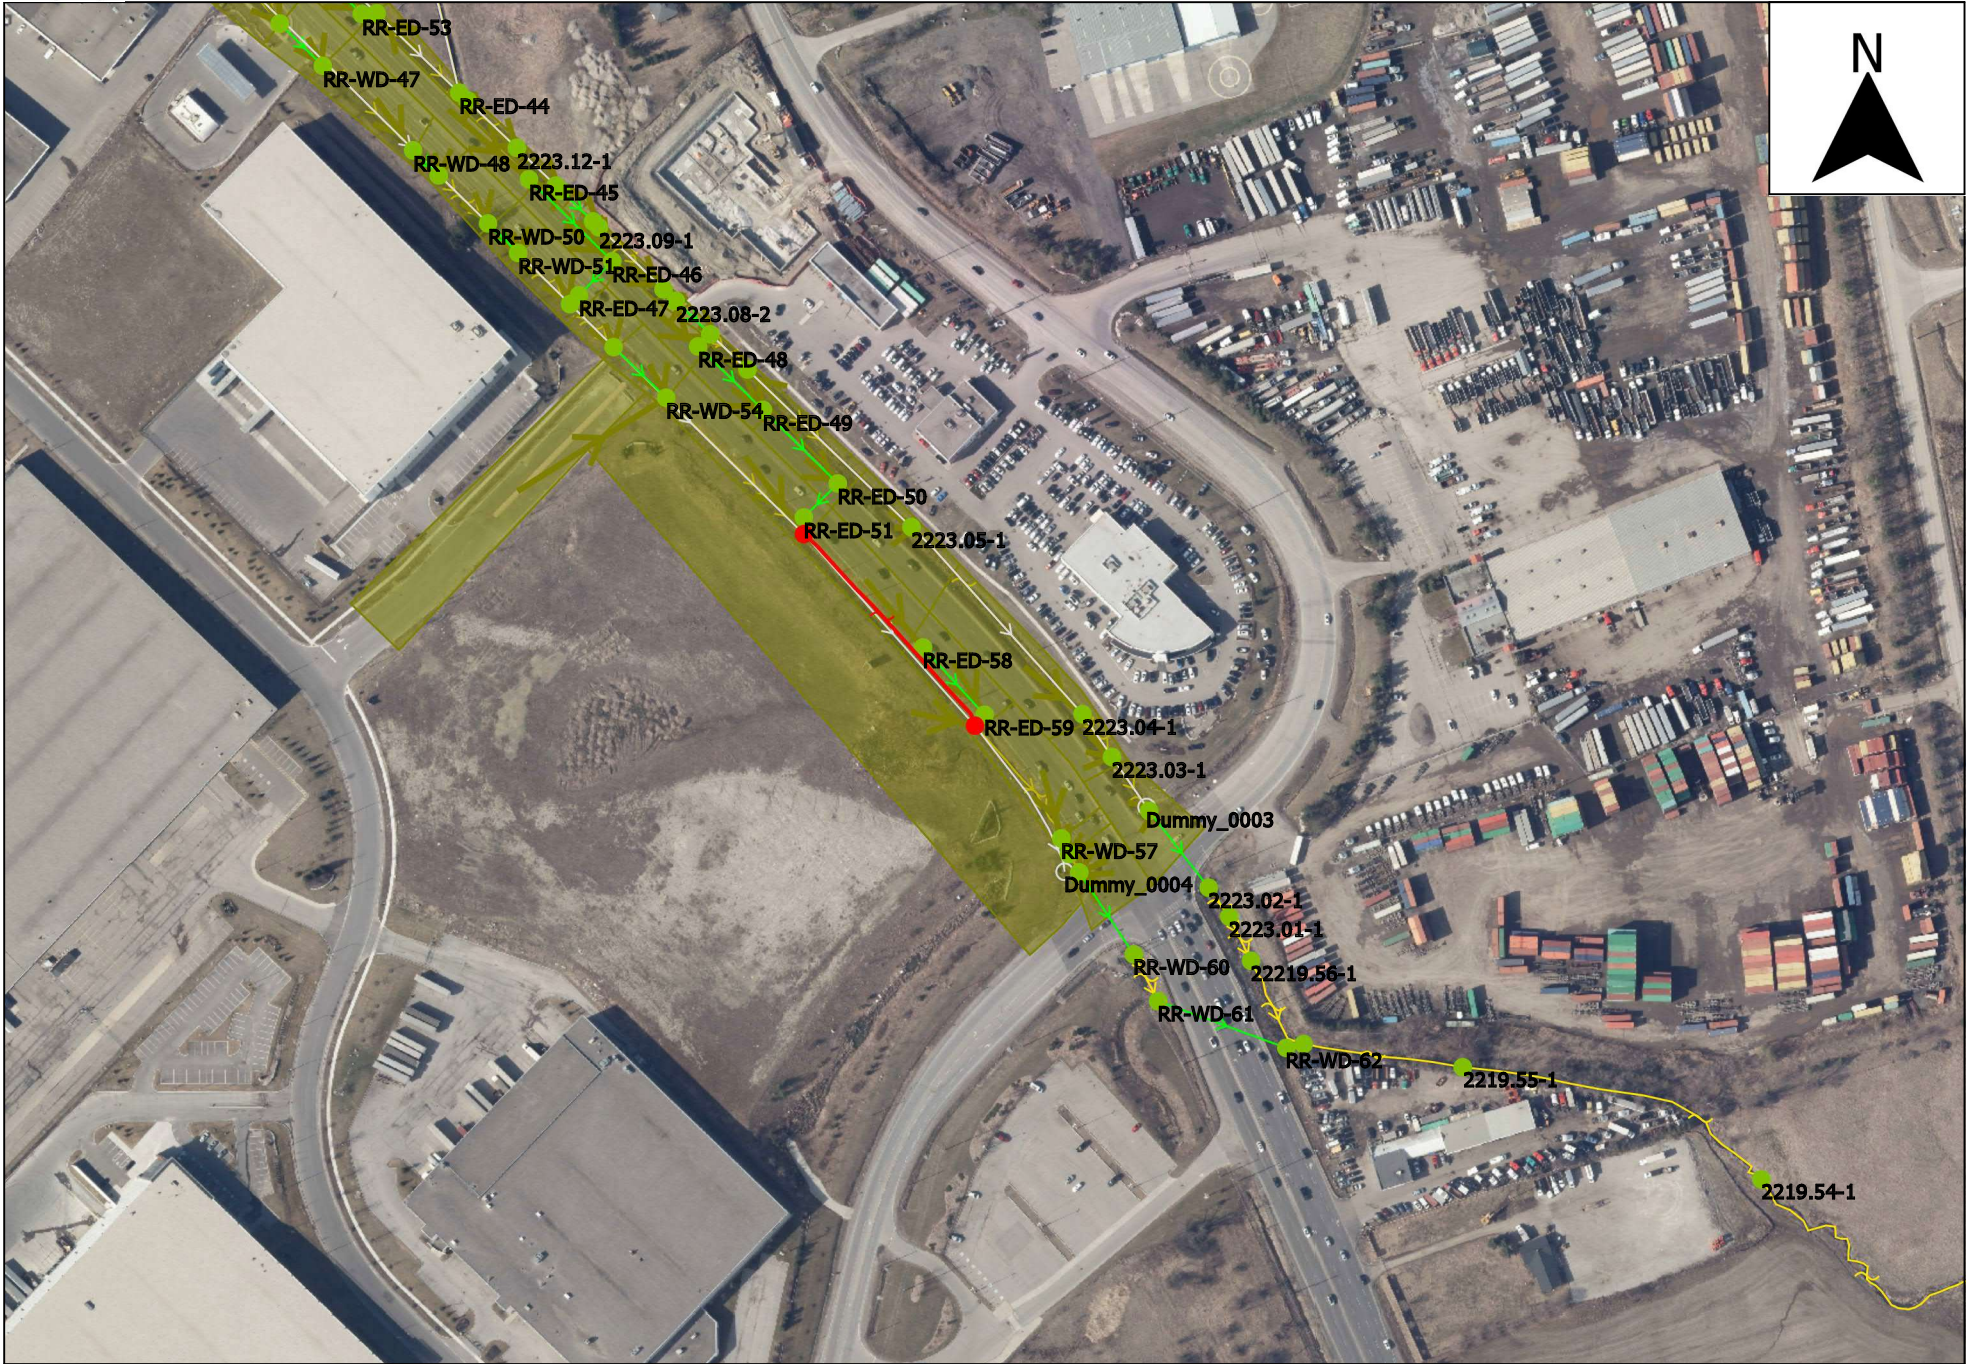
EXISTING CONDITION - 100-YEAR - WEST SIDE PROFILE 17

Link	EXMH-23.1		MH-211A.1
US node ID	EXMH-23		MH-211A
ds node	MH-211A		DCBMH-212
numbarrels	1		1
length (m)	19.2		45.1
Shape ID	CIRC		CIRC
width (mm)	450		525
height (mm)	450		525
Rough type	N		N
us inv (m AD)	226.294		226.123
ds inv (m AD)	226.198		225.898
grad (m/m)	0.00500		0.00499
r.pfc (m3/s)	0.202		0.304
US depth (m)	1.894		1.997
US flow (m3/s)	0.14541		0.48341
US velocity (m/s)	1.055		2.024
Node	EXMH-23	MH-211A	DCBMH-212
Node ID	EXMH-23	MH-211A	DCBMH-212
ground (m AD)	227.898	229.000	227.843
level (m AD)	228.192	228.150	227.571
expr:Freeboard	-0.293528	0.850433	0.272077
