STORMWATER MANAGEMENT REPORT

ENVIRONMENTAL ASSESSMENT (EA) AND PRELIMINARY DESIGN FOR DRAINAGE IMPROVEMENTS OF HIGHWAY 50 FROM MAYFIELD ROAD TO HEALEY ROAD

December 1, 2022

Region of Peel

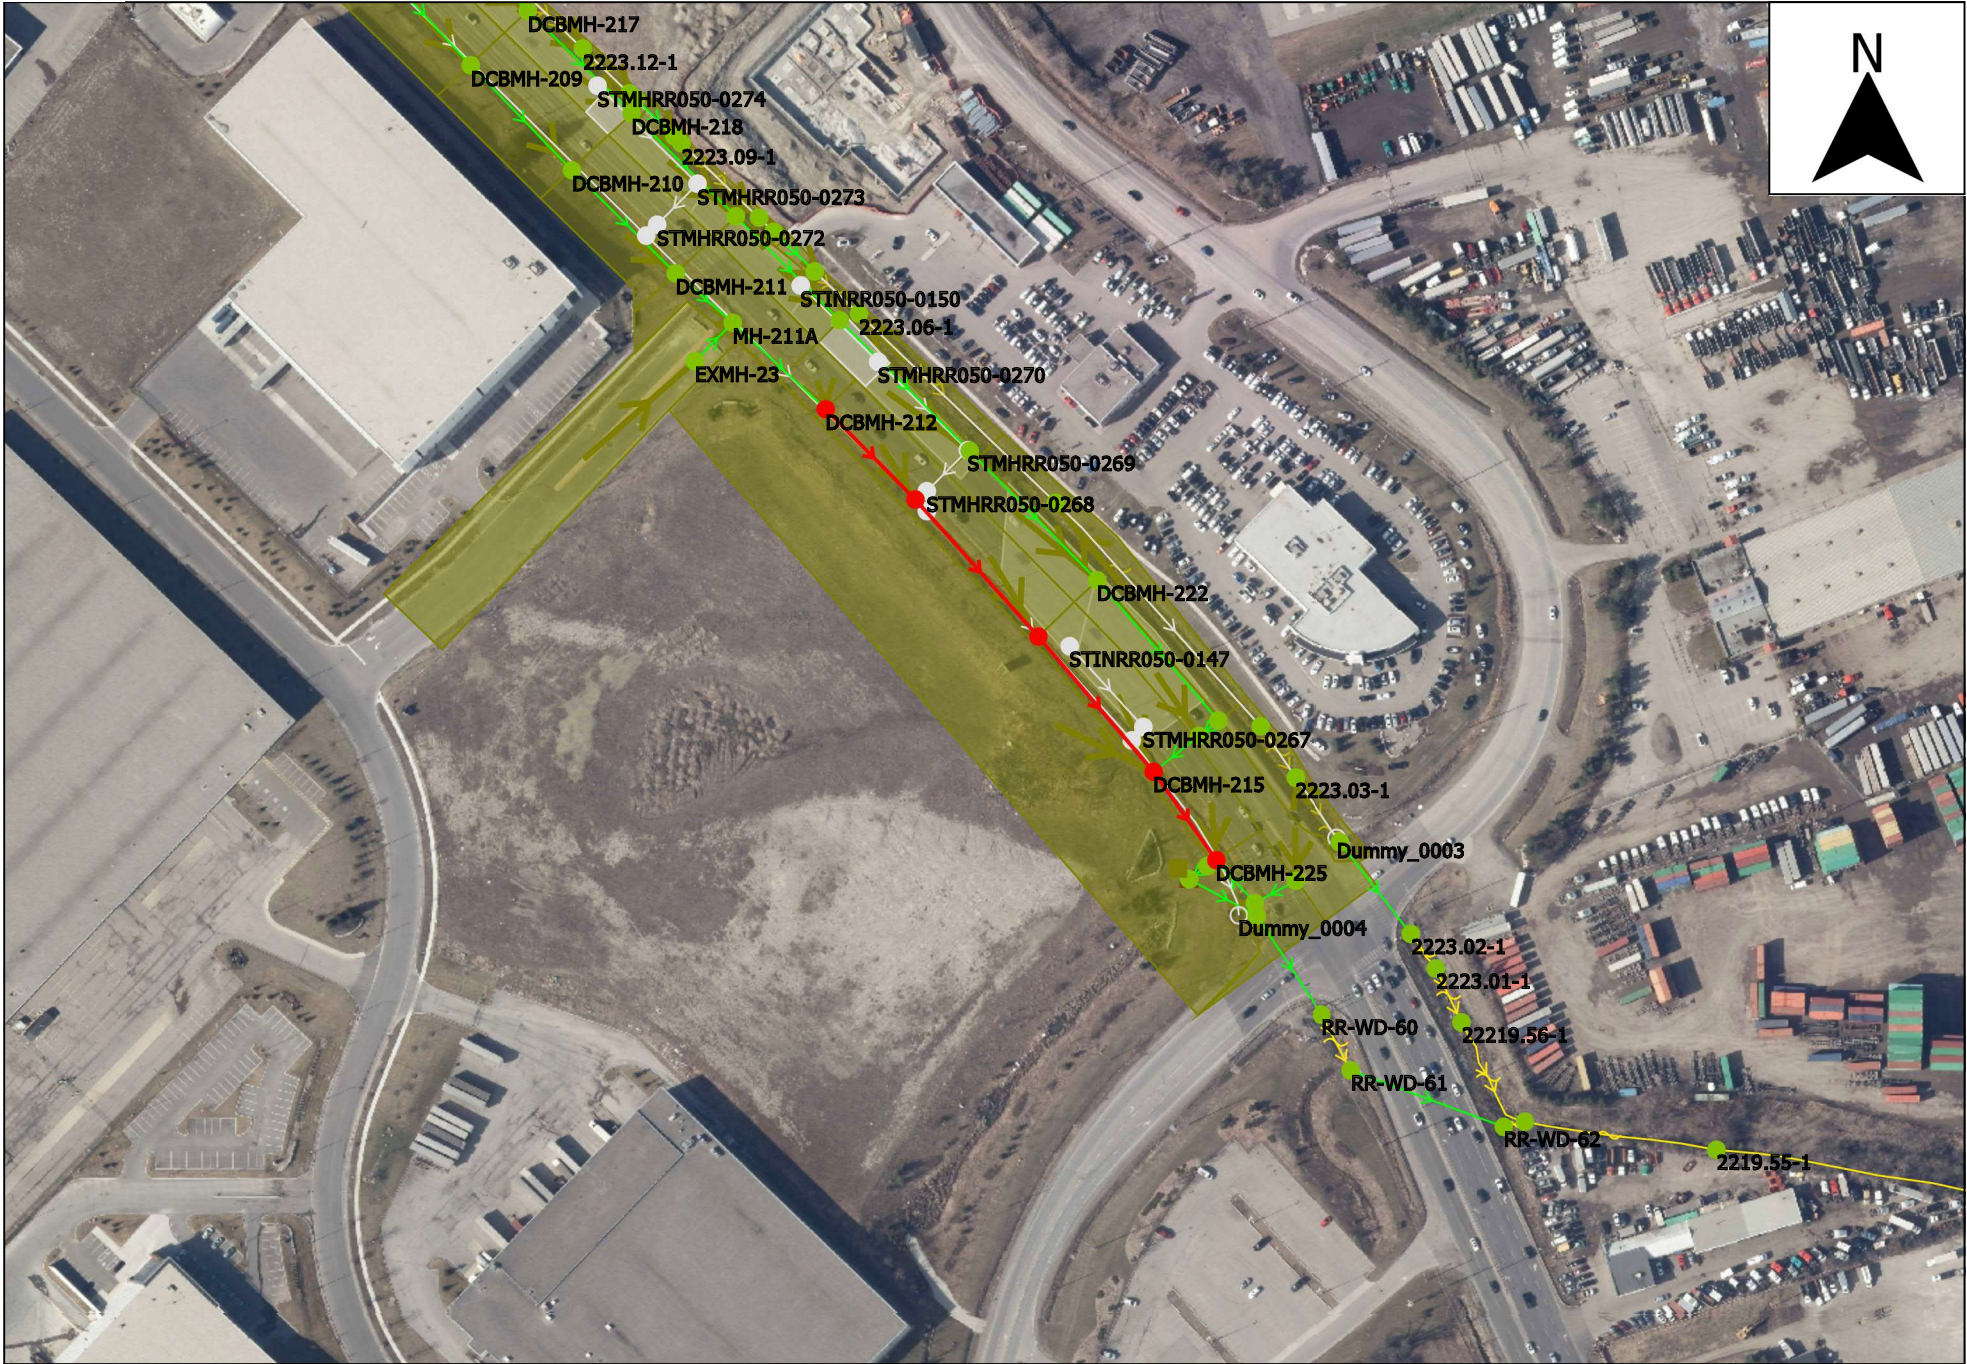
EXISTING CONDITION - 10-YEAR - WEST SIDE PROFILE 18

Link	RR-WD-55.1	
Node	RR-WD-55	RR-WD-56
Node ID	RR-WD-55	RR-WD-56
ground (m AD)	228.000	226.500
level (m AD)	226.118	224.749
expr:Freeboard	1.881989	1.751068

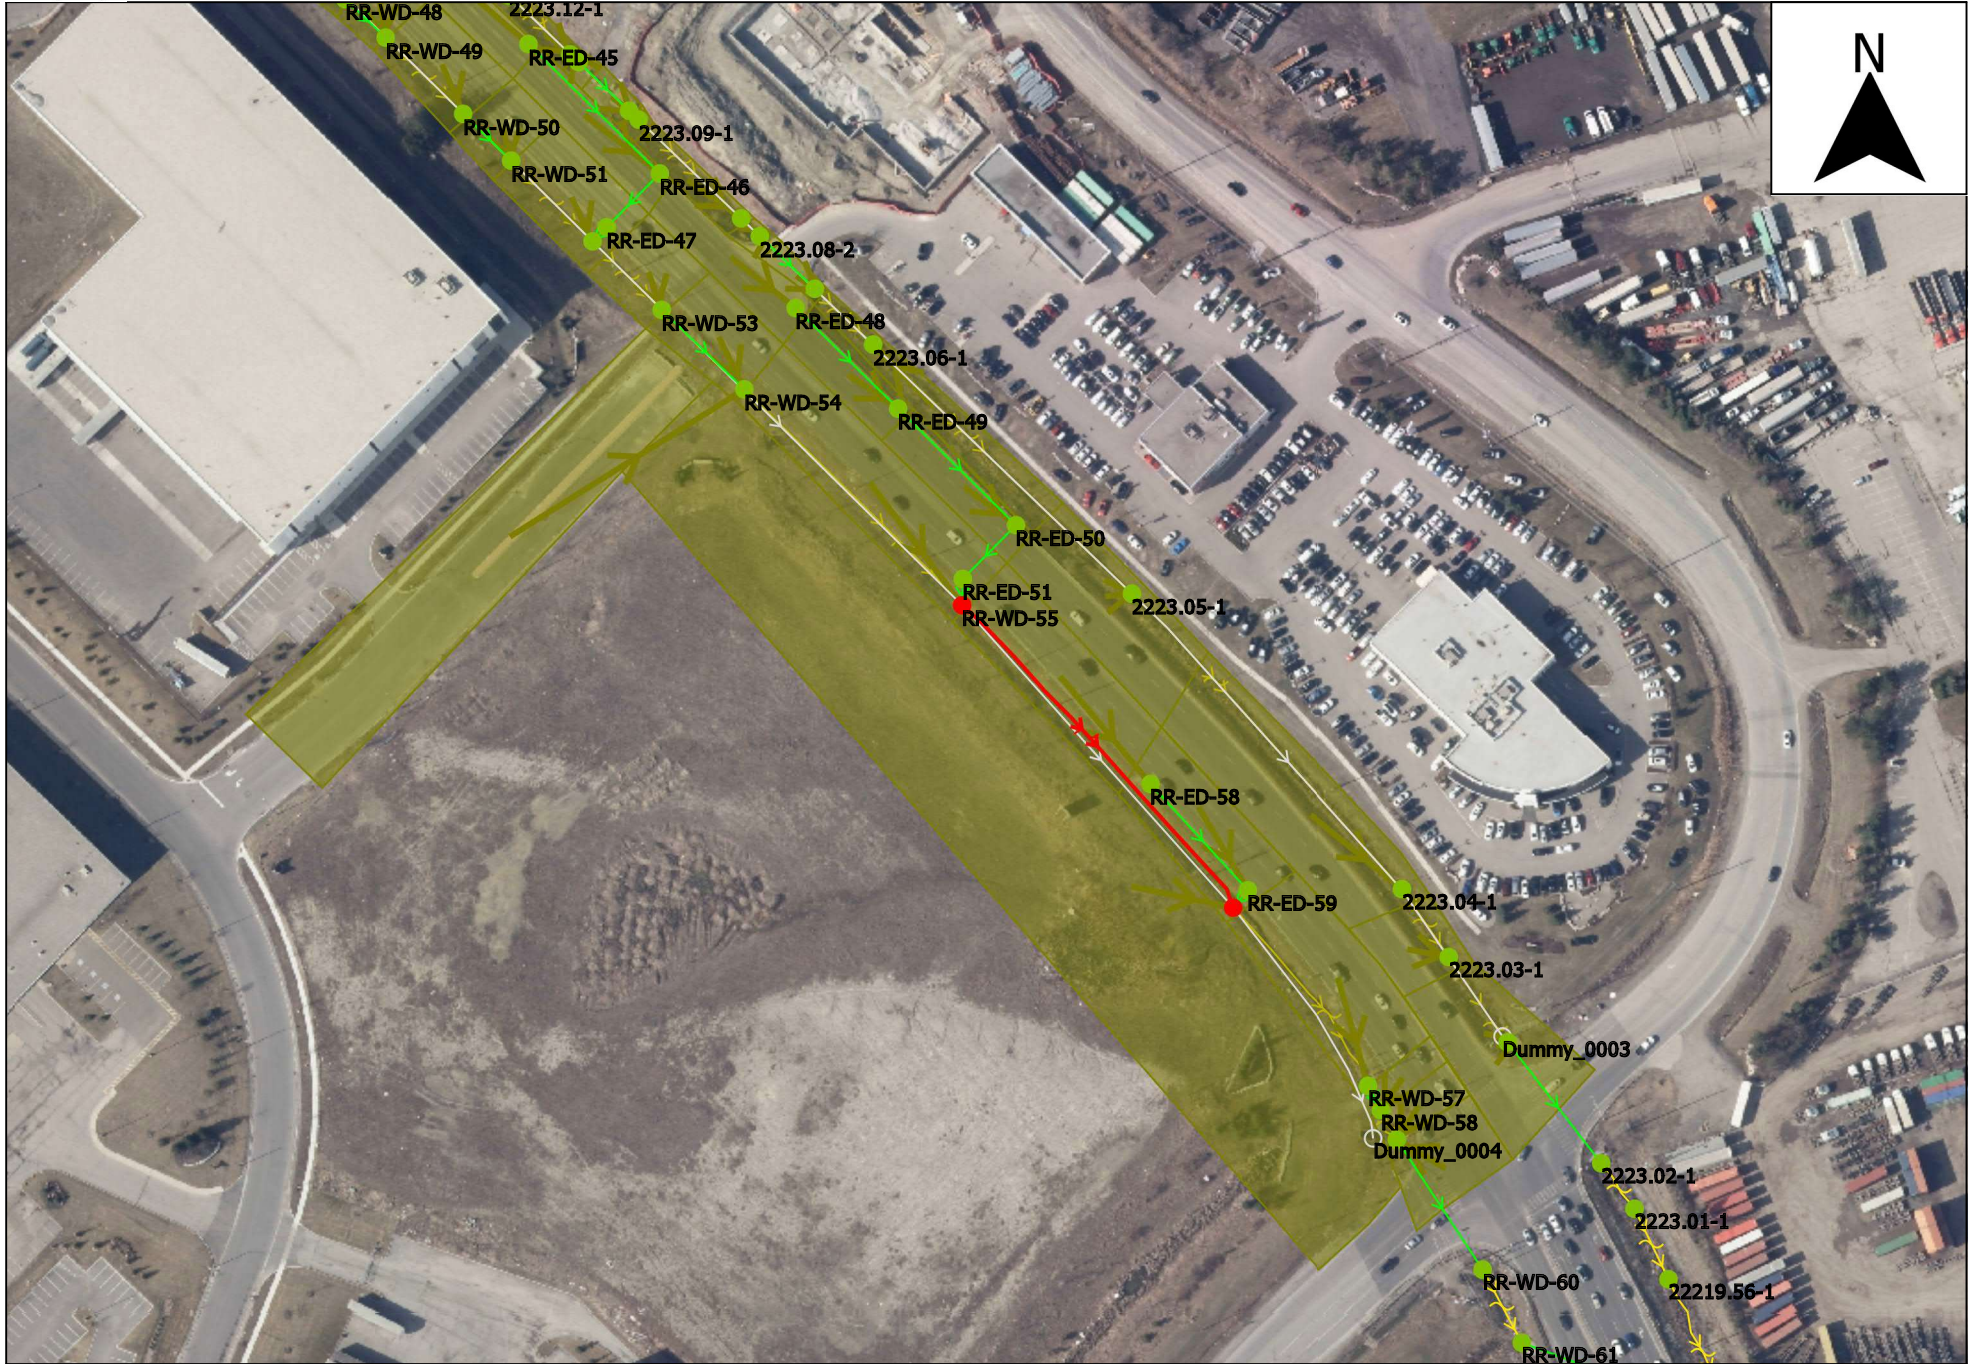
PROPOSED CONDITION - 10-YEAR - WEST SIDE PROFILE 18

Link	DCBMH-212.1		DCBMH-213.1		DCBMH-214.1		DCBMH-215.1	
US node ID	DCBMH-212		DCBMH-213		DCBMH-214		DCBMH-215	
ds node	DCBMH-213		DCBMH-214		DCBMH-215		DCBMH-225	
numbarrels	1		1		1		1	
length (m)	45.2		65.5		63.1		38.5	
Shape ID	CIRC		CIRC		CIRC		CIRC	
width (mm)	525		600		600		825	
height (mm)	525		600		600		825	
Rough type	N		N		N		N	
us inv (m AD)	225.868		225.567		225.209		224.669	
ds inv (m AD)	225.642		225.239		224.894		224.476	
grad (m/m)	0.00499		0.00501		0.00499		0.00501	
r.pfc (m3/s)	0.304		0.435		0.434		1.017	
US depth (m)	0.484		0.431		0.462		0.639	
US flow (m3/s)	0.34551		0.37451		0.41599		0.92973	
US velocity (m/s)	1.689		1.744		1.795		2.144	
Node	DCBMH-212	DCBMH-213	DCBMH-214	DCBMH-215	DCBMH-225			
Node ID	DCBMH-212	DCBMH-213	DCBMH-214	DCBMH-215	DCBMH-225			
ground (m AD)	227.843	227.493	226.924	226.418	226.085			
level (m AD)	226.365	226.005	225.680	225.321	225.122			
expr:Freeboard	1.478162	1.487949	1.243809	1.096833	0.963130

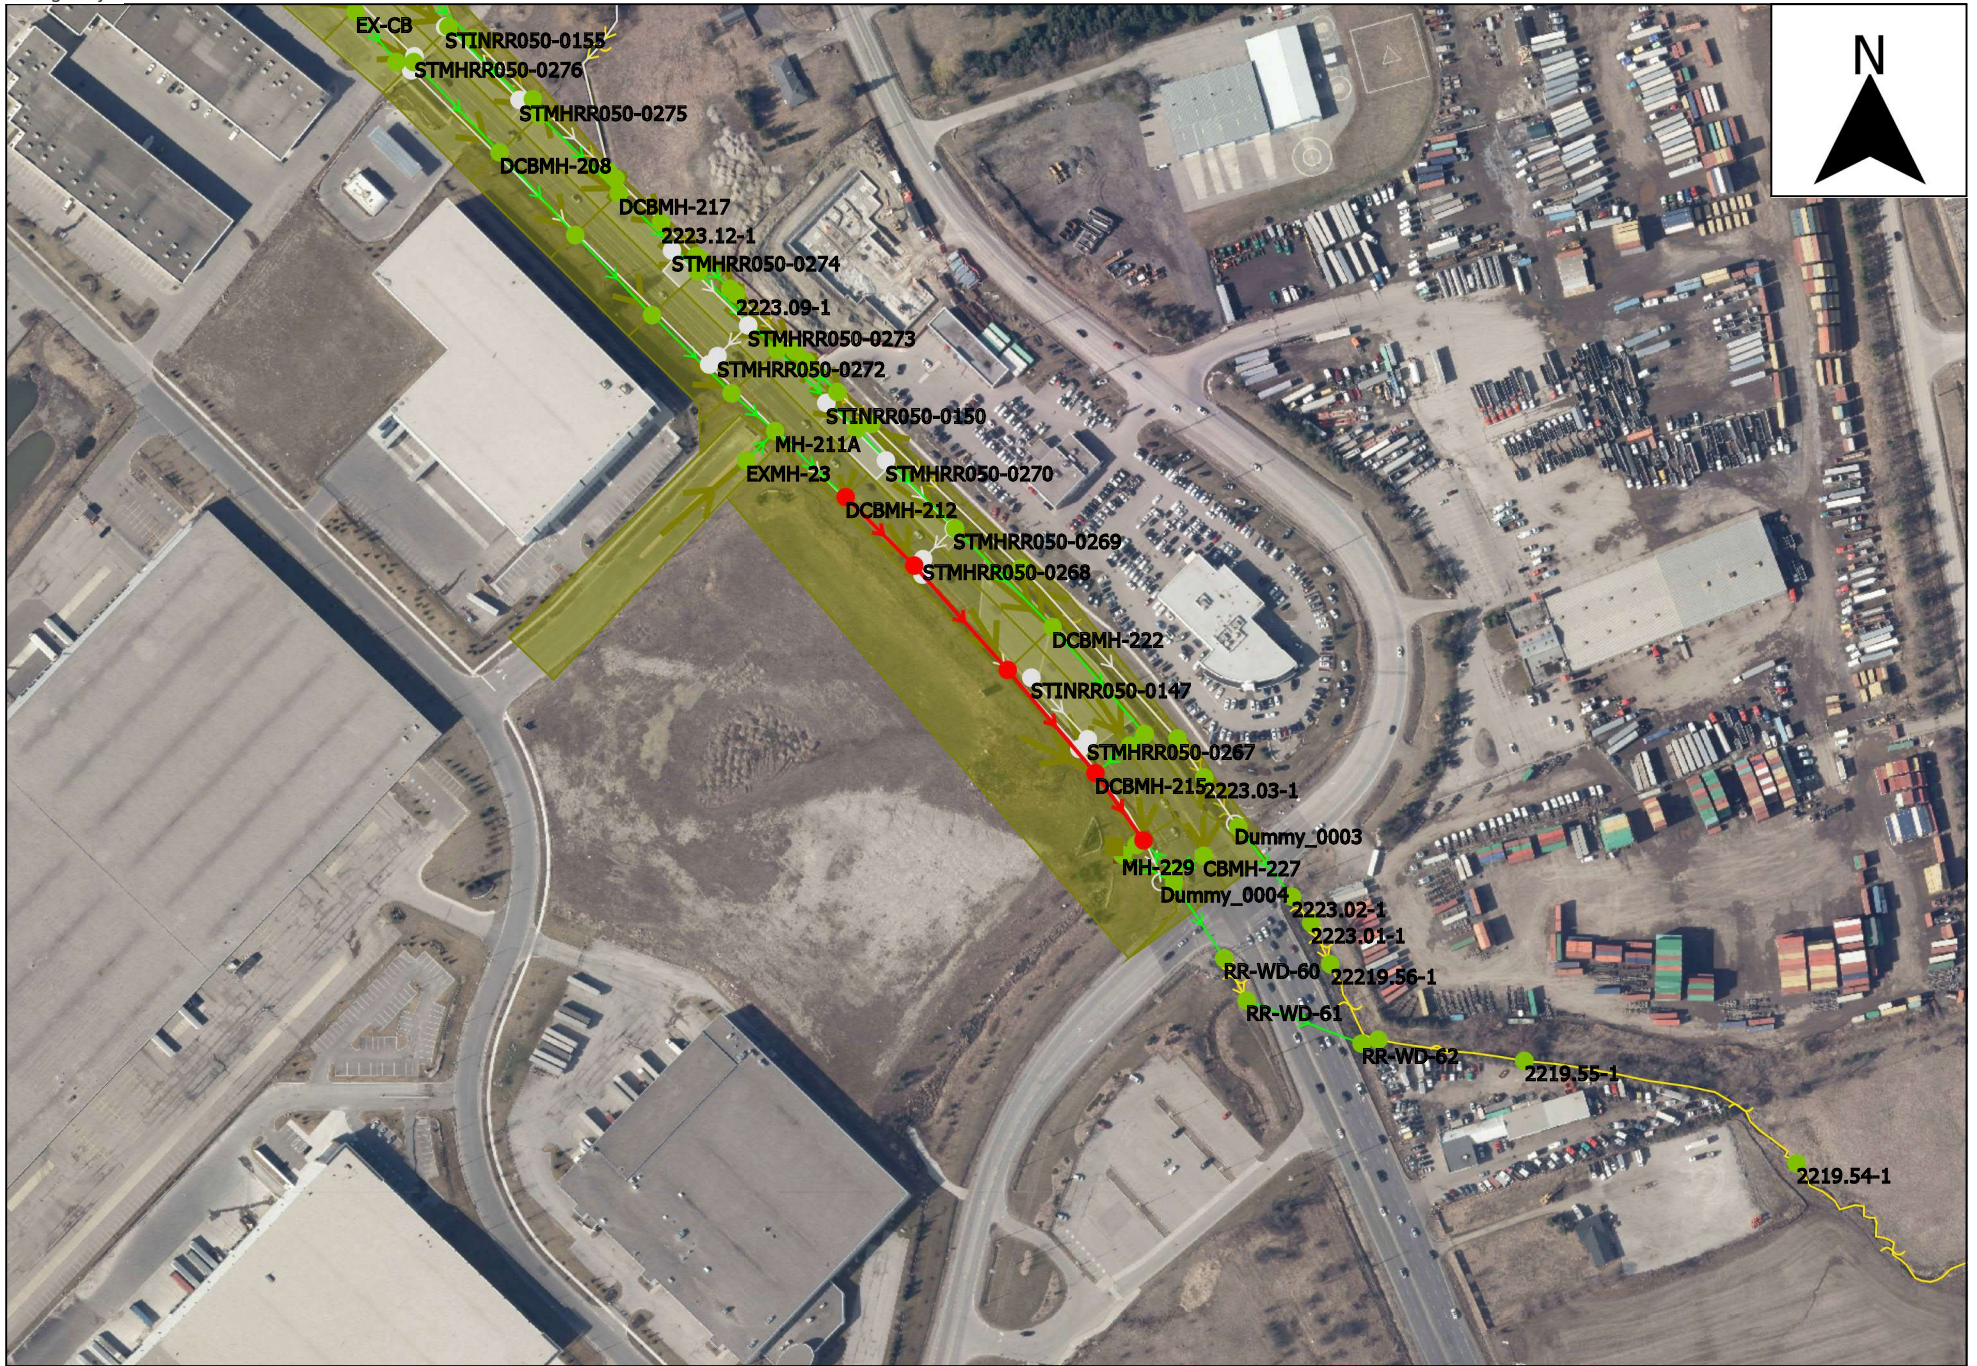
EXISTING CONDITION - 100-YEAR - WEST SIDE PROFILE 18

Link	RR-WD-55.1	
Node	RR-WD-55	RR-WD-56
Node ID	RR-WD-55	RR-WD-56
ground (m AD)	228.000	226.500
level (m AD)	226.161	224.843
expr:Freeboard	1.839249	1.657043

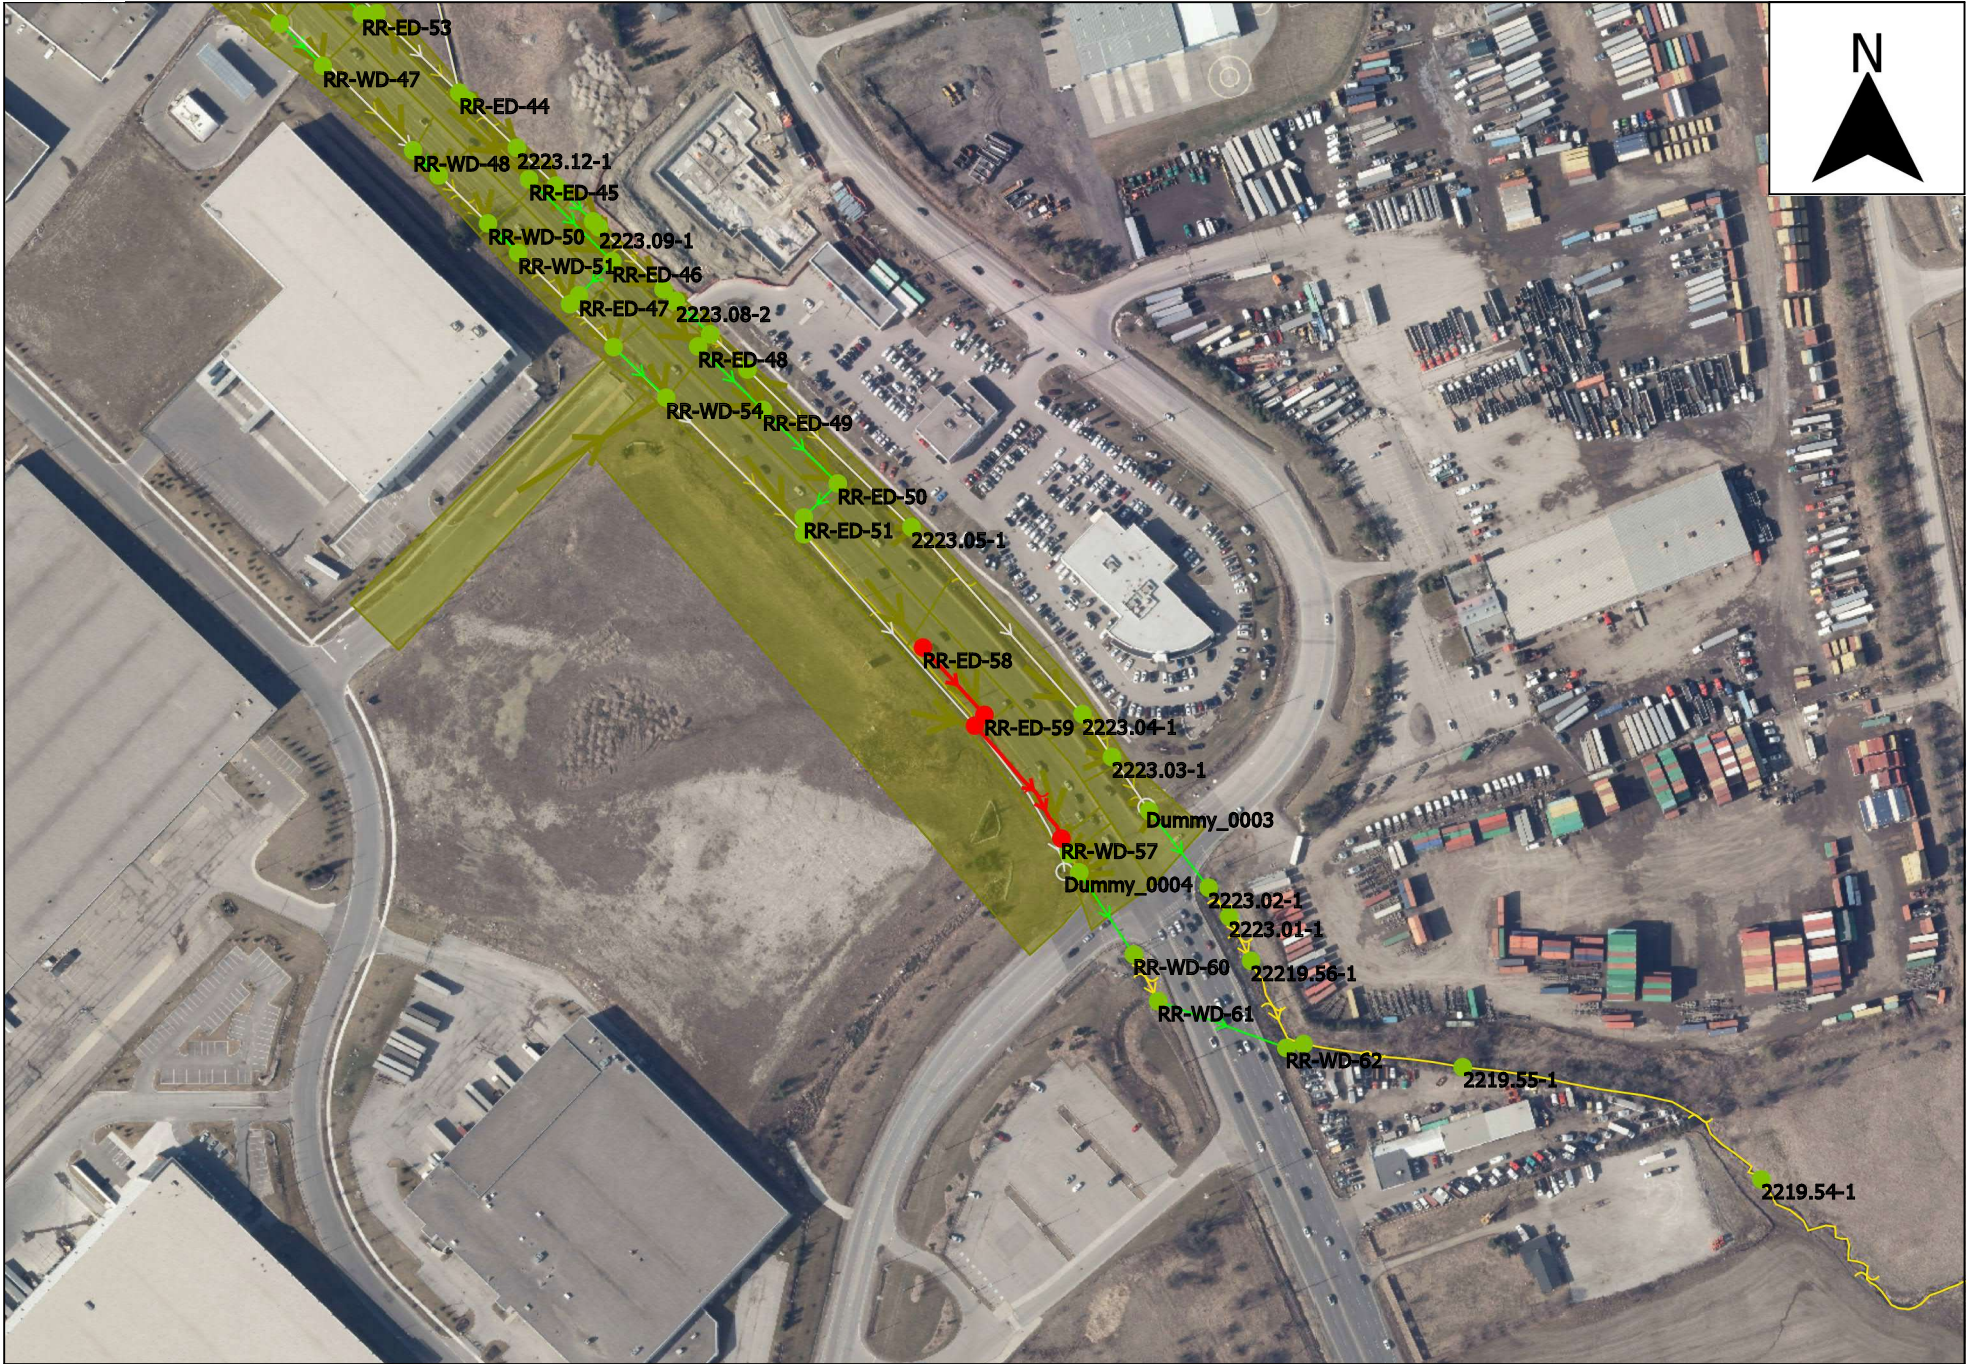
EXISTING CONDITION - 100-YEAR - WEST SIDE PROFILE 18

Link	DCBMH-212.1		DCBMH-213.1		DCBMH-214.1		DCBMH-215.1	
US node ID	DCBMH-212		DCBMH-213		DCBMH-214		DCBMH-215	
ds node	DCBMH-213		DCBMH-214		DCBMH-215		DCBMH-225	
numbarrels	1		1		1		1	
length (m)	45.2		65.5		63.1		38.5	
Shape ID	CIRC		CIRC		CIRC		CIRC	
width (mm)	525		600		600		825	
height (mm)	525		600		600		825	
Rough type	N		N		N		N	
us inv (m AD)	225.868		225.567		225.209		224.669	
ds inv (m AD)	225.642		225.239		224.894		224.476	
grad (m/m)	0.00499		0.00501		0.00499		0.00501	
r.pfc (m3/s)	0.304		0.435		0.434		1.017	
US depth (m)	1.670		1.359		1.190		1.074	
US flow (m3/s)	0.49755		0.53066		0.58580		1.37776	
US velocity (m/s)	2.117		1.826		1.957		2.472	
Node	DCBMH-212	DCBMH-213	DCBMH-214	DCBMH-215	DCBMH-225			
Node ID	DCBMH-212	DCBMH-213	DCBMH-214	DCBMH-215	DCBMH-225			
ground (m AD)	227.843	227.493	226.924	226.418	226.085			
level (m AD)	227.571	226.949	226.436	225.816	225.385			
expr:Freeboard	0.272077	0.543873	0.487812	0.602067	0.700373

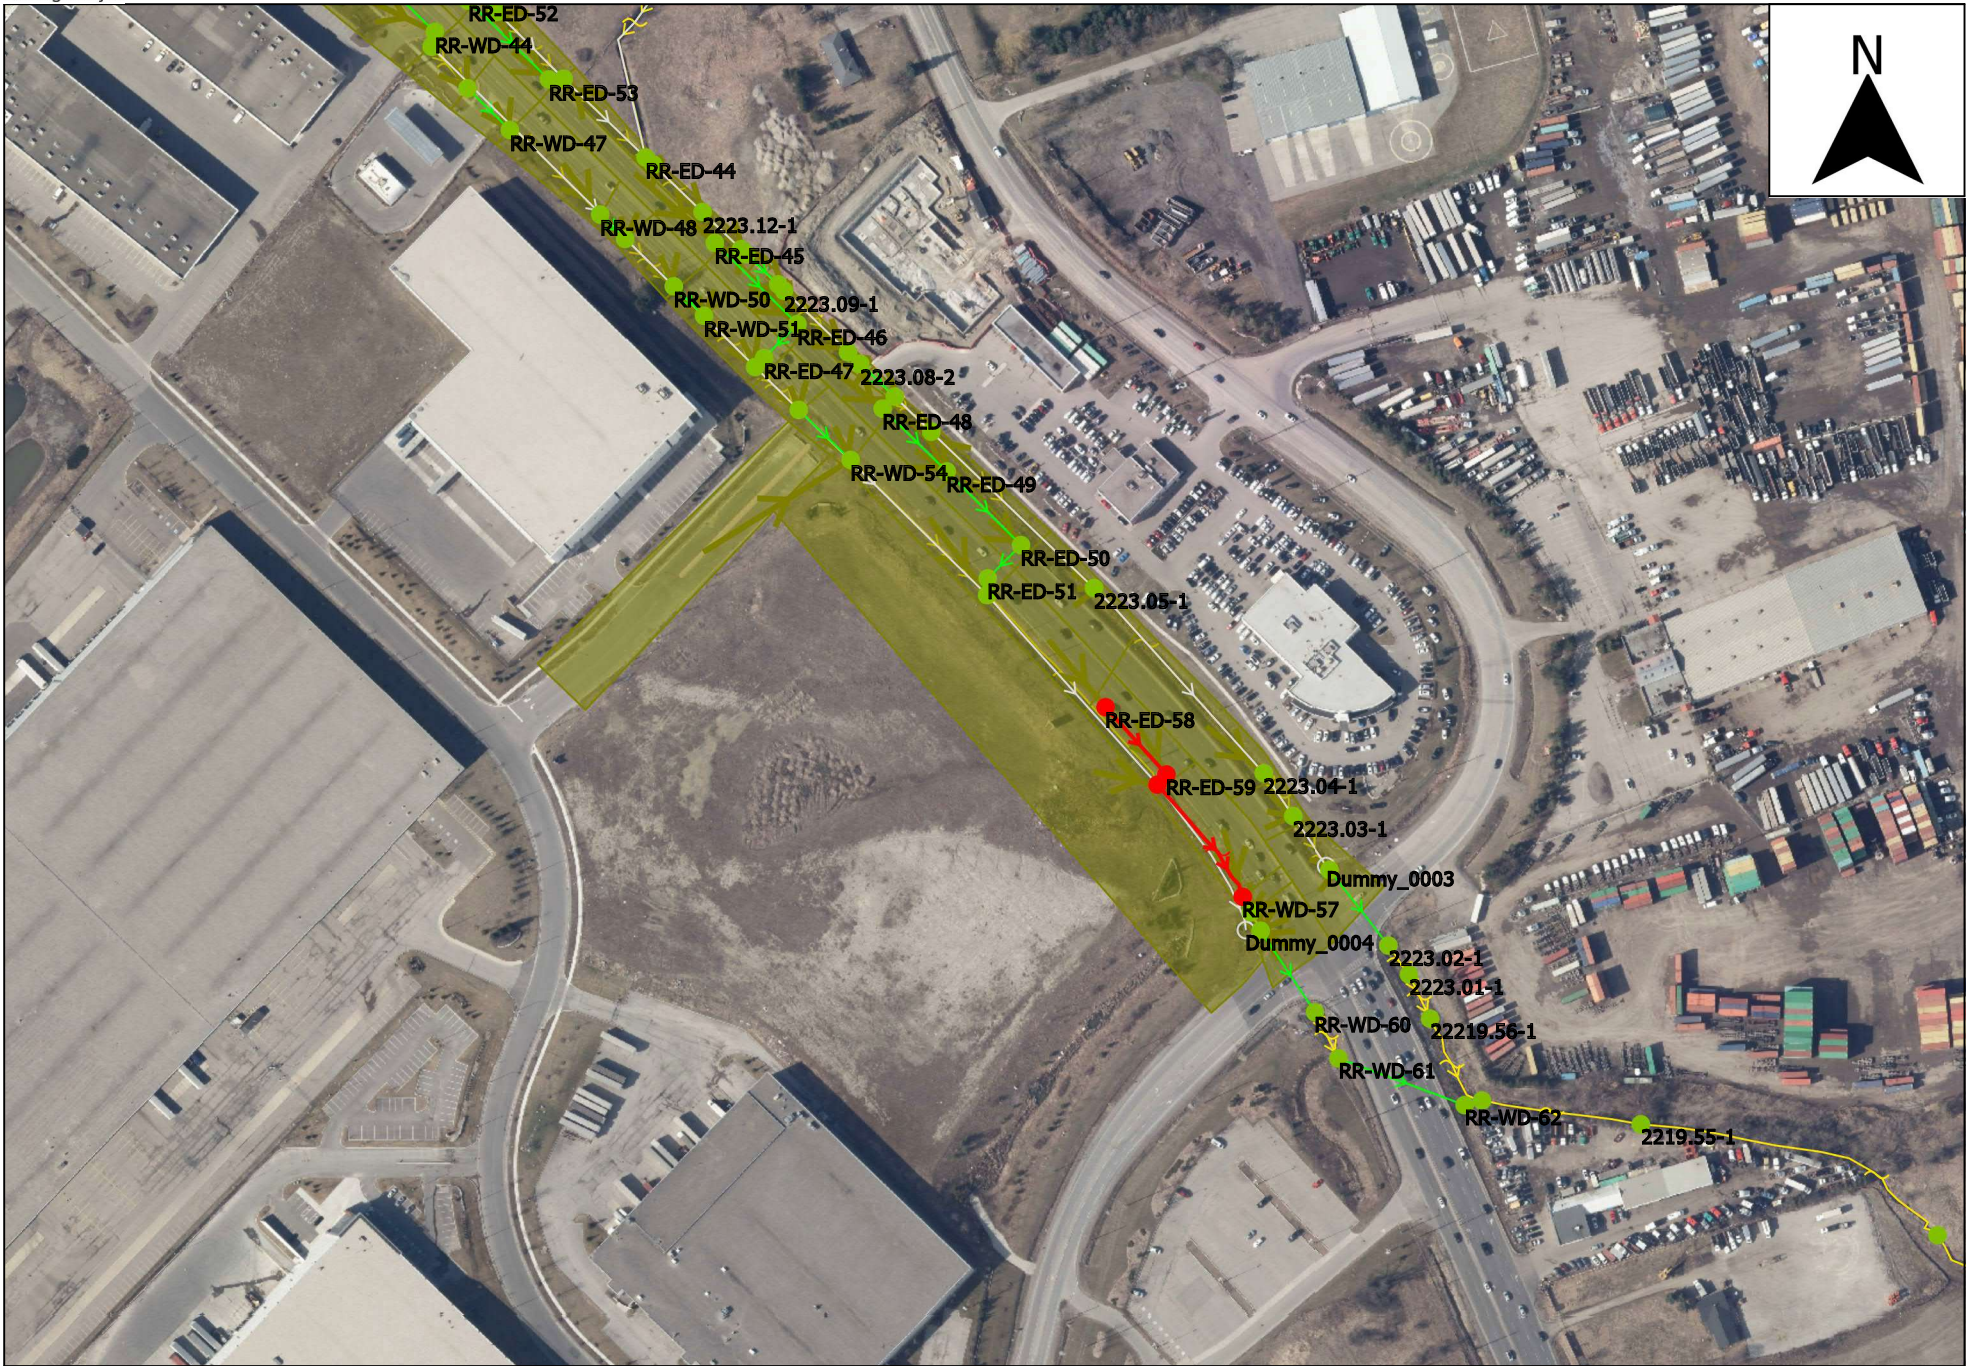
PROPOSED CONDITION - 10-YEAR - WEST SIDE PROFILE 19

Link	CBMH-227.1		DCBMH-228.1		-	OGS-20.1		MH-229.1	
US node ID	CBMH-227		DCBMH-228		-	OGS-20		MH-229	
ds node	DCBMH-228		DCBMH-225		OGS-20	MH-229		Chamber#19	
numbarrels	1		1		1	1		1	
length (m)	16.7		20.7		3.7	7.9		5.3	
Shape ID	CIRC		CIRC		CIRC	CIRC		CIRC	
width (mm)	300		300		825	825		450	
height (mm)	300		300		825	825		450	
Rough type	N		N		N	N		N	
us inv (m AD)	224.768		224.624		224.320	224.224		224.200	
ds inv (m AD)	224.684		224.520		224.299	224.202		224.017	
grad (m/m)	0.00504		0.00503		0.00561	0.00278		0.03442	
r.pfc (m3/s)	0.069		0.069		1.075	0.757		0.529	
US depth (m)	0.485		0.595		0.784	0.838		0.817	
US flow (m3/s)	0.03865		0.07307		1.02041	1.01905		0.18723	
US velocity (m/s)	0.962		1.112		2.015	1.883		1.716	
Node	CBMH-227	DCBMH-228	DCBMH-225	OGS-20	MH-229	-			
Node ID	CBMH-227	DCBMH-228	DCBMH-225	OGS-20	MH-229	-			
ground (m AD)	226.344	226.019	226.085	226.293	226.218	-			
level (m AD)	225.256	225.227	225.122	225.083	225.017	-

expr:Freeboard	1.087942	0.792438	0.963130	1.210007	1.201200	-

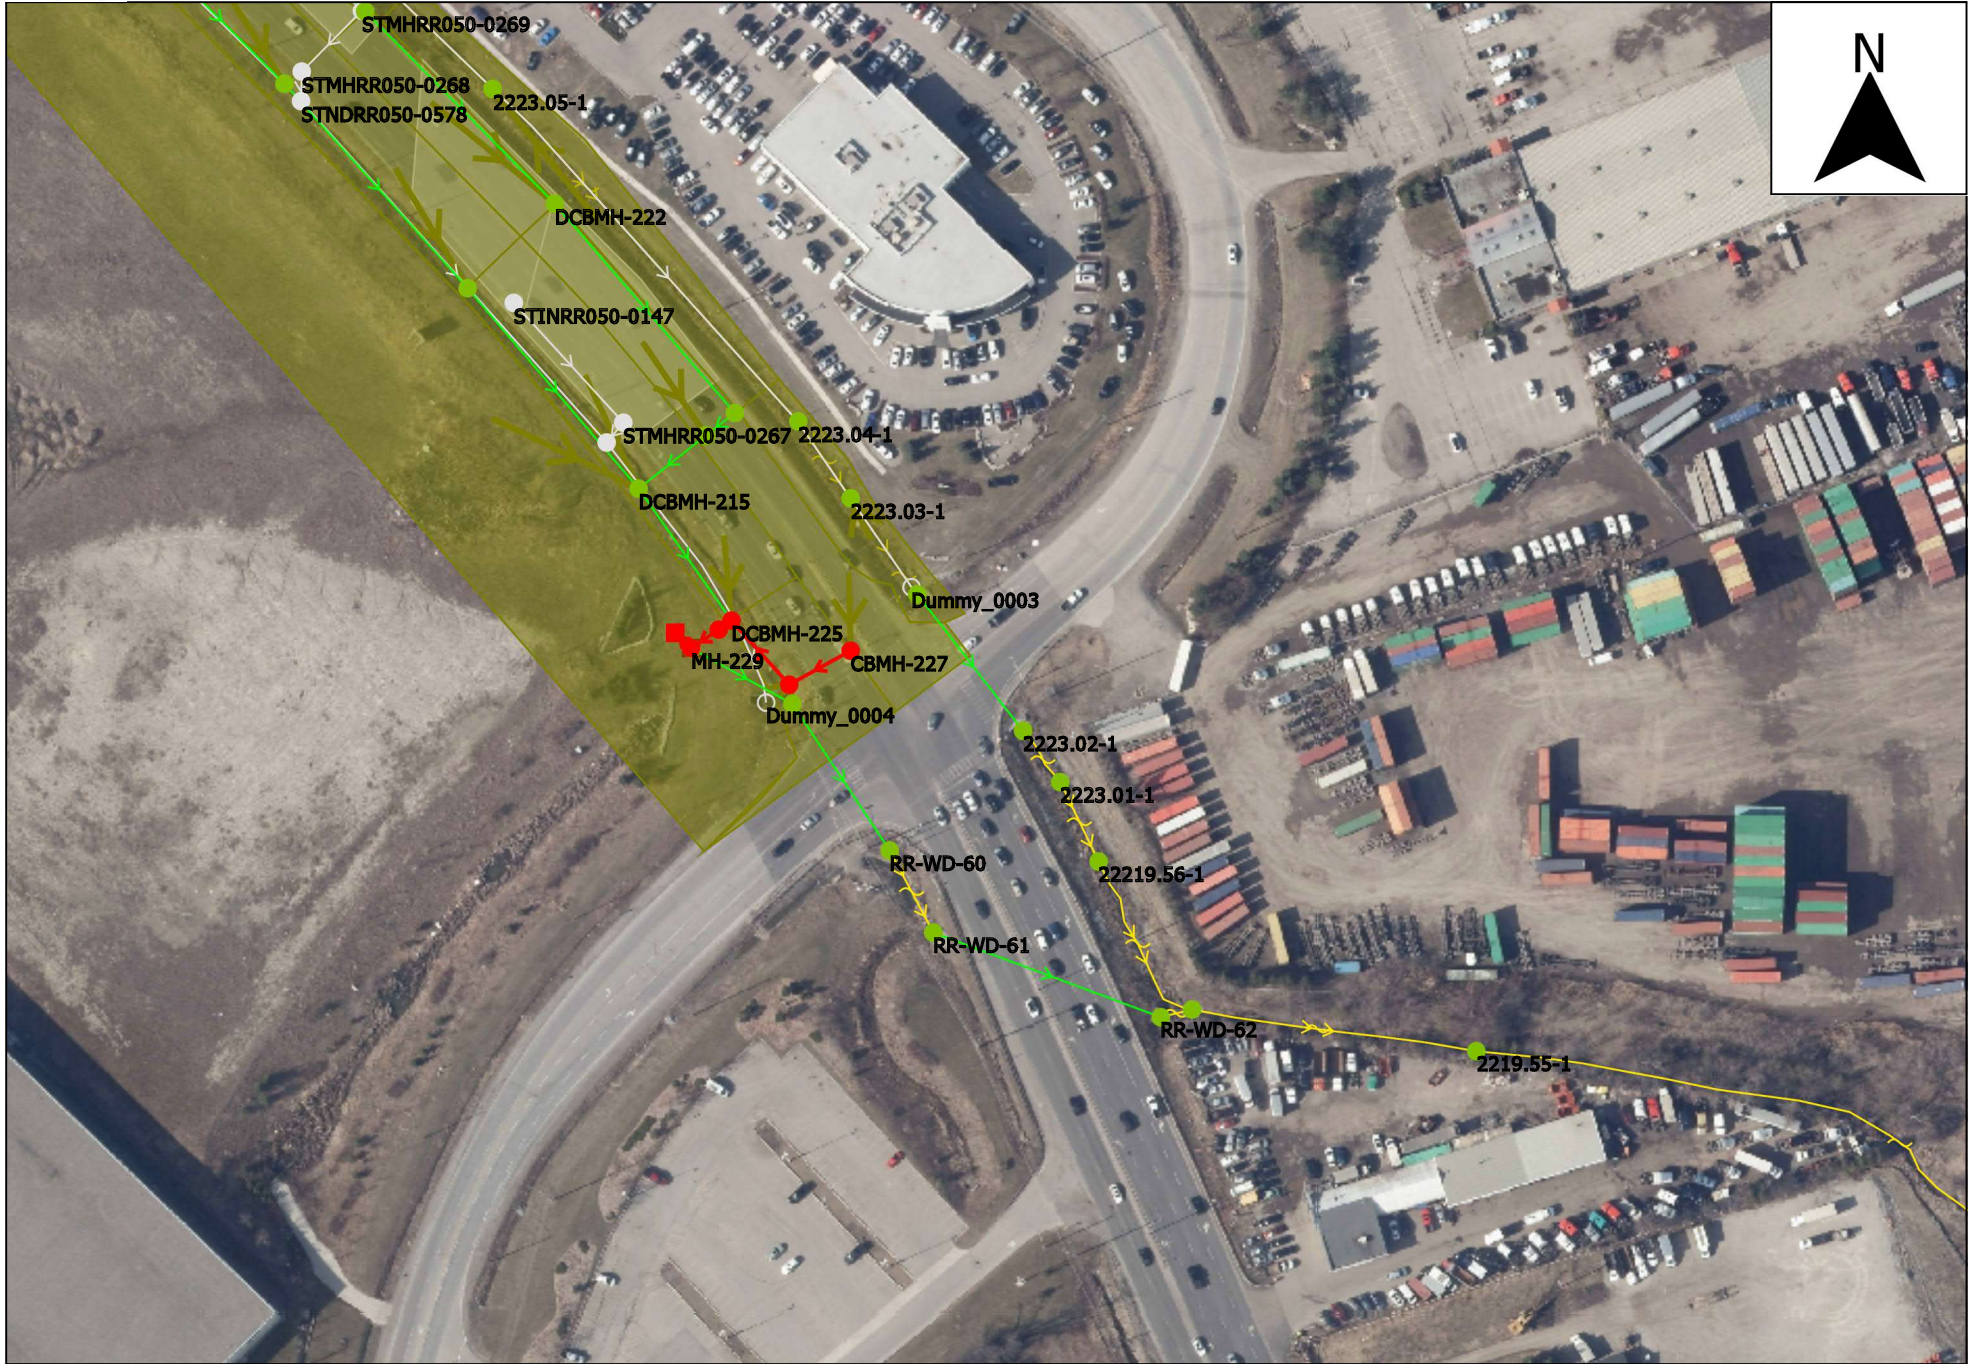
EXISTING CONDITION - 100-YEAR - WEST SIDE PROFILE 19

Link	RR-ED-58.1		-	RR-WD-56.1
US node ID	RR-ED-58	RR-ED-59	-	RR-WD-56
ds node	RR-ED-58	RR-ED-59	-	RR-WD-57
numbarrels	1	1	1	1
length (m)	38.9	6.1		
Shape ID	CIRC	CIRC		West Side Ditch-8 (Downstream of George Bolton Pkwy)
width (mm)	300	300		
height (mm)	300	300		
Rough type	N	N		
us inv (m AD)	224.648	224.330		224.280
ds inv (m AD)	224.330	224.280		224.000
grad (m/m)	0.00818	0.00818		
r.pfc (m3/s)	0.087	0.087		10.653
US depth (m)	0.694	0.629		0.563
US flow (m3/s)	0.07227	0.13442		1.02332
US velocity (m/s)	1.042	1.789		0.999
Node	RR-ED-58	RR-ED-59	RR-WD-56	RR-WD-57
Node ID	RR-ED-58	RR-ED-59	RR-WD-56	RR-WD-57
ground (m AD)	226.178	225.607	226.500	226.000
level (m AD)	225.349	225.117	224.843	224.313
expr:Freeboard	0.829056	0.489868	1.657043	1.686722

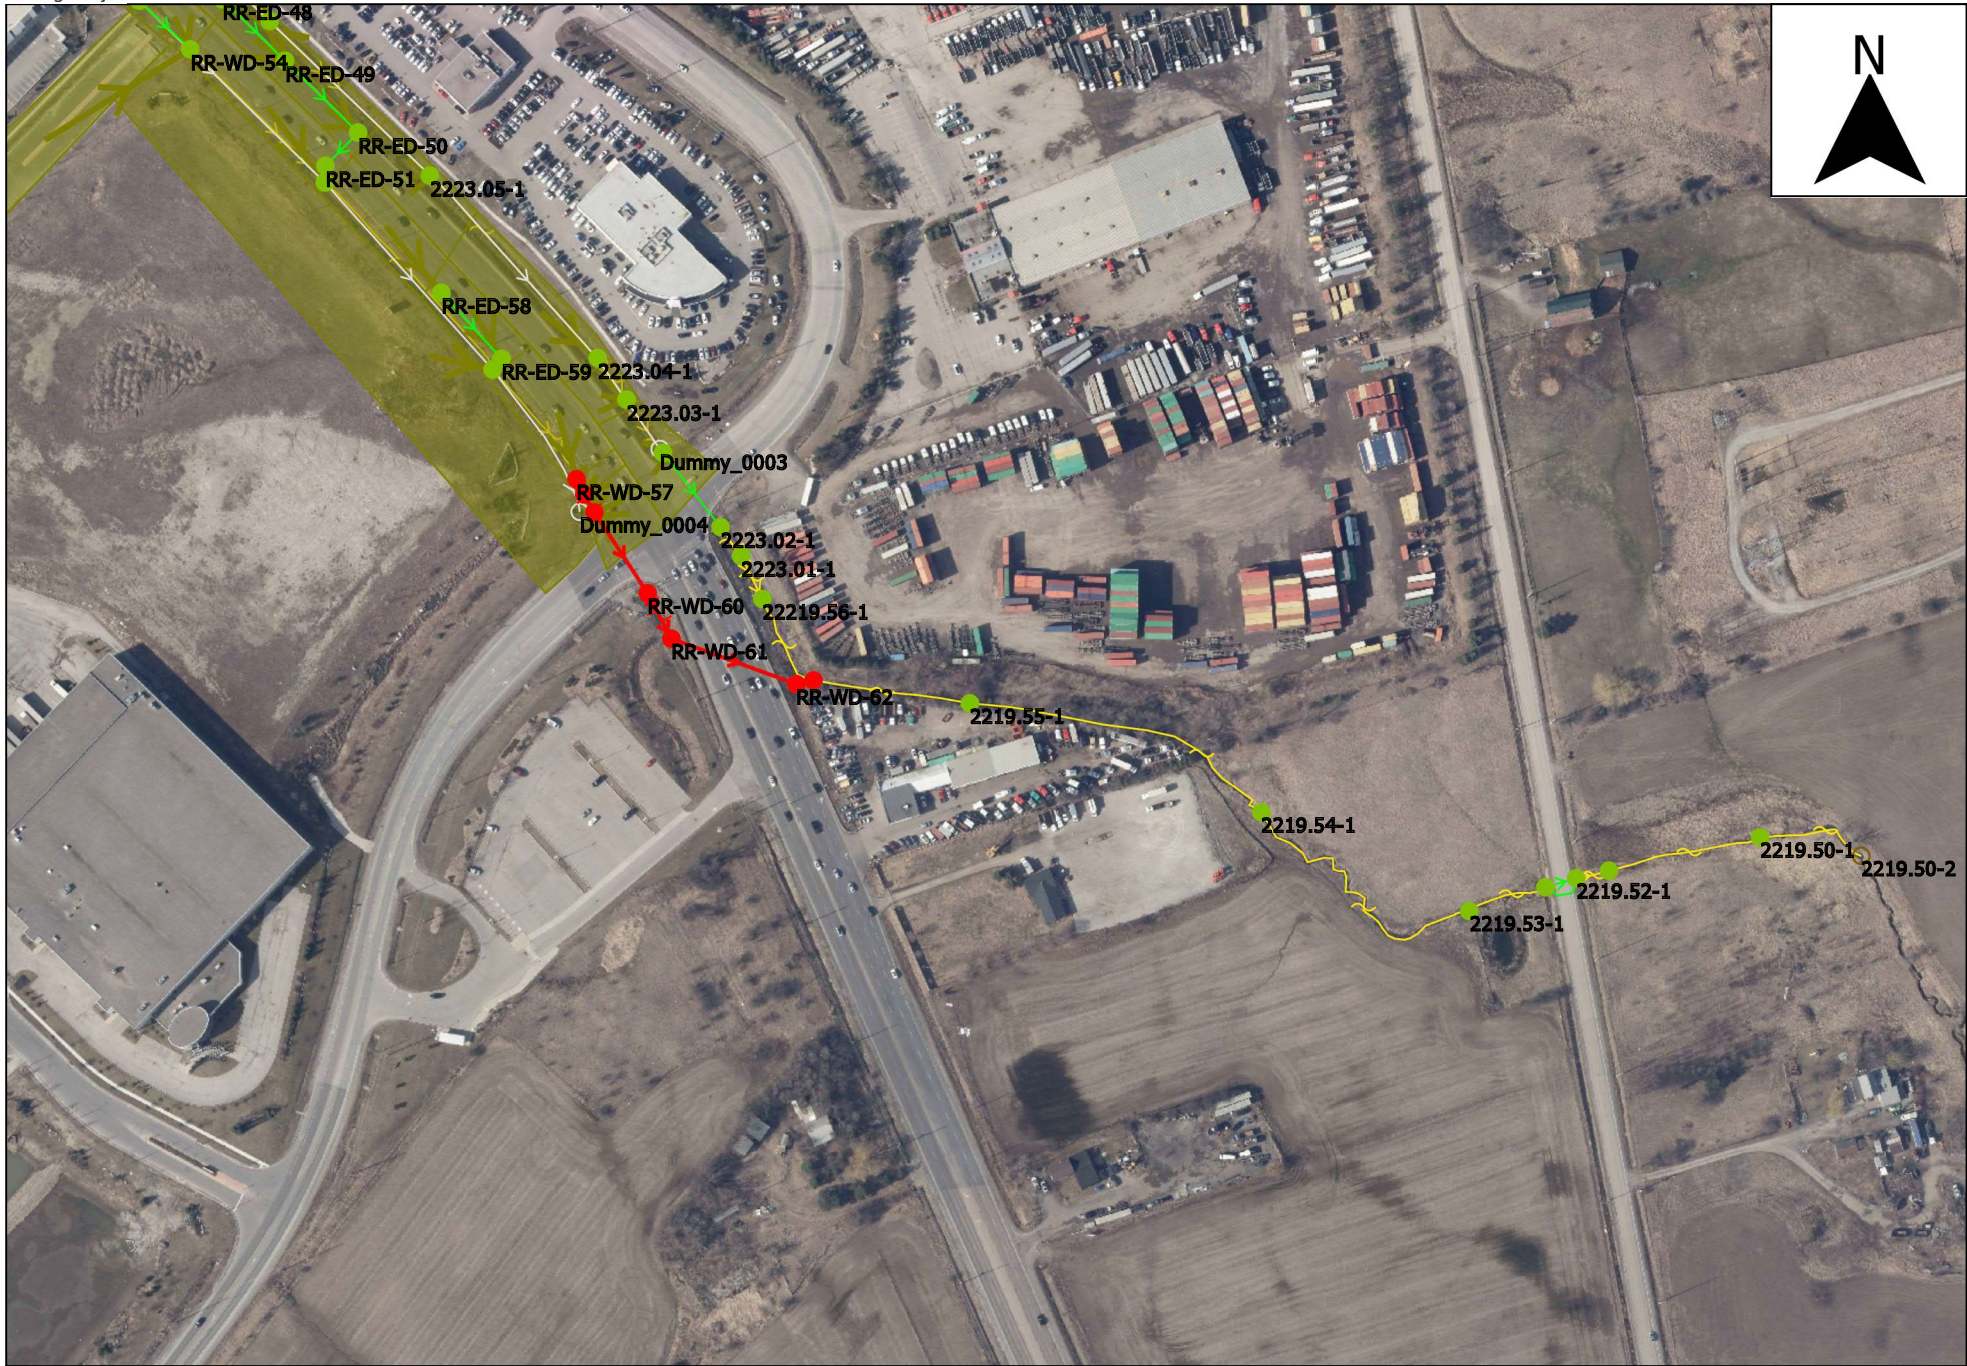
EXISTING CONDITION - 100-YEAR - WEST SIDE PROFILE 19

Link	CBMH-227.1		DCBMH-228.1		-	OGS-20.1		MH-229.1	
US node ID	CBMH-227		DCBMH-228		-	OGS-20		MH-229	
ds node	DCBMH-228		DCBMH-225		OGS-20	MH-229		Chamber#19	
numbarrels	1		1		1	1		1	
length (m)	16.7		20.7		3.7	7.9		5.3	
Shape ID	CIRC		CIRC		CIRC	CIRC		CIRC	
width (mm)	300		300		825	825		450	
height (mm)	300		300		825	825		450	
Rough type	N		N		N	N		N	
us inv (m AD)	224.768		224.624		224.320	224.224		224.200	
ds inv (m AD)	224.684		224.520		224.299	224.202		224.017	
grad (m/m)	0.00504		0.00503		0.00561	0.00278		0.03442	
r.pfc (m3/s)	0.069		0.069		1.075	0.757		0.529	
US depth (m)	0.952		1.019		0.986	0.958		0.883	
US flow (m3/s)	0.06202		0.11367		1.51798	1.51702		0.17335	
US velocity (m/s)	0.970		1.470		2.731	2.732		1.658	
Node	CBMH-227		DCBMH-228		DCBMH-225	OGS-20		MH-229	
Node ID	CBMH-227		DCBMH-228		DCBMH-225	OGS-20		MH-229	
ground (m AD)	226.344		226.019		226.085	226.293		226.218	
level (m AD)	225.724		225.658		225.385	225.258		225.083

expr:Freeboard	0.619879		0.361178		0.700373	1.035477		1.134519

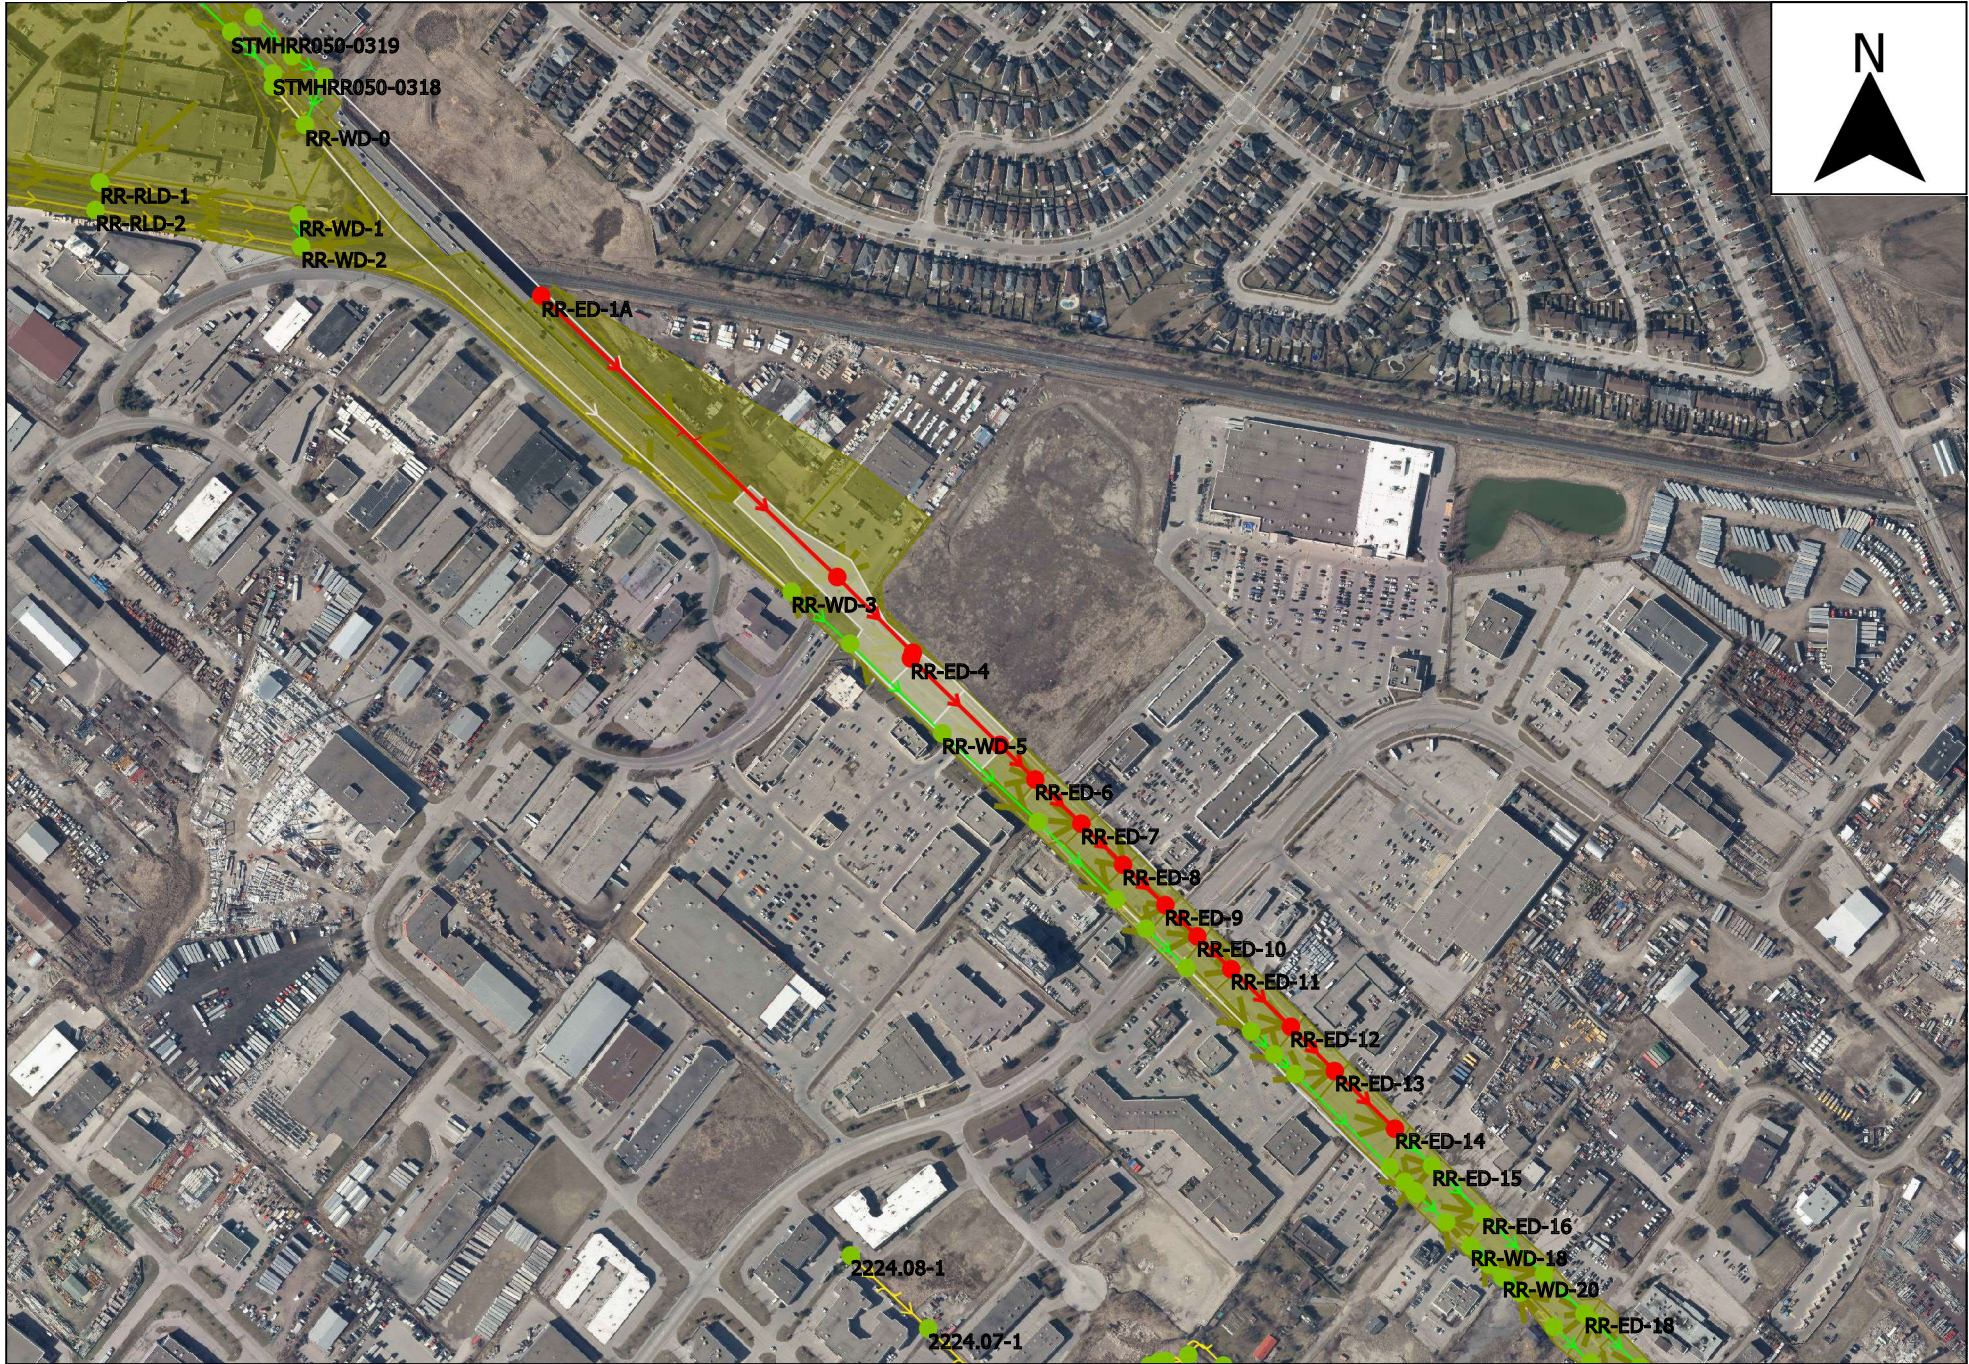
FIGURE NO. 21A

EXISTING CONDITION - 10-YEAR - EAST SIDE PLAN 1
