STORMWATER MANAGEMENT REPORT

ENVIRONMENTAL ASSESSMENT (EA) AND PRELIMINARY DESIGN FOR DRAINAGE IMPROVEMENTS OF HIGHWAY 50 FROM MAYFIELD ROAD TO HEALEY ROAD

December 1, 2022

Region of Peel

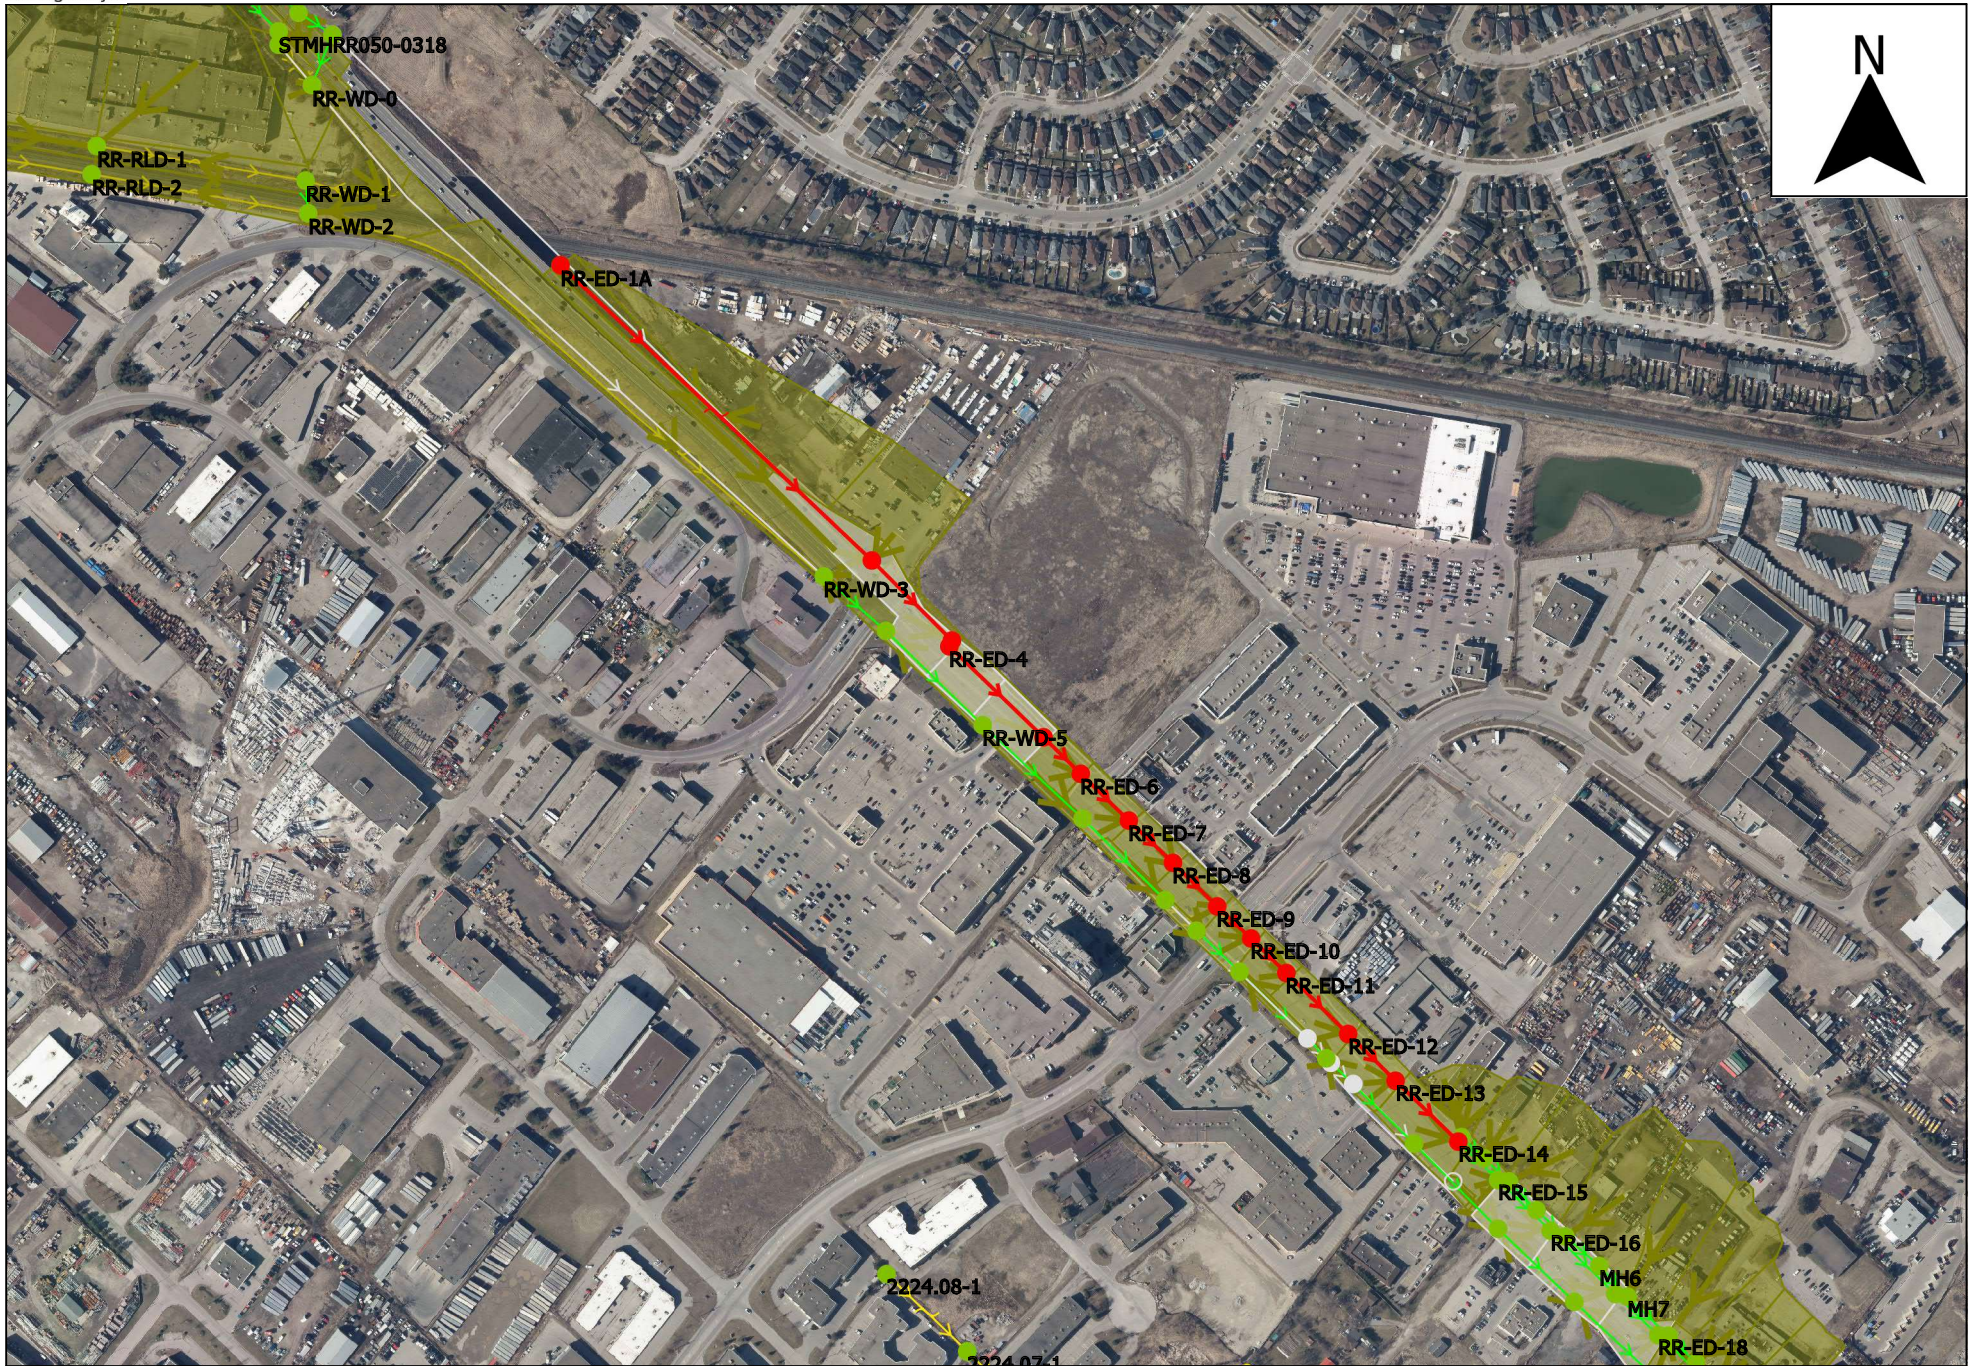
FIGURE NO. 21C

PROPOSED CONDITION - 10-YEAR - EAST SIDE PLAN 1

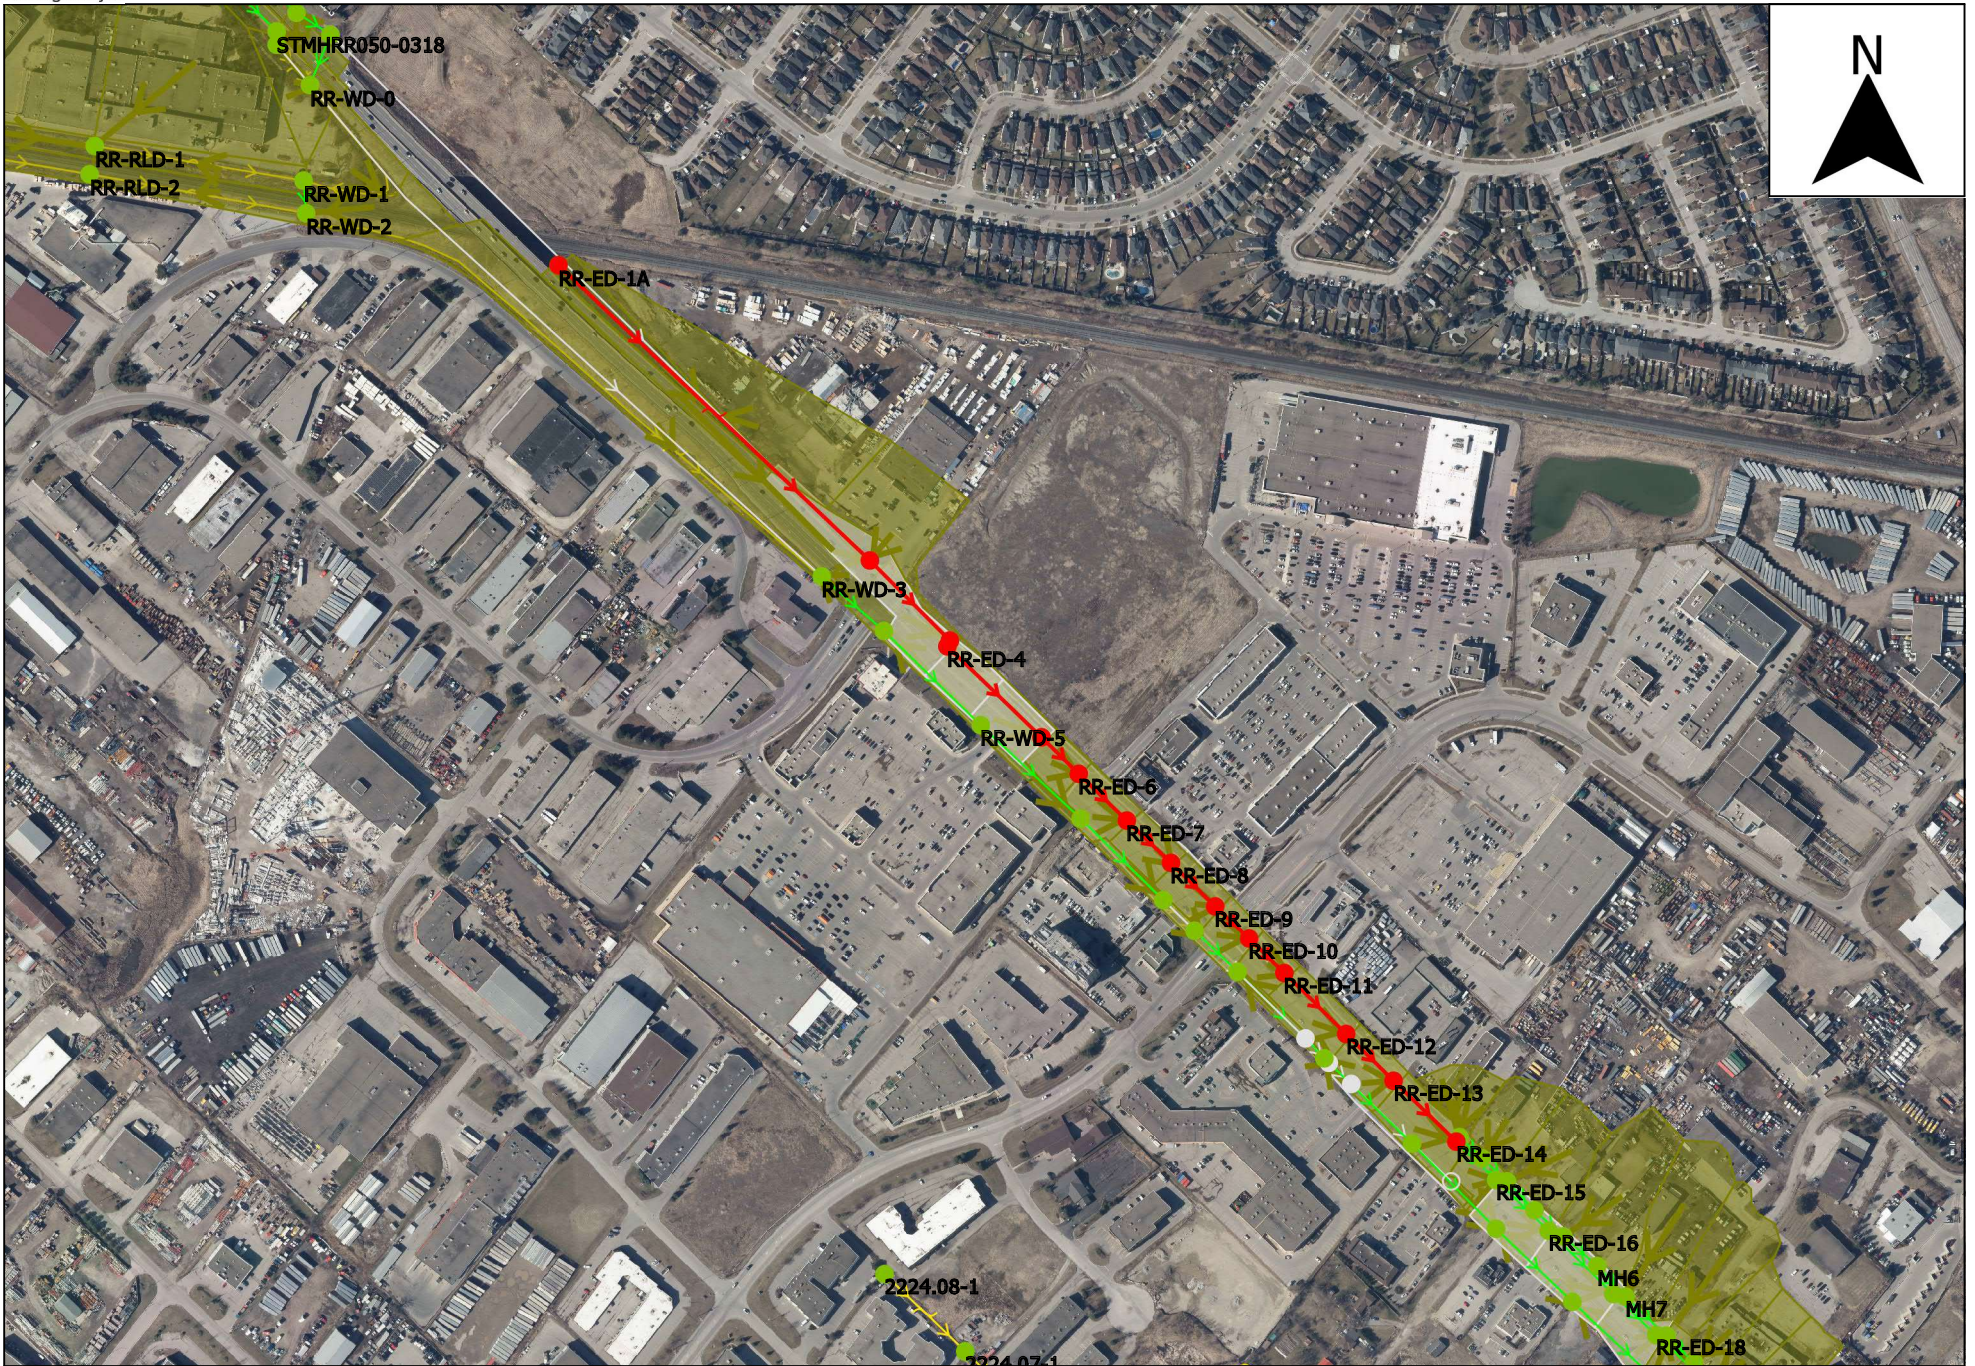
FIGURE NO. 21G

PROPOSED CONDITION - 100-YEAR - EAST SIDE PLAN 1

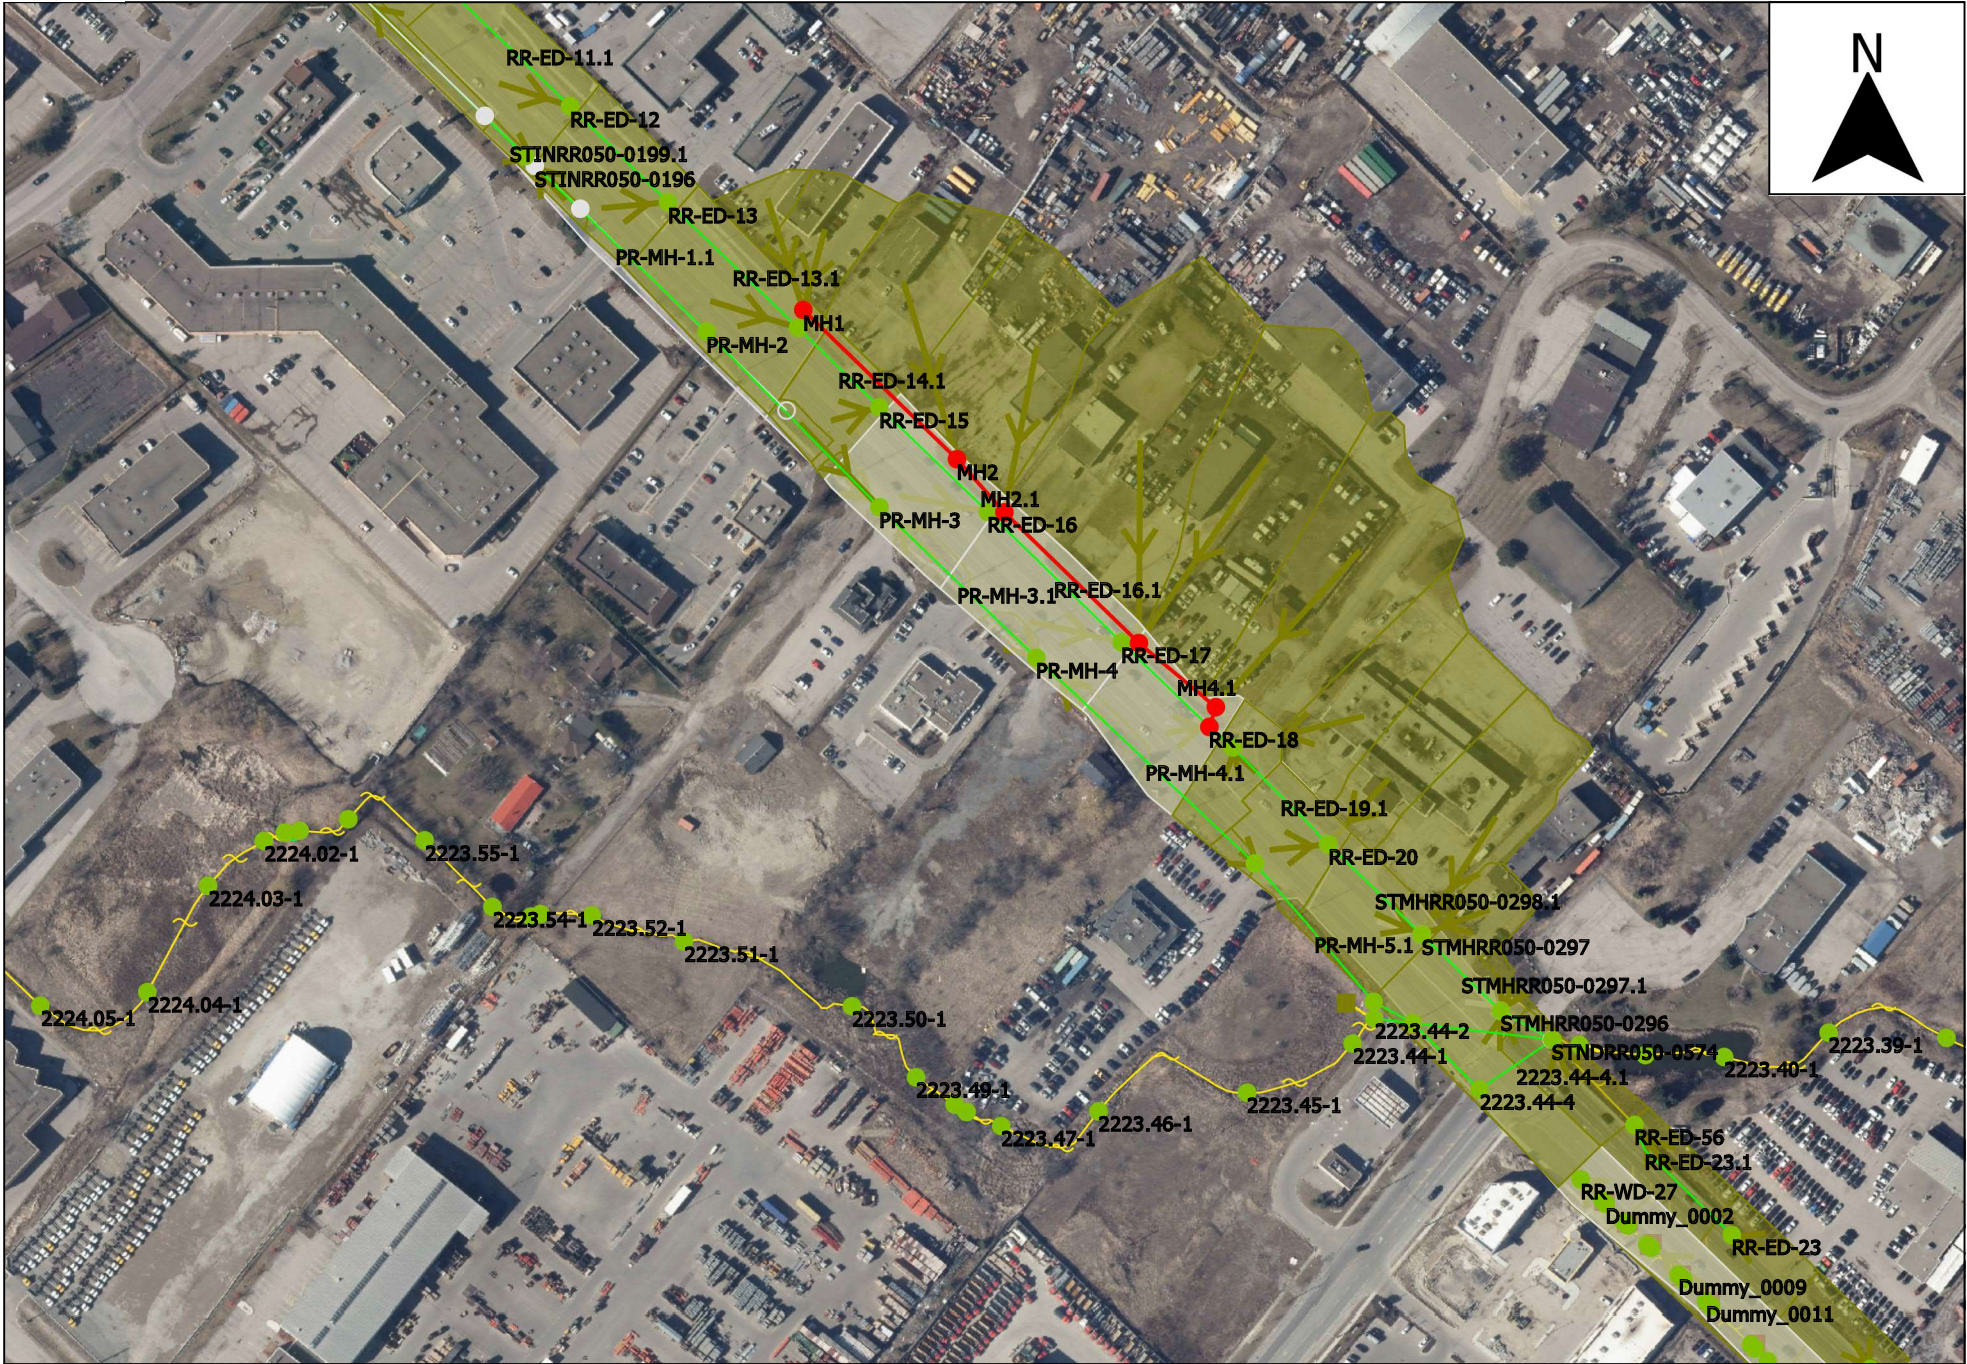
**PROPOSED CONDITION - 10-YEAR - EAST SIDE PLAN 2-1
(PROPOSED STORM SEWERS UNDERNEATH THE PROPOSED SIDEWALK)**

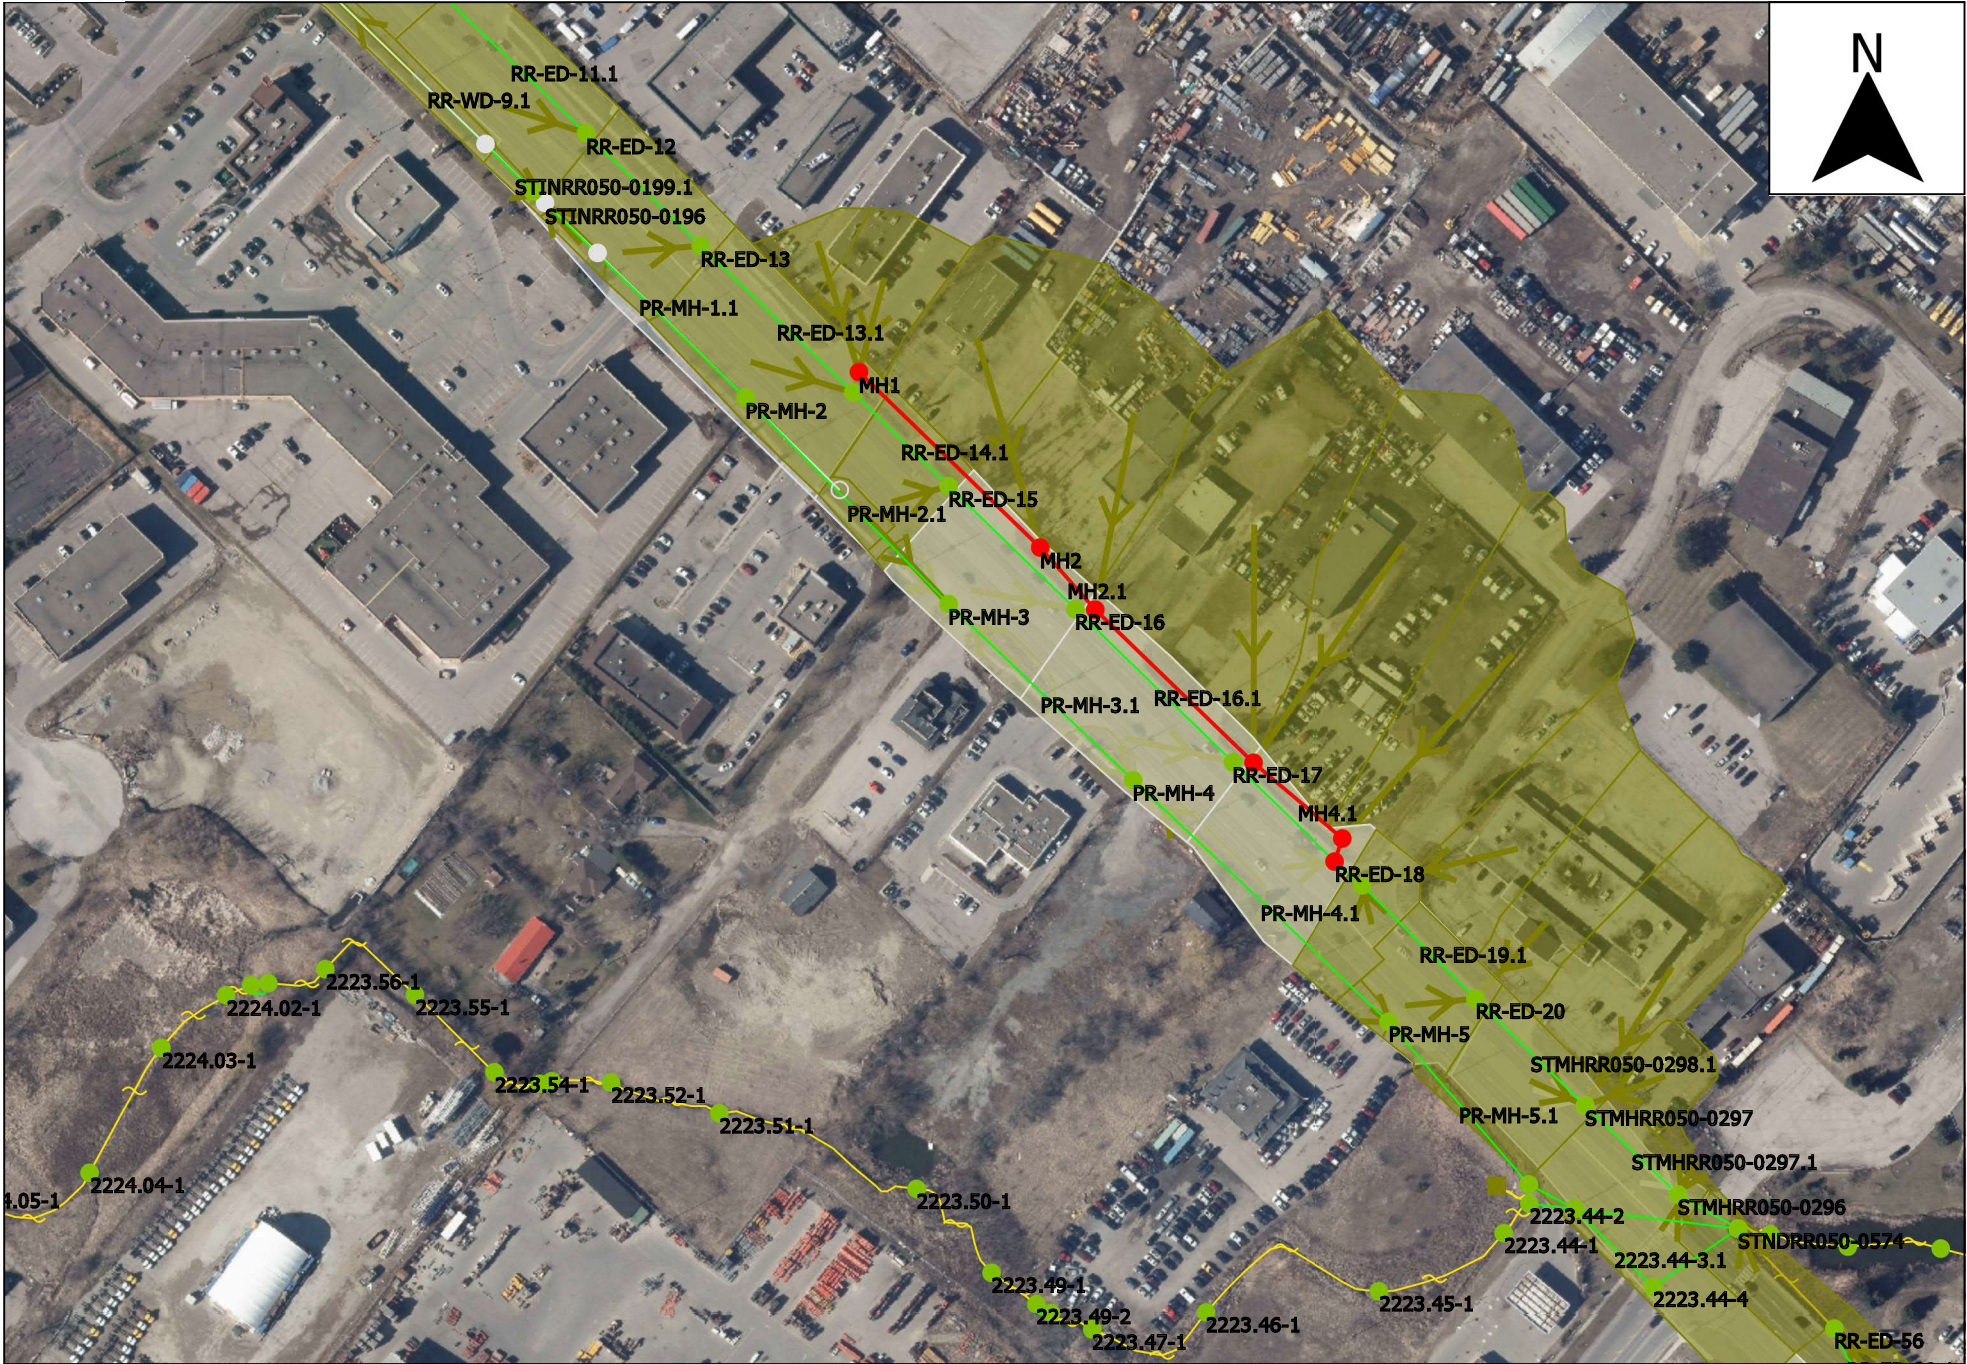
**PROPOSED CONDITION - 100-YEAR - EAST SIDE PLAN 2-1
(PROPOSED STORM SEWERS UNDERNEATH THE PROPOSED SIDEWALK)**

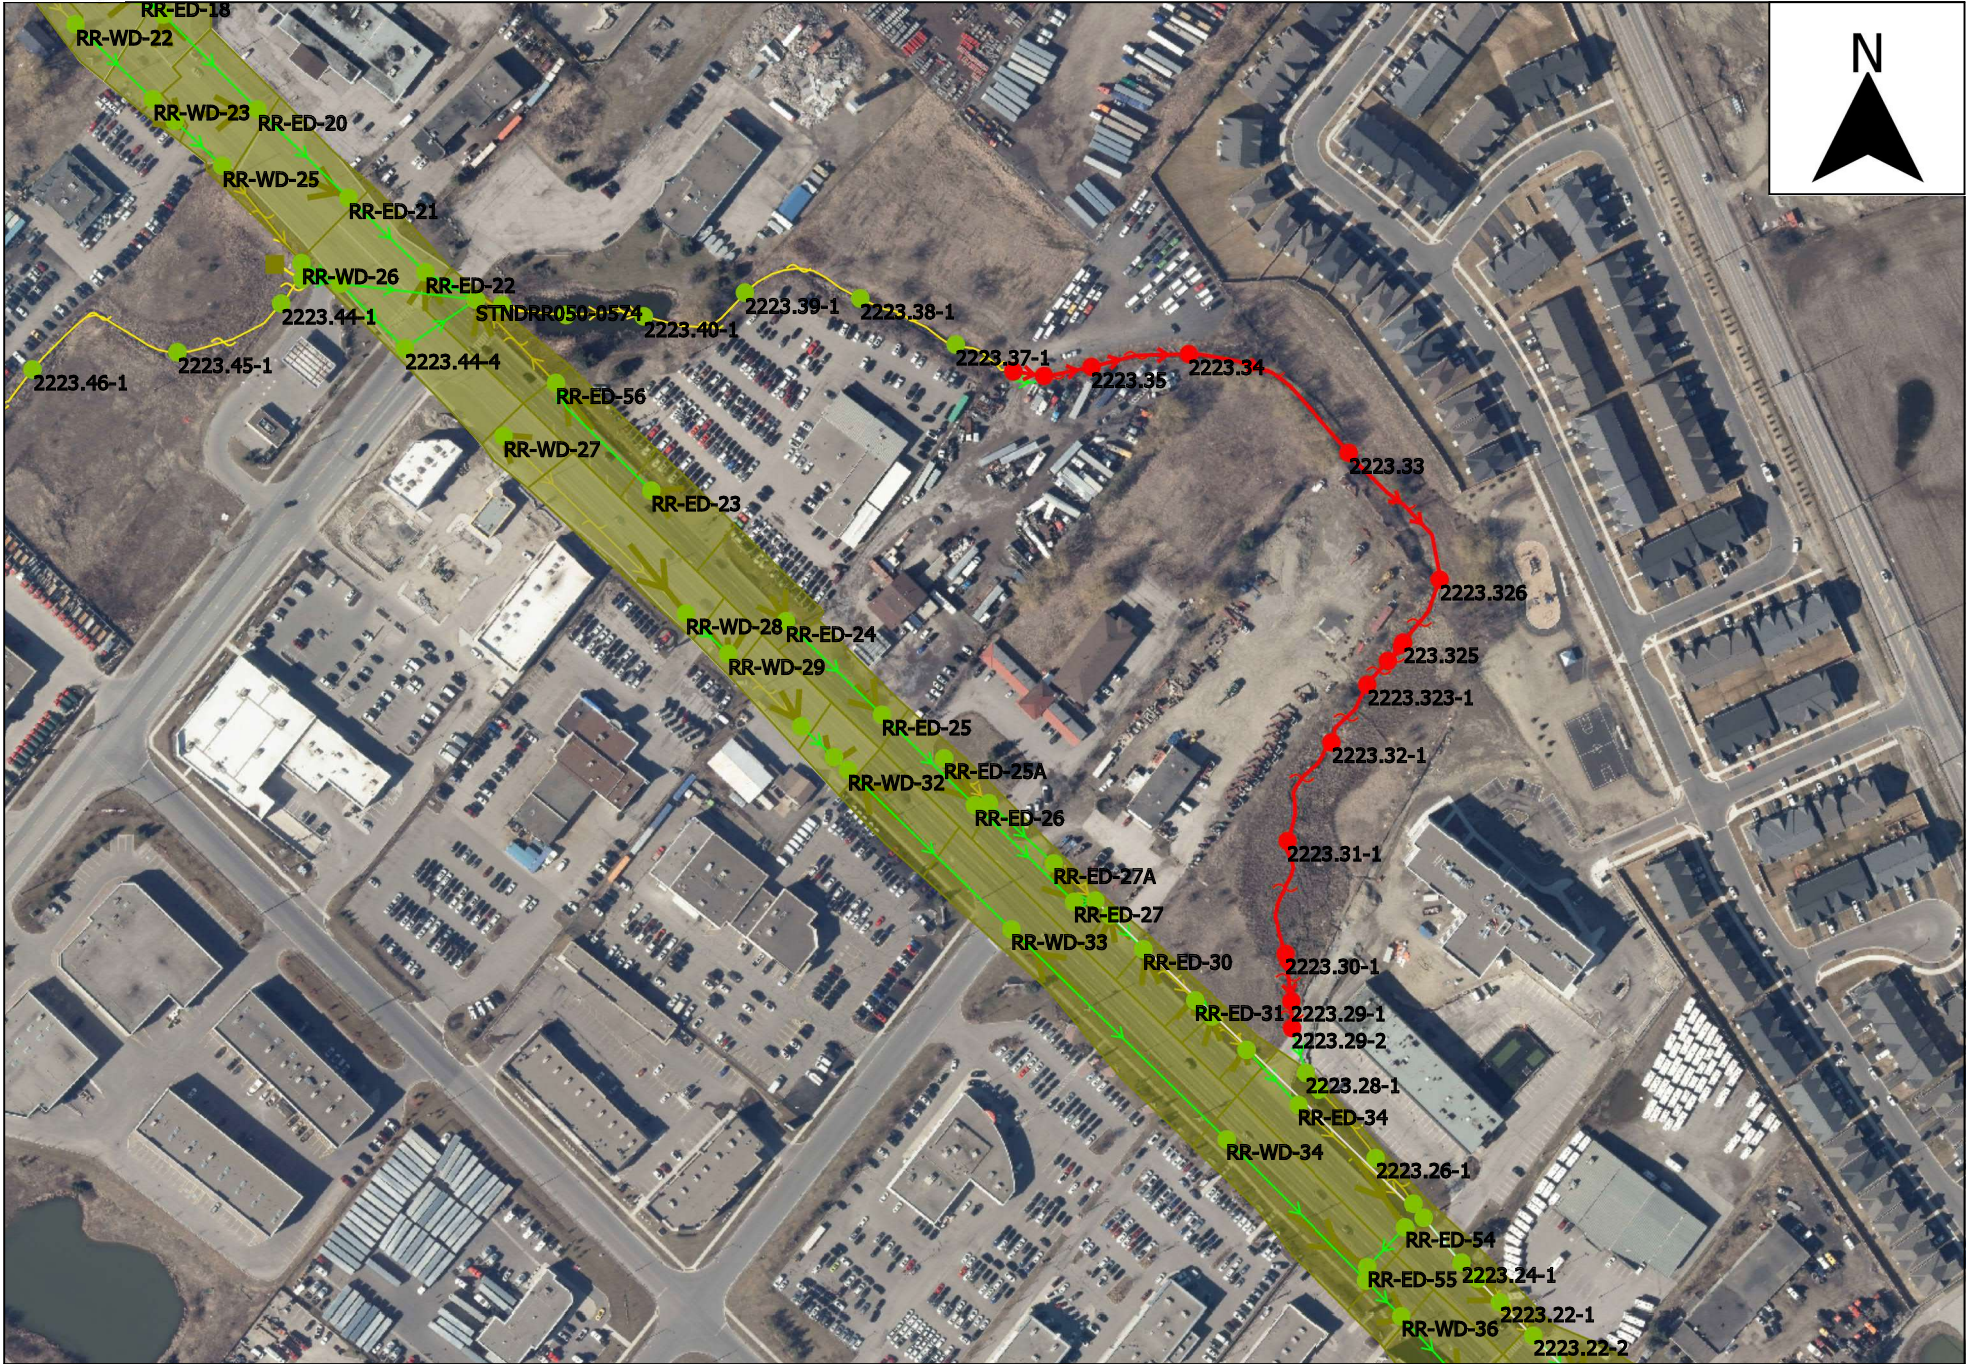
PROPOSED CONDITION - 100-YEAR - EAST SIDE PROFILE 3

Link	-	2223.42.1	2223.41-1.1	2223.40-1.1	2223.39-1.1	2223.38-1.1	2223.37-1.1	
US node ID	-	2223.42	2223.41-1	2223.40-1	2223.39-1	2223.38-1	2223.37-1	
ds node	2223.42	2223.41-1	2223.40-1	2223.39-1	2223.38-1	2223.37-1	2223.37-2	
numbarrels	1	1	1	1	1	1	1	
Length (m)	11.3	26.0	31.0	46.2	51.6	42.6	26.6	
Shape ID	-	Matrix-2223.42	Matrix-2223.41	Matrix-2223.40	Matrix-2223.39	Matrix-2223.38	Matrix-2223.37	
us inv (m AD)	235.653	235.652	235.651	235.600	234.750	234.500	233.650	
ds inv (m AD)	235.652	235.651	235.600	234.750	234.500	233.650	233.510	
grad (m/m)								
US depth (m)	0.957	0.874	0.849	0.890	1.255	1.238	2.012	
US flow (m3/s)	7.89915	7.89915	7.89914	7.89912	7.89930	7.90986	8.48899	
US velocity (m/s)	1.195	0.608	0.427	2.134	1.692	1.890	1.230	
r.pfc (m3/s)	20.564	18.000	96.350	96.539	112.156	176.862	97.931	
Node	-	2223.42	2223.41-1	2223.40-1	2223.39-1	2223.38-1	2223.37-1	-
Node ID	-	2223.42	2223.41-1	2223.40-1	2223.39-1	2223.38-1	2223.37-1	-

ground (m AD)	238.500	238.500	238.500	238.400	238.300	238.000	237.500	
level (m AD)	-	236.526	236.500	236.490	236.005	235.738	235.662	235.651
expr:Freeboard	-	1.974167	2.000488	2.009644	2.395010	2.561703	2.337555	-

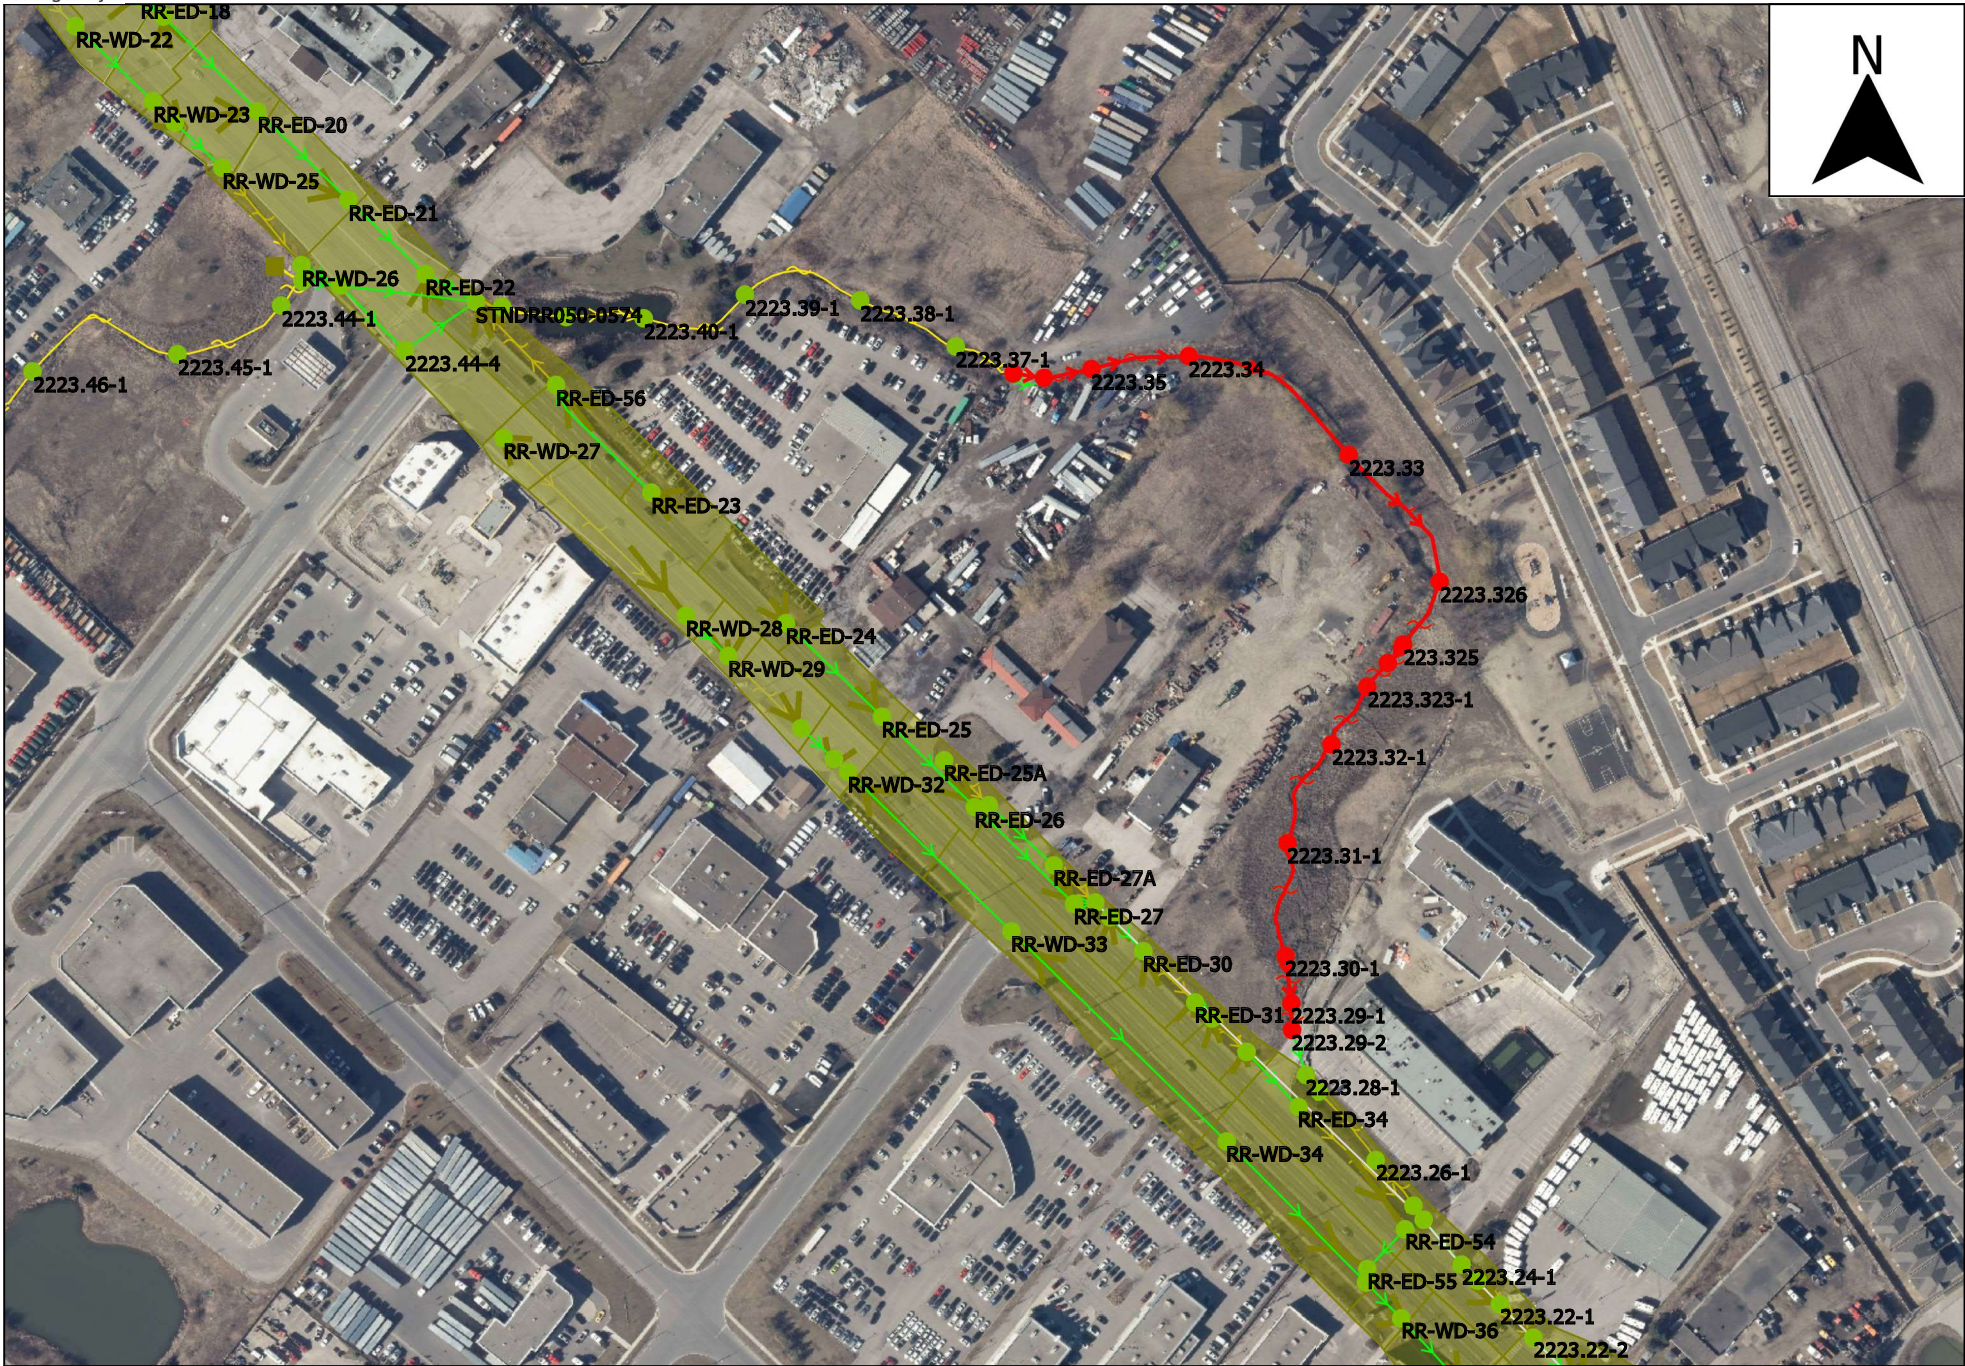
PROPOSED CONDITION - 10-YEAR - EAST SIDE PROFILE 4

Link	-	-	2223.35.1	2223.34.1	2223.33.1	2223.326.1	-	-	-	2223.32-1.1	2223.31-1.1	-	-
US node ID	-	-	2223.35	2223.34	2223.33	2223.326	-	-	2223.323-1	2223.32-1	2223.31-1	-	-
ds node	-	-	2223.34	2223.33	2223.326	223.325	-	-	2223.32-1	2223.31-1	2223.30-1	-	-
numbarrels	1	1	1	1	1	1	1	1	1	1	1	1	1
length (m)	11.4	-	-	-	-	-	-	-	-	-	-	-	-
Shape ID	-	-	Matrix-2223.35	Matrix-2223.34	Matrix-2223.33	-	-	-	-	Matrix-2223.32	Matrix-2223.31	-	-
width (mm)	-	-	-	-	-	-	-	-	-	-	-	-	-
height (mm)	-	-	-	-	-	-	-	-	-	-	-	-	-
Rough type	N	-	-	-	-	-	-	-	-	-	-	-	-
us inv (m AD)	-	-	233.250	233.000	232.500	232.031	-	-	231.984	231.670	231.511	-	-
ds inv (m AD)	-	-	233.000	232.500	232.031	232.000	-	-	231.670	231.511	231.500	-	-
grad (m/m)	-	-	-	-	-	-	-	-	-	-	-	-	-
r.pfc (m3/s)	-	-	353.527	169.587	107.007	45.047	-	-	186.614	143.820	82.012	-	-
US depth (m)	-	0.847	0.810	0.695	0.606	0.773	-	-	0.611	0.857	0.764	0.746	-
US flow (m3/s)	-	-	5.47871	5.47871	5.47871	5.47871	-	-	5.47871	5.47871	5.47871	-	-

US velocity (m/s)	-	1.567	1.589	0.906	1.108	0.545	-	-	0.656	0.880	0.398	0.676	-
Node	-	2223.35	2223.34	2223.33	2223.326	-	-	-	2223.32-1	2223.31-1	2223.30-1	-	-
Node ID	-	2223.35	2223.34	2223.33	2223.326	-	-	-	2223.32-1	2223.31-1	2223.30-1	-	-
ground (m AD)	-	236.850	236.500	236.250	236.100	-	-	-	234.800	235.000	234.800	-	-
level (m AD)	-	234.060	233.695	233.106	232.804	-	-	-	232.527	232.275	232.246	-	-
expr:Freeboard	-	2.790292	2.804794	3.144073	3.295984	-	-	-	2.273450	2.725113	2.553815	-	-

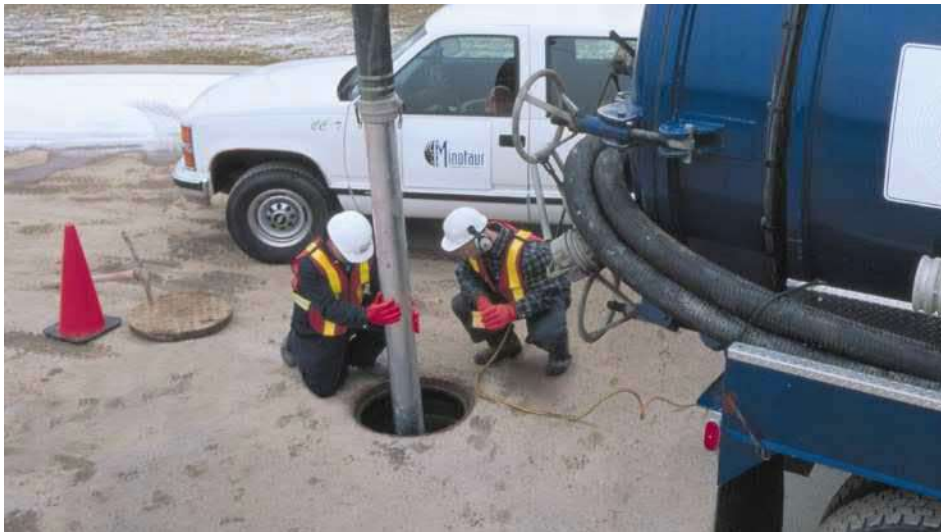
Figure 9

- Visually inspect the insert, weir, and drop pipe inlet opening to ensure there is no damage or blockage.
- **NOTE:** If the unit has an **outlet platform**, the outlet platform is typically in the UP position (see Figure 3A) for normal treatment conditions, and for inspection and maintenance. If manned entry into the unit is required, the outlet platform must first be placed in the DOWN position (see Figure 3B). After manned entry is completed, return the outlet platform to the UP position for treatment.

- When maintenance is required, a standard vacuum truck is used to remove the pollutants from the lower chamber of the unit through the **Outlet Riser**.
