**Appendix U**  
**Geotechnical and Pavement Assessment**

**Appendix U.1**  
**Geotechnical and Pavement Assessment**  
**for Mississauga Road/Old Main Street**  
**and Bush Street**

## PRELIMINARY PAVEMENT DESIGN REPORT

BUSH STREET (RR 11) AND MISSISSAUGA ROAD (RR 1)

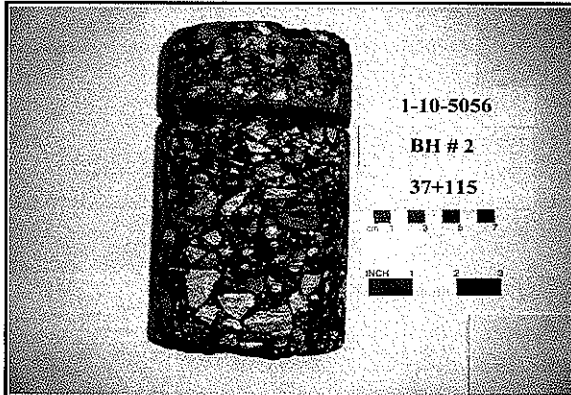
BH # 2

Type	Core (mm)
HL-3	90
HL-8	90
<b>Total</b>	<b>180</b>

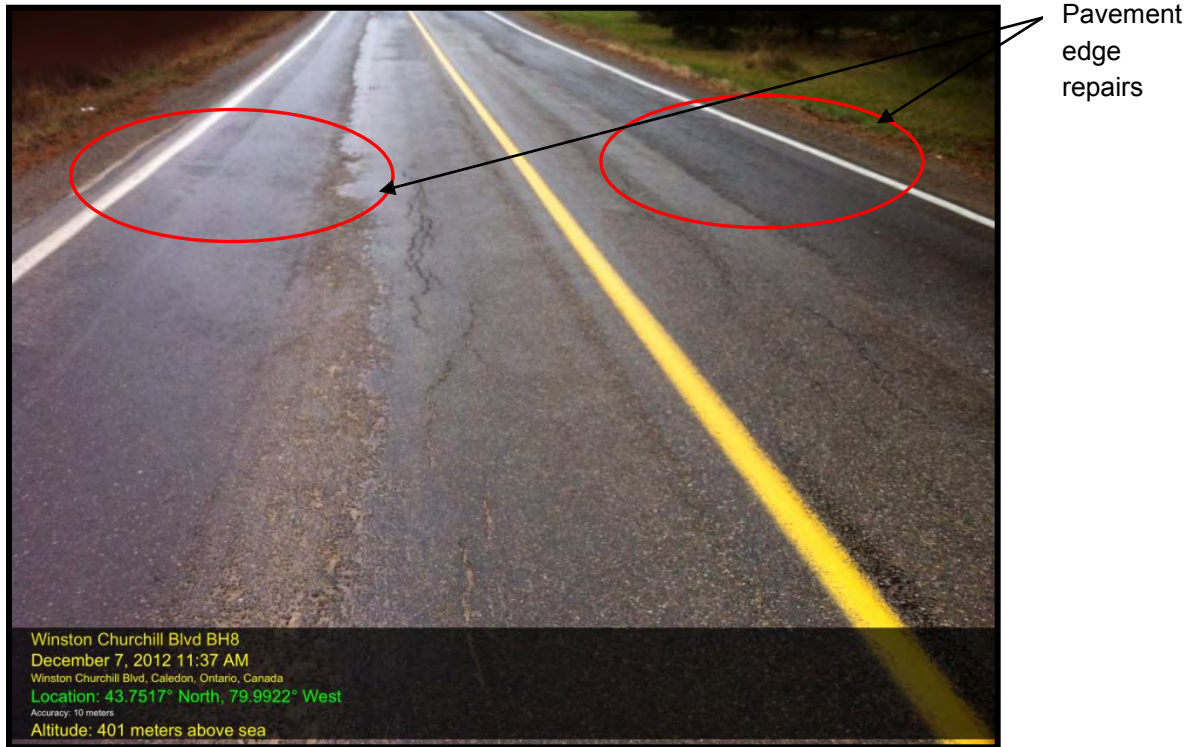
**Figure 1 Winston Churchill Blvd. - General Pavement Overview, noting extensive edge repairs**

Evidence of multiple rehabilitation efforts was observed in many areas along the roadway.

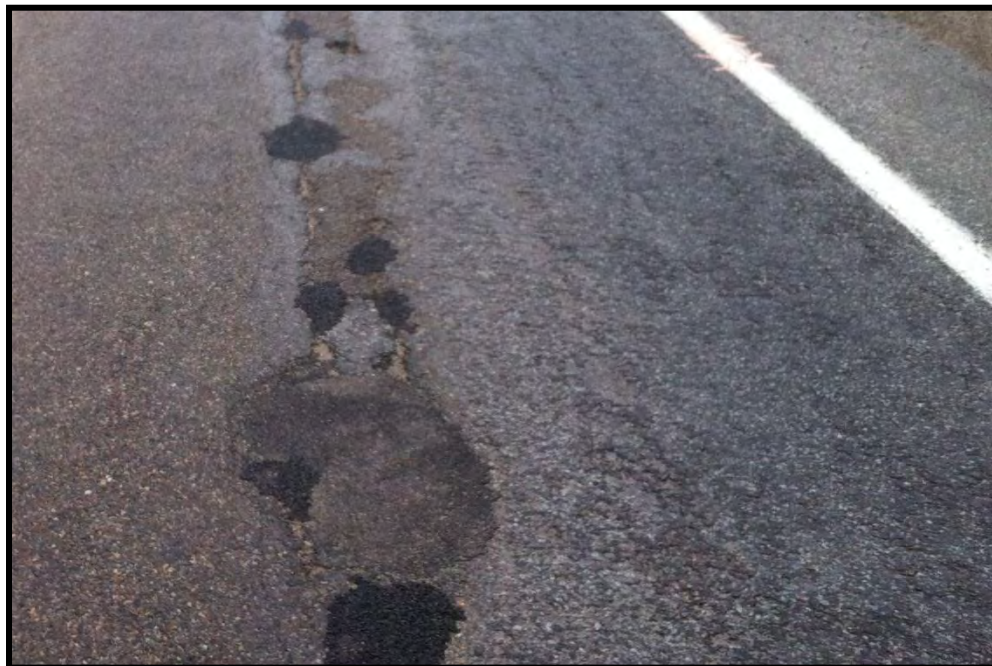
**Figure 2 Winston Churchill Blvd. - Close up on Pavement Surface Condition: Failing Patch Work, Severe Ravelling**

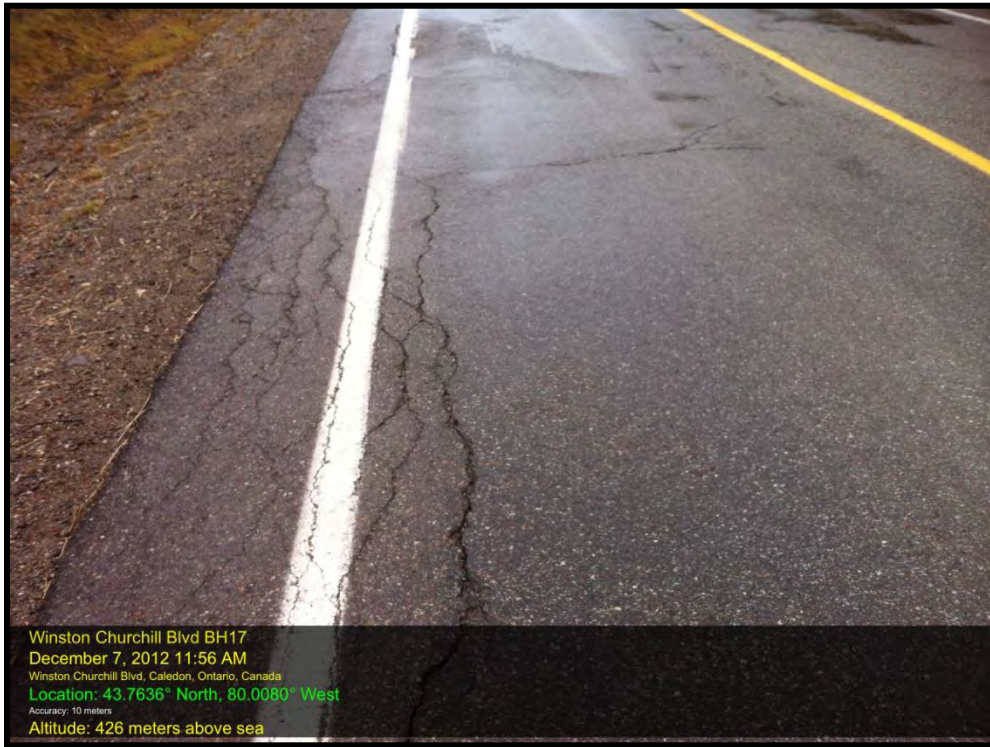
**Figure 3 Winston Churchill Blvd. - Pavement Edge Break/ Severe Cracking**

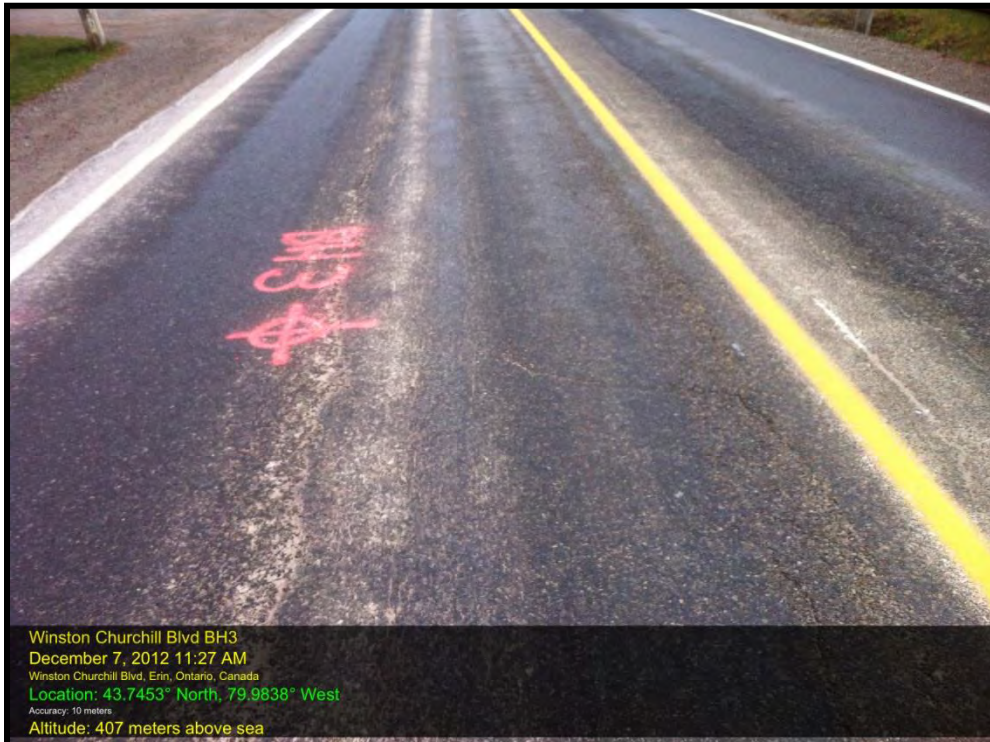
**Figure 4 Winston Churchill Blvd. - Surface Distortion (Wheel Path Rutting), and Flushing**

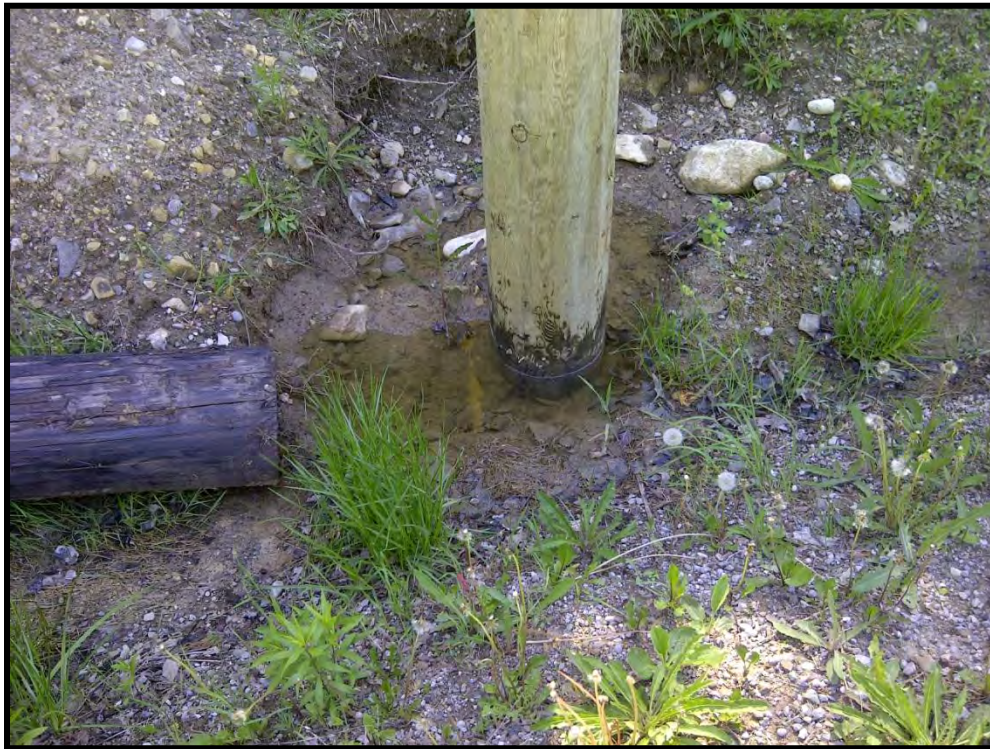
**Figure 5 Winston Churchill Blvd. - Depress Areas near a Hydro Pole in Shoulder**

Side ditches are generally in need of major maintenance. In some areas, siltation and heavy vegetation were observed, which impede the performance of effective drainage conditions. Occasionally, faulty longitudinal or horizontal grading created a “bath tub” effect in the local areas.

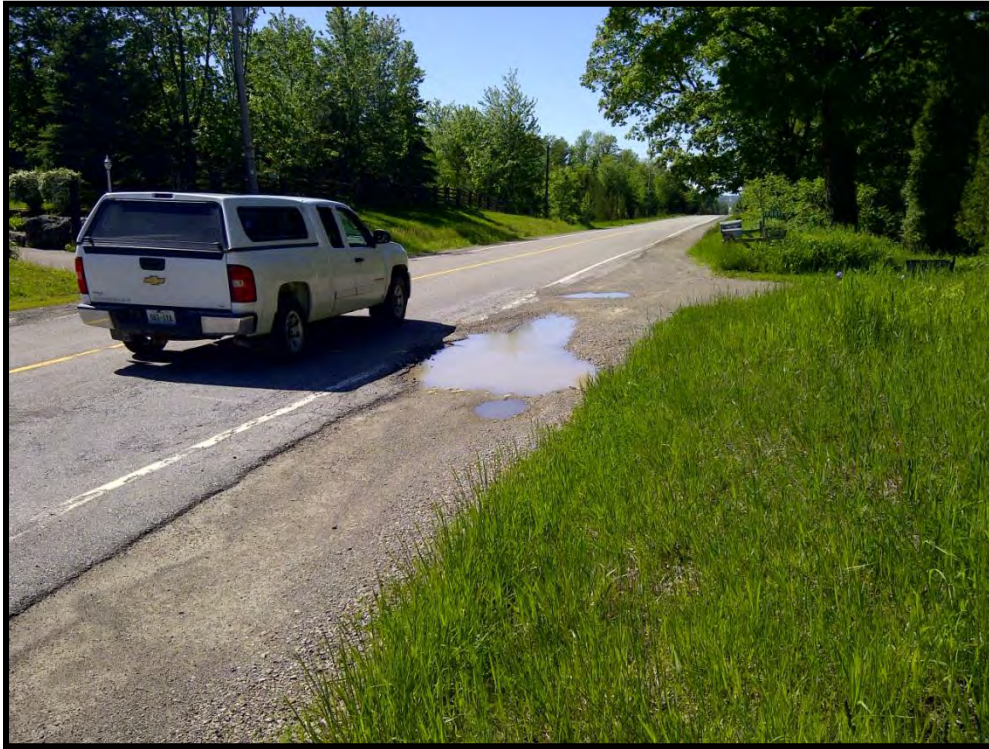
**Figure 6 Winston Churchill Blvd. - Ponding in Shoulder - Faulty Grading near Pavement Edge**

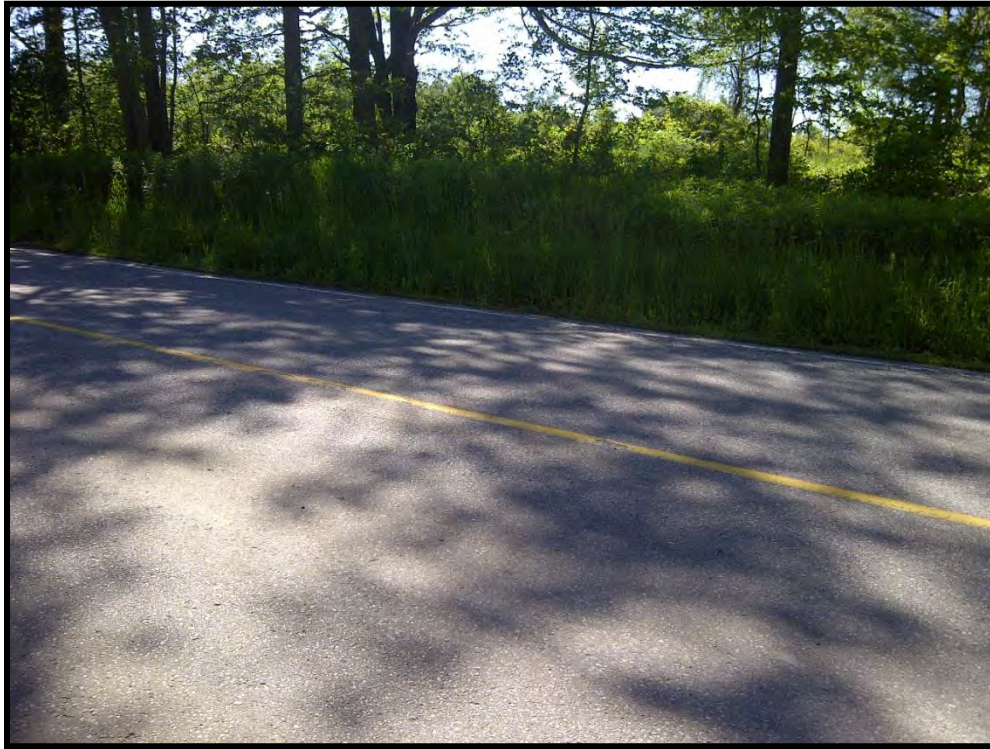
**Figure 7 Olde Base Line - Typical Condition of Roadway**

The pavement condition along Olde Base Line Road is visually fair to poor with extensive sections of narrow shoulders. The pavement structure is constructed on near or at-grade with shallow side ditch flanking both sides of the road. The pavement distresses include frequent medium-severity cracking being observed throughout the project length. In isolated areas, it exhibits intermittent raveling and high-severity single and multiple cracking. Local depressions were observed elsewhere in the paved area.

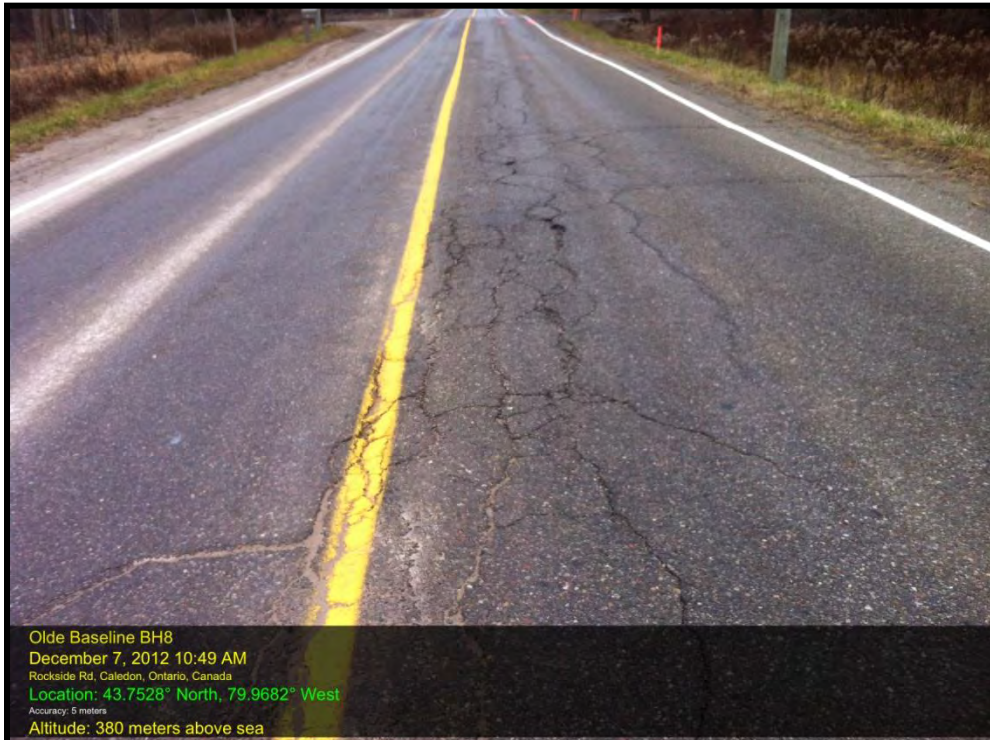
**Figure 8 Olde Base Line - Multiple High Severity Longitudinal Cracks**

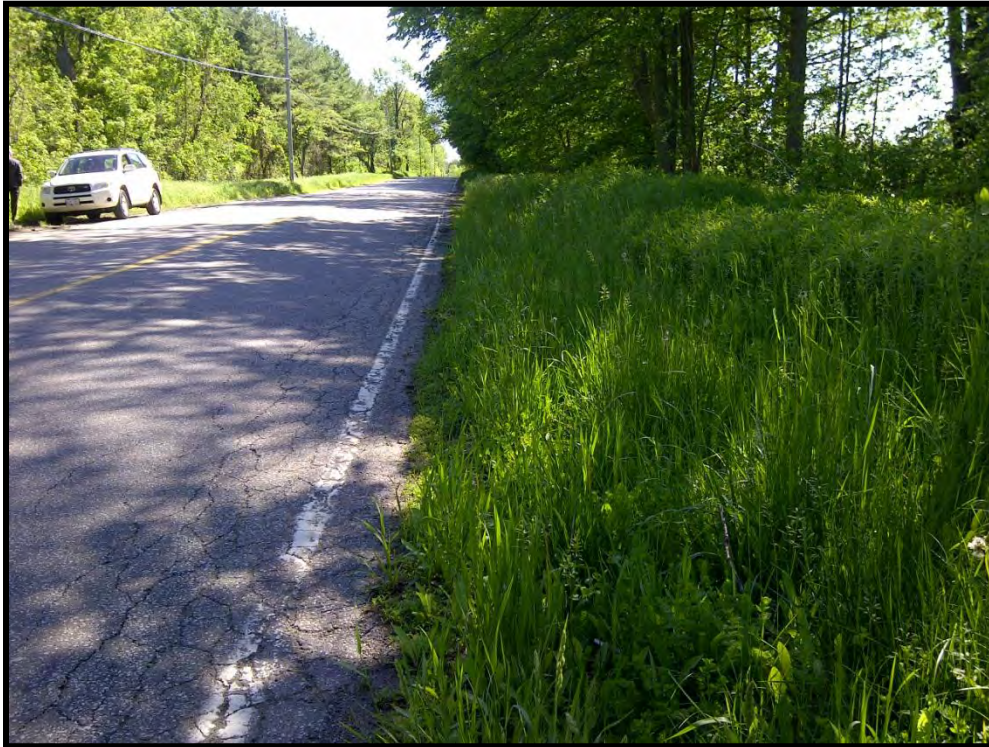
**Figure 9 Olde Base Line - Very Narrow (or No) Shoulder, Tall Grass, Extensive Pavement Edge Cracking**

Largely, a 0.6 to 1.2 m wide unpaved shoulder flanks each side of the road. The shoulders are generally unpaved. The overall condition of the shoulder is poor to fair.

Roadside ditches of the roadway appeared to be partially functional. Tall grass overgrowth was observed in many sections of the drainage ditches.

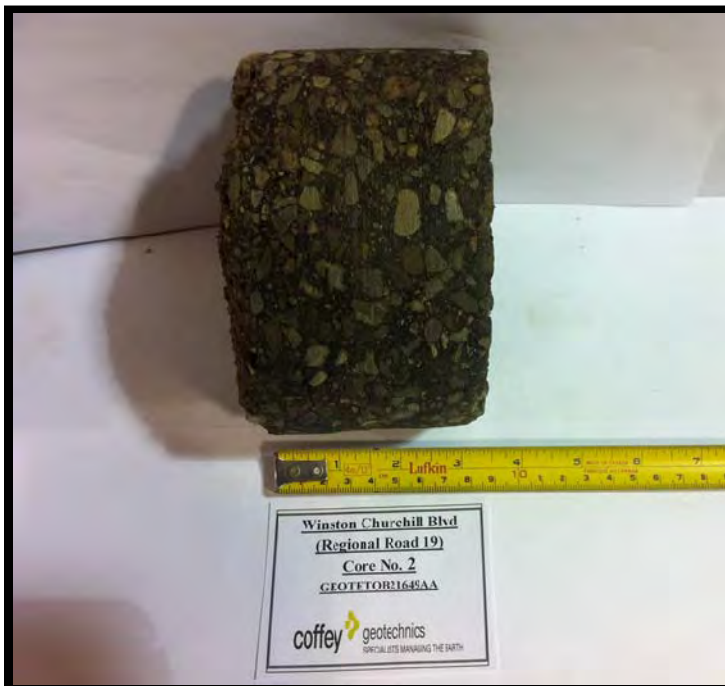
**Photograph No. (2)**

**Core No.:** 2  
**Station:** 1+650  
**Offset:** 1.8 m Rt C/L  
**Total Thickness:** 85 mm  
**Asphalt Mix Types**  
**& Thickness**  
Top 55mm HL3, 30mm HL4  
Bottom

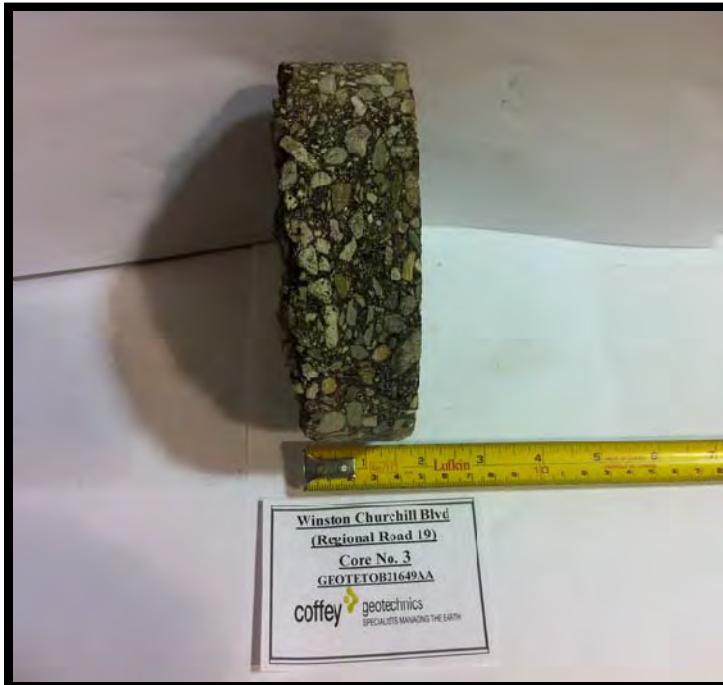
**Photograph No. (3)**

**Core No.:** 3  
**Station:** 2+650  
**Offset:** 1.5 m Lt C/L  
**Total Thickness:** 45 mm  
**Asphalt Mix Types**  
**& Thickness**  
45mm HL4

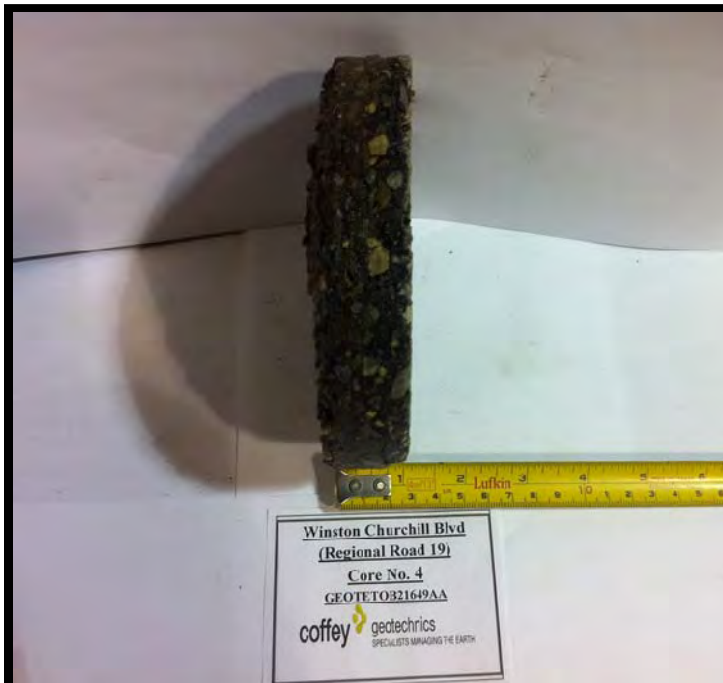
**Photograph No. (4)**

**Core No.:** 4  
**Station:** 3+650  
**Offset:** 2.1 m Rt C/L  
**Total Thickness:** 25 mm  
**Asphalt Mix Types**  
**& Thickness**  
25mm HL4

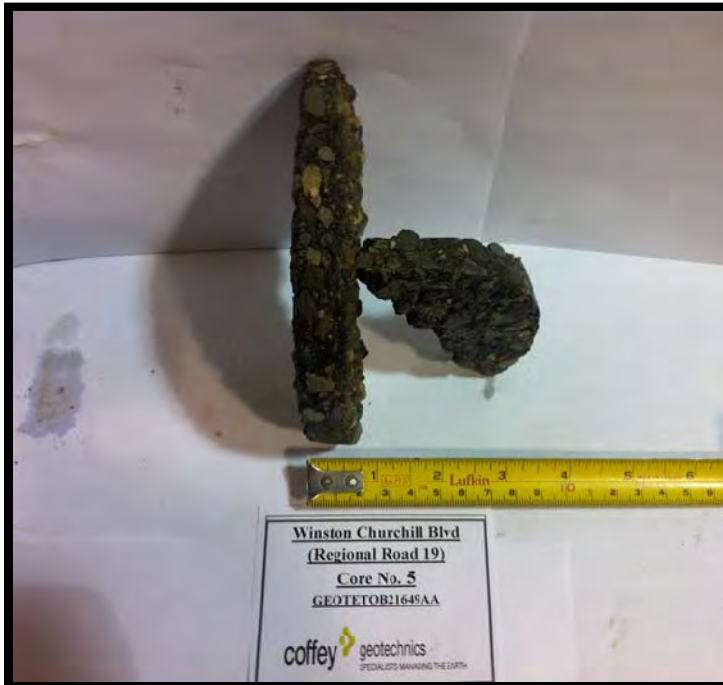
**Photograph No. (5)**

**Core No.:** 5  
**Station:** 4+650  
**Offset:** 1.1 m Lt C/L  
**Total Thickness:** 15 mm  
**Asphalt Mix Types**  
**& Thickness**  
15mm HL4

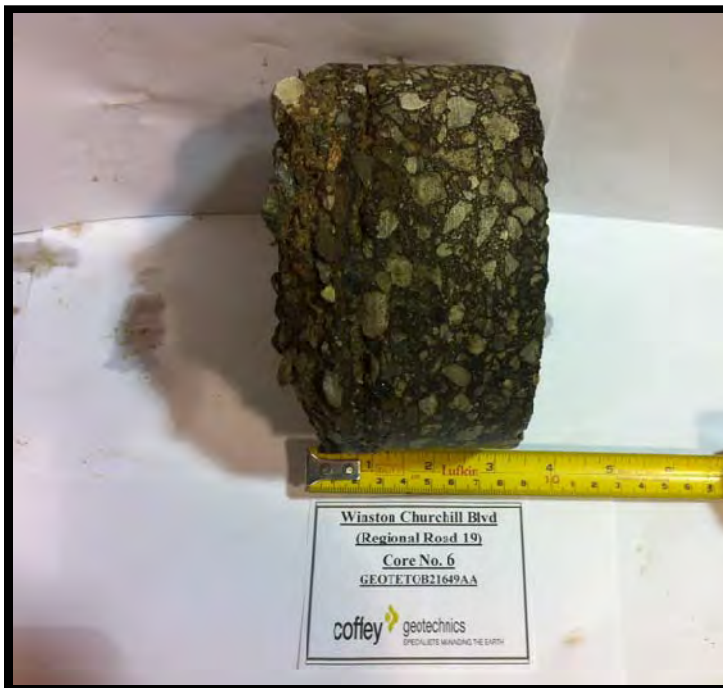
**Photograph No. (6)**

**Core No.:** 6  
**Station:** 5+650  
**Offset:** 1.9 m Rt C/L  
**Total Thickness:** 80 mm  
**Asphalt Mix Types**  
**& Thickness**  
Top 55mm HL3, 25mm HL4  
Bottom

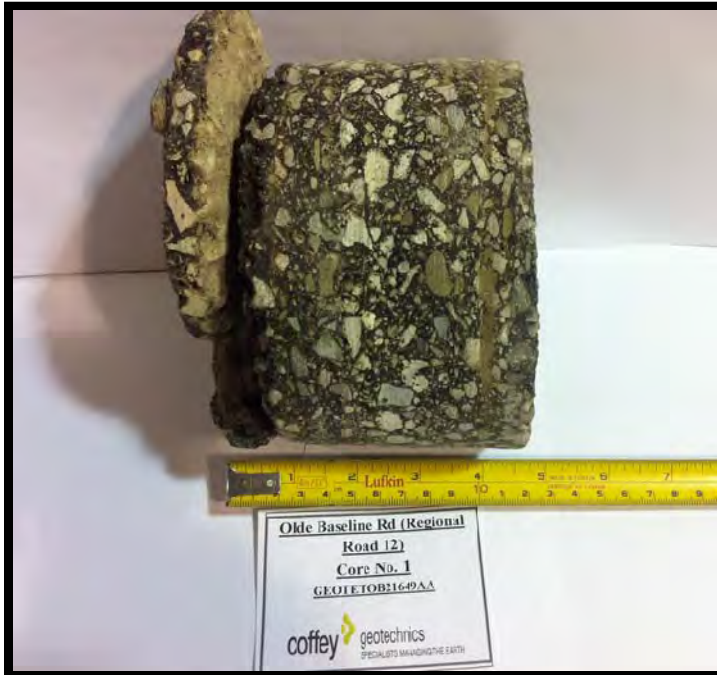
**Photograph No. (1)**

**Core No.:** 1  
**Station:** 0+455  
**Offset:** 2.4 m Rt C/L  
**Total Thickness:** 120 mm  
**Asphalt Mix Types & Thickness**  
Top 45mm HL3, 45mm HL3,  
30mm HL4 Bottom

Station	Offset from Hwy C/L (m)	Direction (Lt/Rt)	Core No.	Total Asphalt Thickness (mm)	Asphalt Mix Types and Thickness (mm)	Remarks
Olde Baseline Rd (Regional Road 12)						
0+455	2.40	Rt	1	120	Top 45 HL3, 45 HL3, 30 HL4 Bottom	Weak bonding between HL4 and HL3 layers
1+450	1.50	Lt	2	105	Top 60 HL3, 25 HL3, 20 HL4 Bottom	Weak bonding between layers
2+450	2.70	Rt	3	140	Top 55 HL3, 50 HL3, 35 HL4 Bottom	Weak bonding between layers
Count				3		
Minimum				105		
Maximum				140		
Mean				121.7

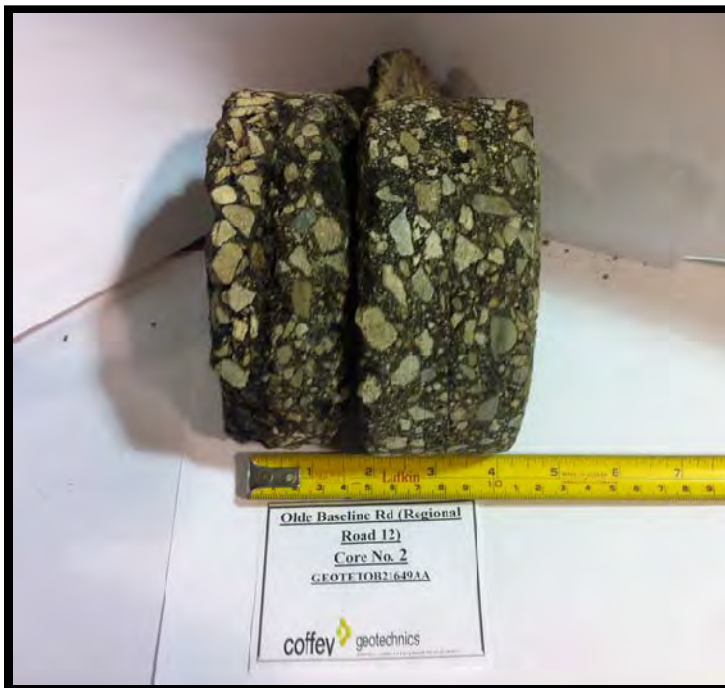
**Photograph No. (2)**

**Core No.:** 2  
**Station:** 1+450  
**Offset:** 1.5 m Lt C/L  
**Total Thickness:** 105 mm  
**Asphalt Mix Types & Thickness**  
Top 60mm HL3, 25mm HL3,  
20mm HL4 Bottom
