Appendix O

Structural Memo

Region of Halton

For the Bridge on Winston Churchill Blvd
 Located 2.70 km North of Steeles Avenue
 Structure No. 19-1196390 BR01

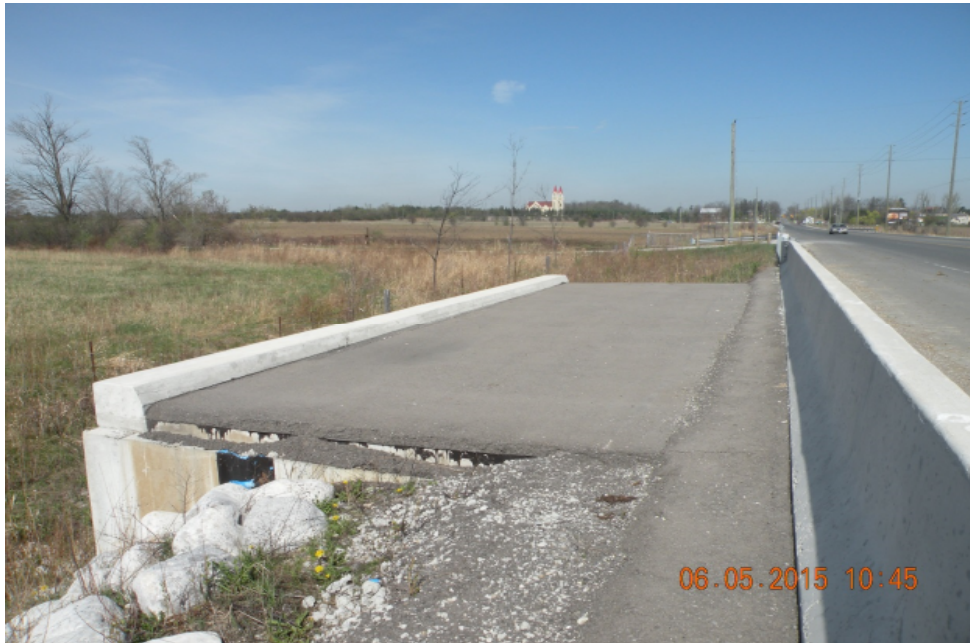
Extension and Header Wall on West Side
